Alabama Statewide Airport Pavement Management Program Update

Shelby County Airport (EET)

Final Report

February 2022

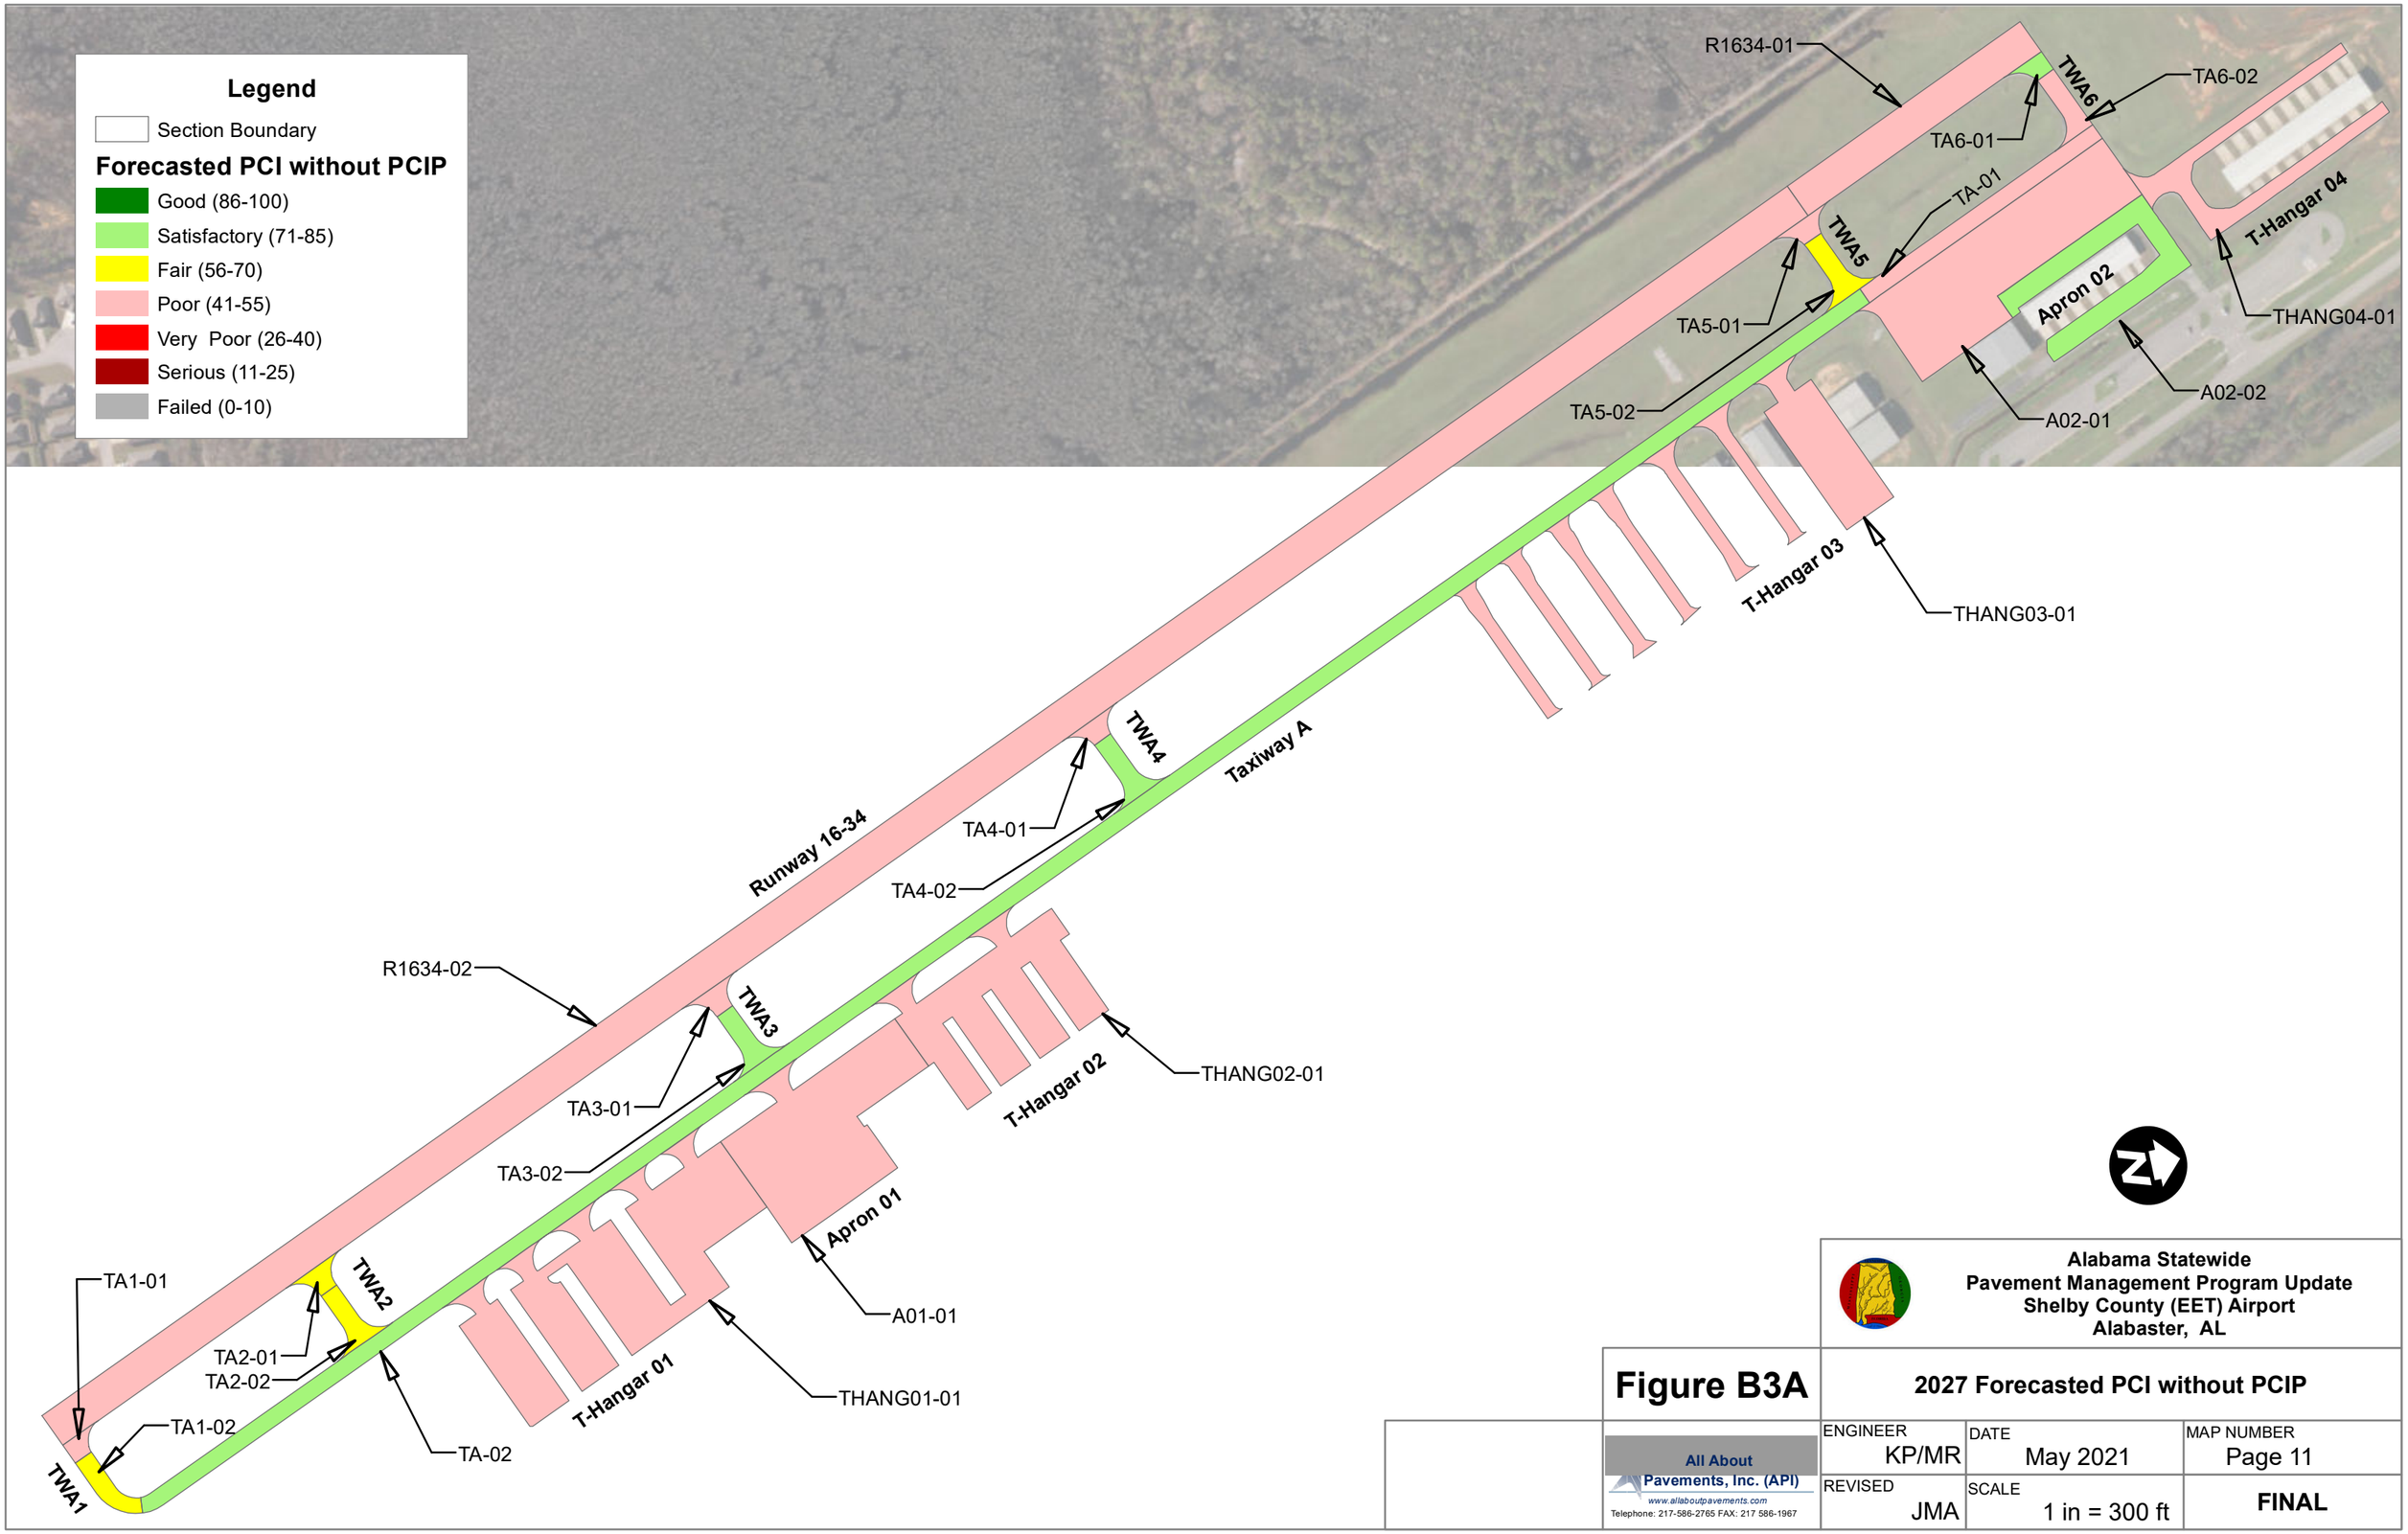
Figure B3A

Map B3A in Appendix B presents the 2027 forecasted PCI by section when the M&R activities recommended in the CIP are not conducted.
