Alabama Statewide Airport Pavement Management Program Update

Albertville Regional Airport-Thomas J Brumlik Field (8A0)

Final Report

February 2022

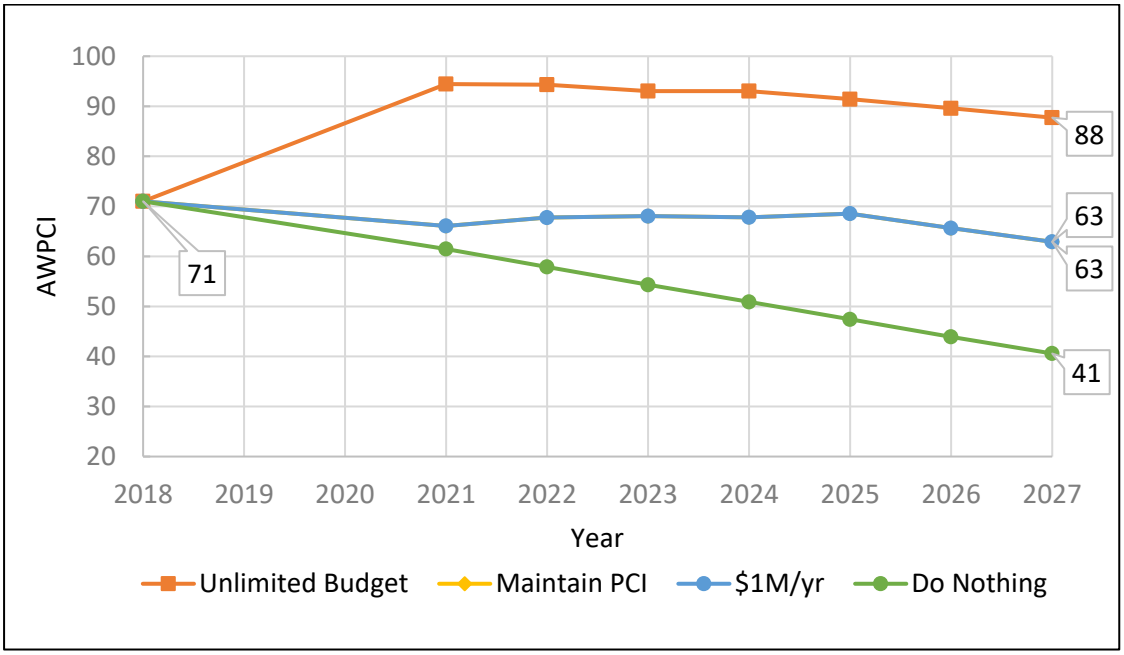
Figure ES-2: M&R Funding Levels.

The PAVER database was updated with 2018 condition data, maintenance and repair (M&R) policies, and unit costs; which were then used to evaluate the effect of multiple funding levels on the overall future pavement condition. Figure ES-2 presents the forecasted 8A0 network PCI values for each funding level.

The analysis output from the unlimited funding budget scenario was used as a starting point in developing the PCIP. For this scenario, sections were grouped into projects to allow for a logical construction sequence. Table ES-2 summarizes the 7-year PCIP, which has an estimated total cost of approximately $8.2 million. These recommendations are based on a network-level evaluation. Project-level evaluations should be conducted prior to developing design and bid package documents.

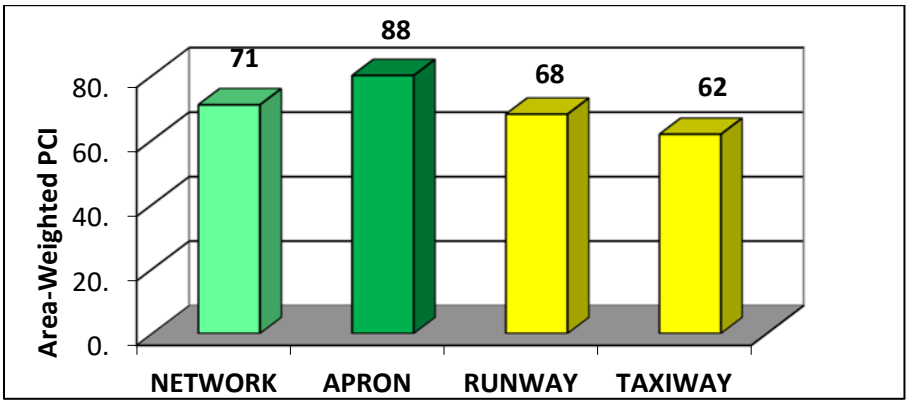
Figure 3.2: Pavement Condition by Branch Use.

Figure 3.2 presents the area-weighted PCI by use and the overall airside network.

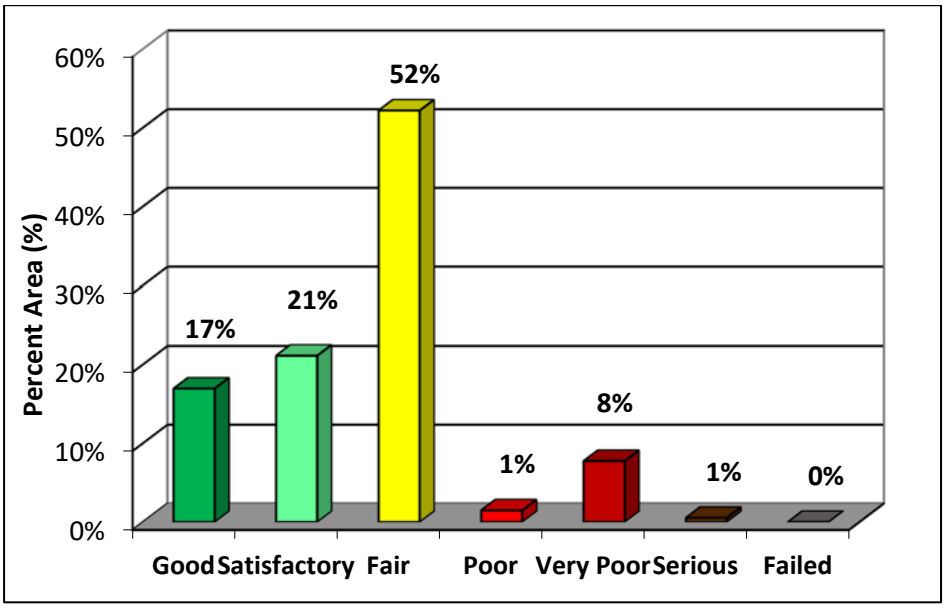
Figure 3.3: Pavement Condition by Percent of Area.

Figure 3.3 shows the distribution of the 8A0 pavement network by condition. Approximately 10 percent of the network is in "Poor" or worse condition.

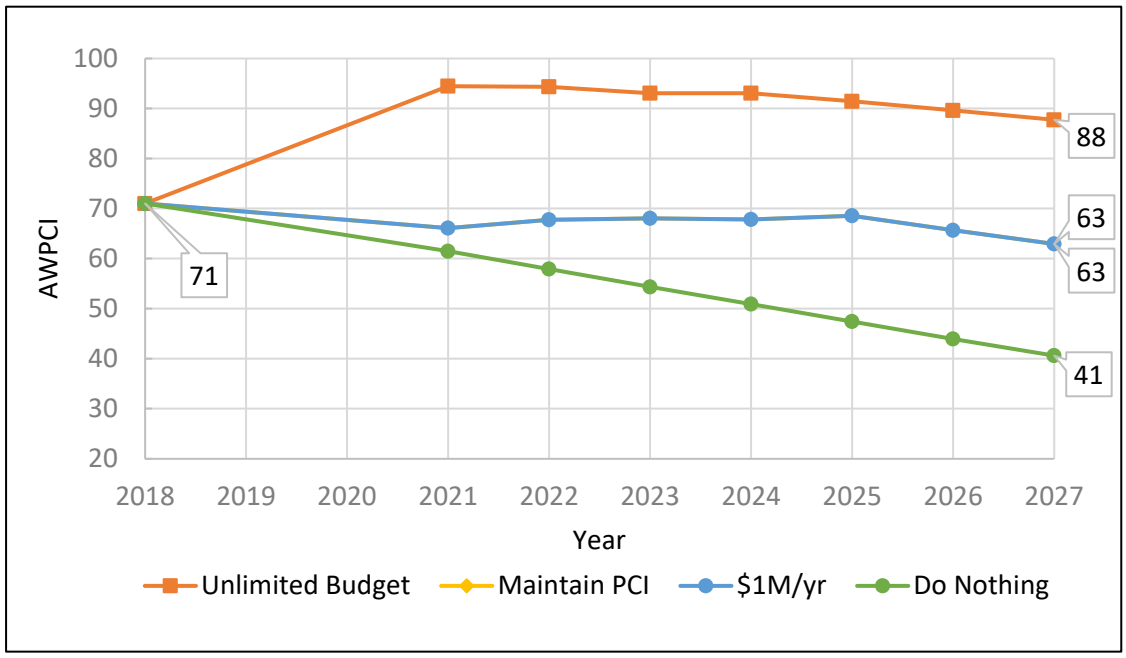
Figure 4.4: M&R Funding Levels.

The following M&R funding levels were used for the 8A0 pavement network to help establish the 7-Year PCIP. Figure 4.4 presents the network area-weighted average PCI for each of the following funding scenarios at the end of the analysis period:

- Unlimited Funding: Unlimited funding is available for all pavement needs. The PCI increases to 88 by 2027.
- Maintain PCI: Maintain existing PCI of 71.
- Constrained Funding: This scenario constrains the funding to $1 million each year (total of $7 million). The PCI decreases to 63 in 2027.
- Do Nothing: Performing no M&R would reduce the network PCI from 71 to 41 by 2027.

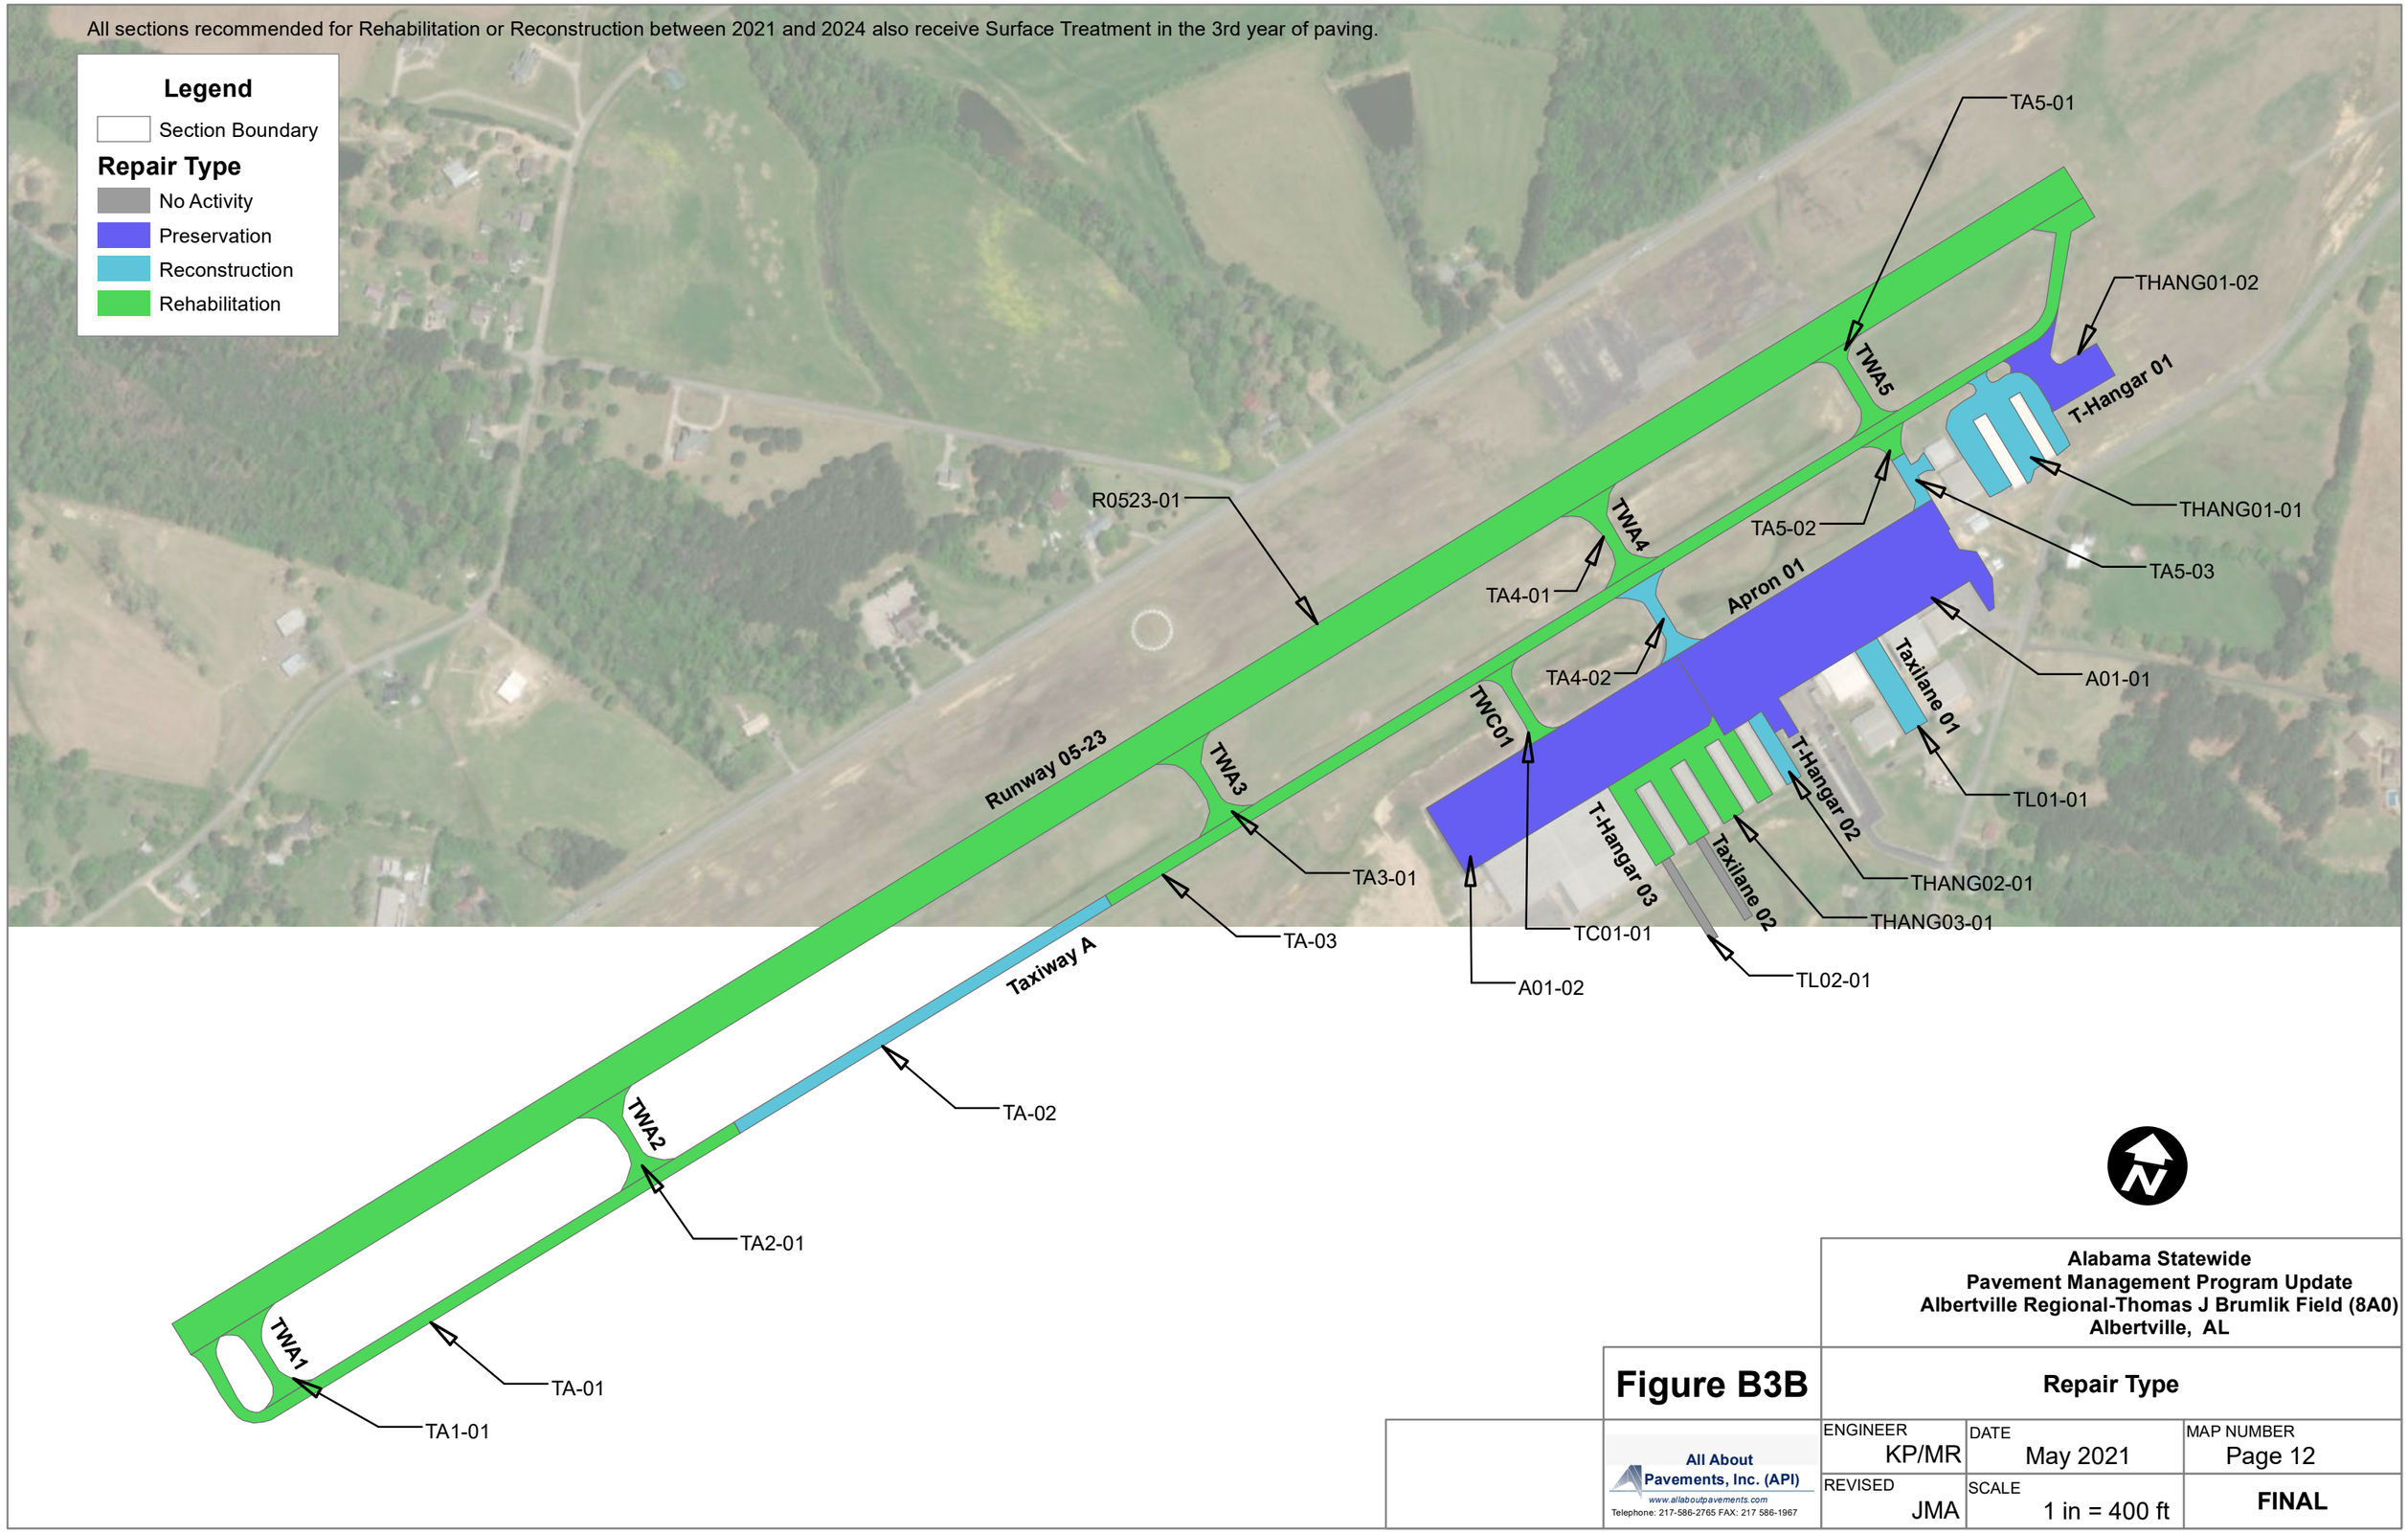
Figure B3B

All sections recommended for Mill & AC Overlay or AC Reconstruction between 2021 and 2024 also receive Surface Treatment in the 3rd year of paving
