Alabama Statewide Airport Pavement Management Program Update

Cullman Regional Airport-Folsom Field (CMD)

Final Report

February 2022

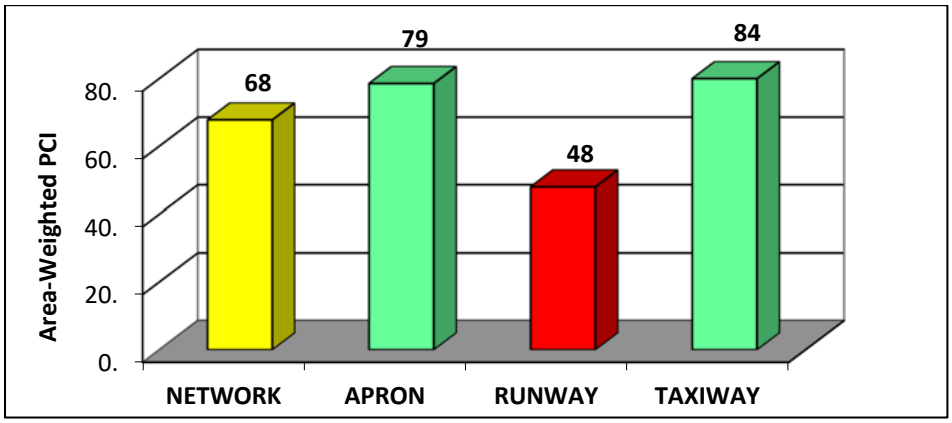
Figure 3.2: Pavement Condition by Branch Use.

Figure 3.2 presents the area-weighted PCI by use and the overall airside network.

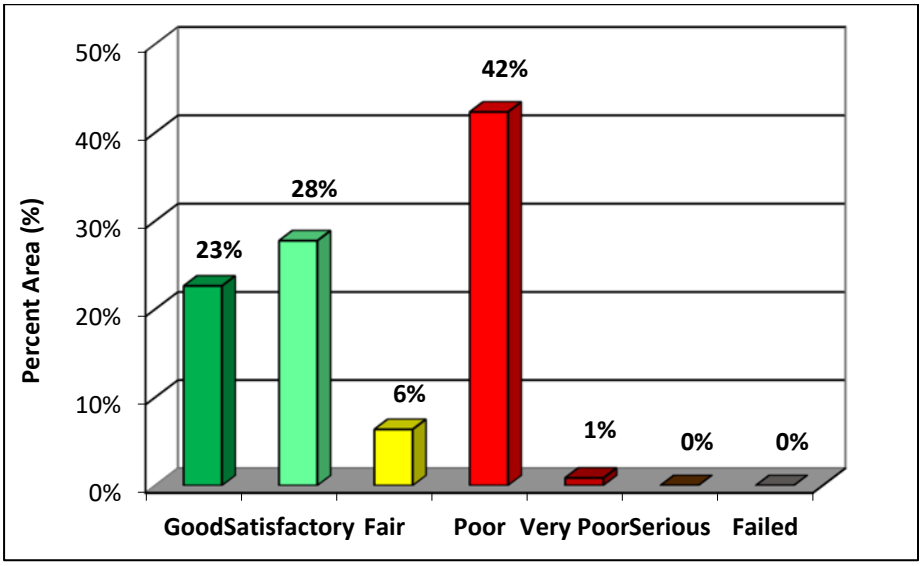
Figure 3.3: Pavement Condition by Percent of Area.

Figure 3.3 shows the distribution of the CMD pavement network by condition. Approximately 43 percent of the network is in "Poor" or worse condition.

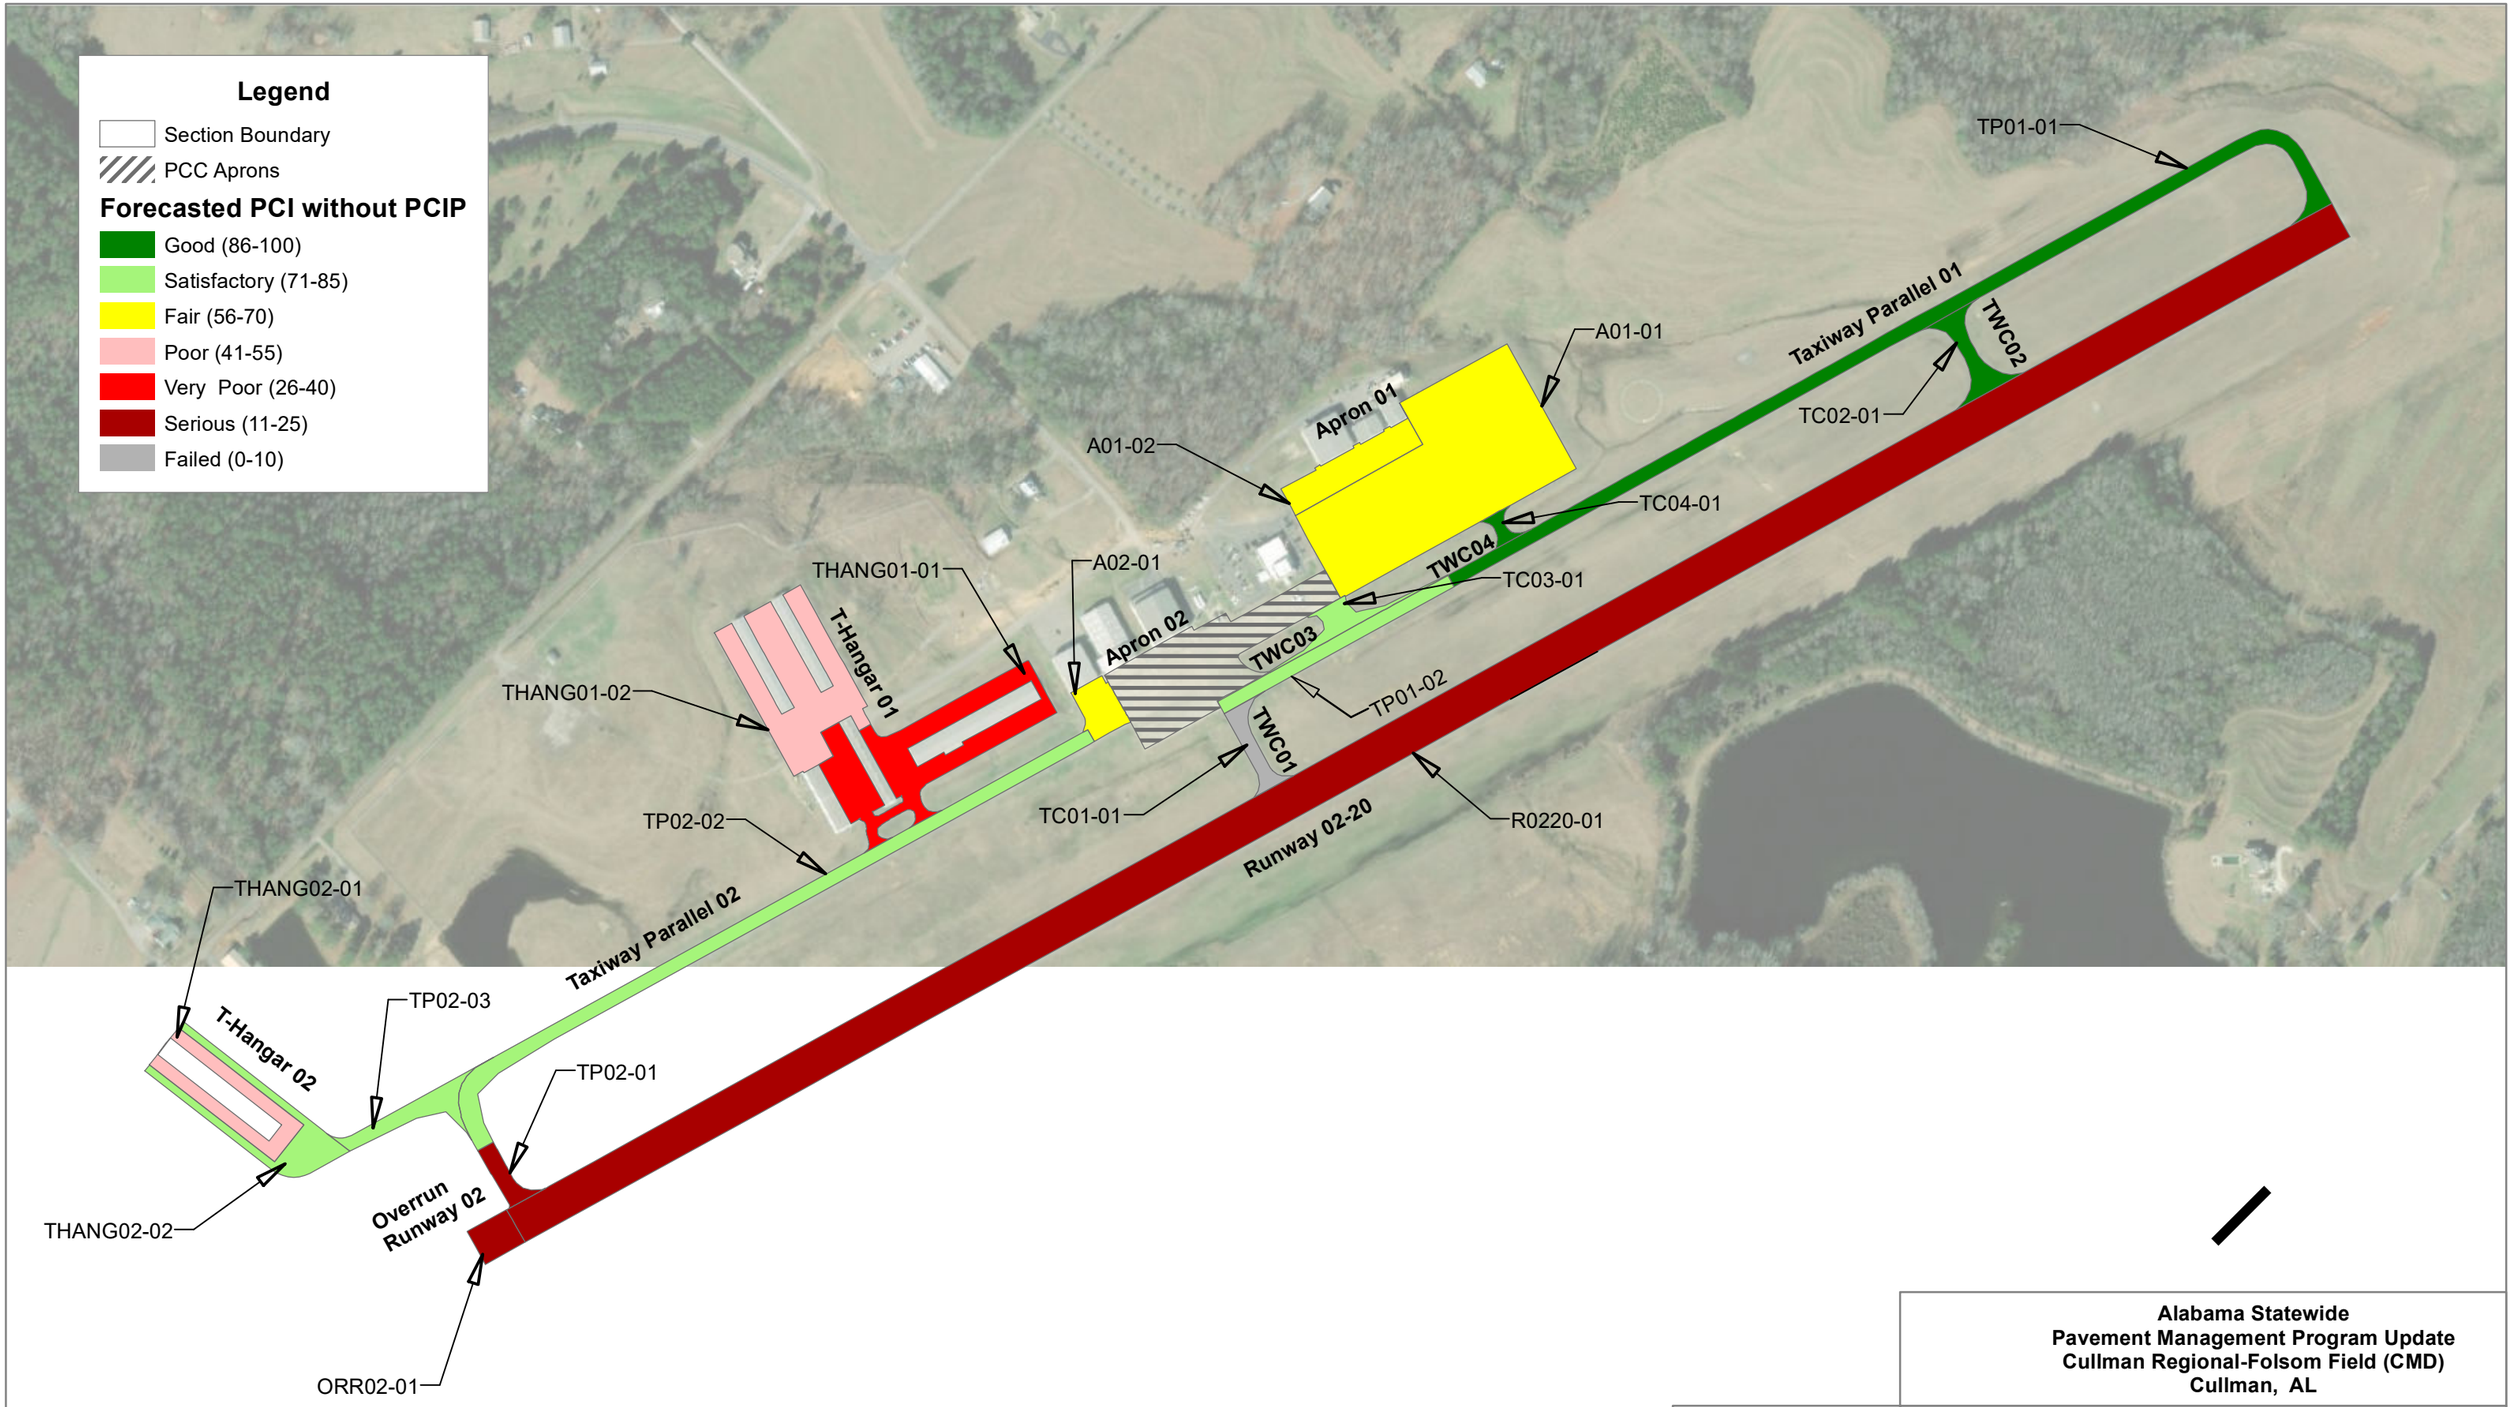
Figure B3A

Map B3A in Appendix B presents the 2027 forecasted PCI by section when the M&R activities recommended in the CIP are not conducted.
