Alabama Statewide Airport Pavement Management Program Update

Northeast Alabama Regional Airport (GAD)

Final Report

February 2022

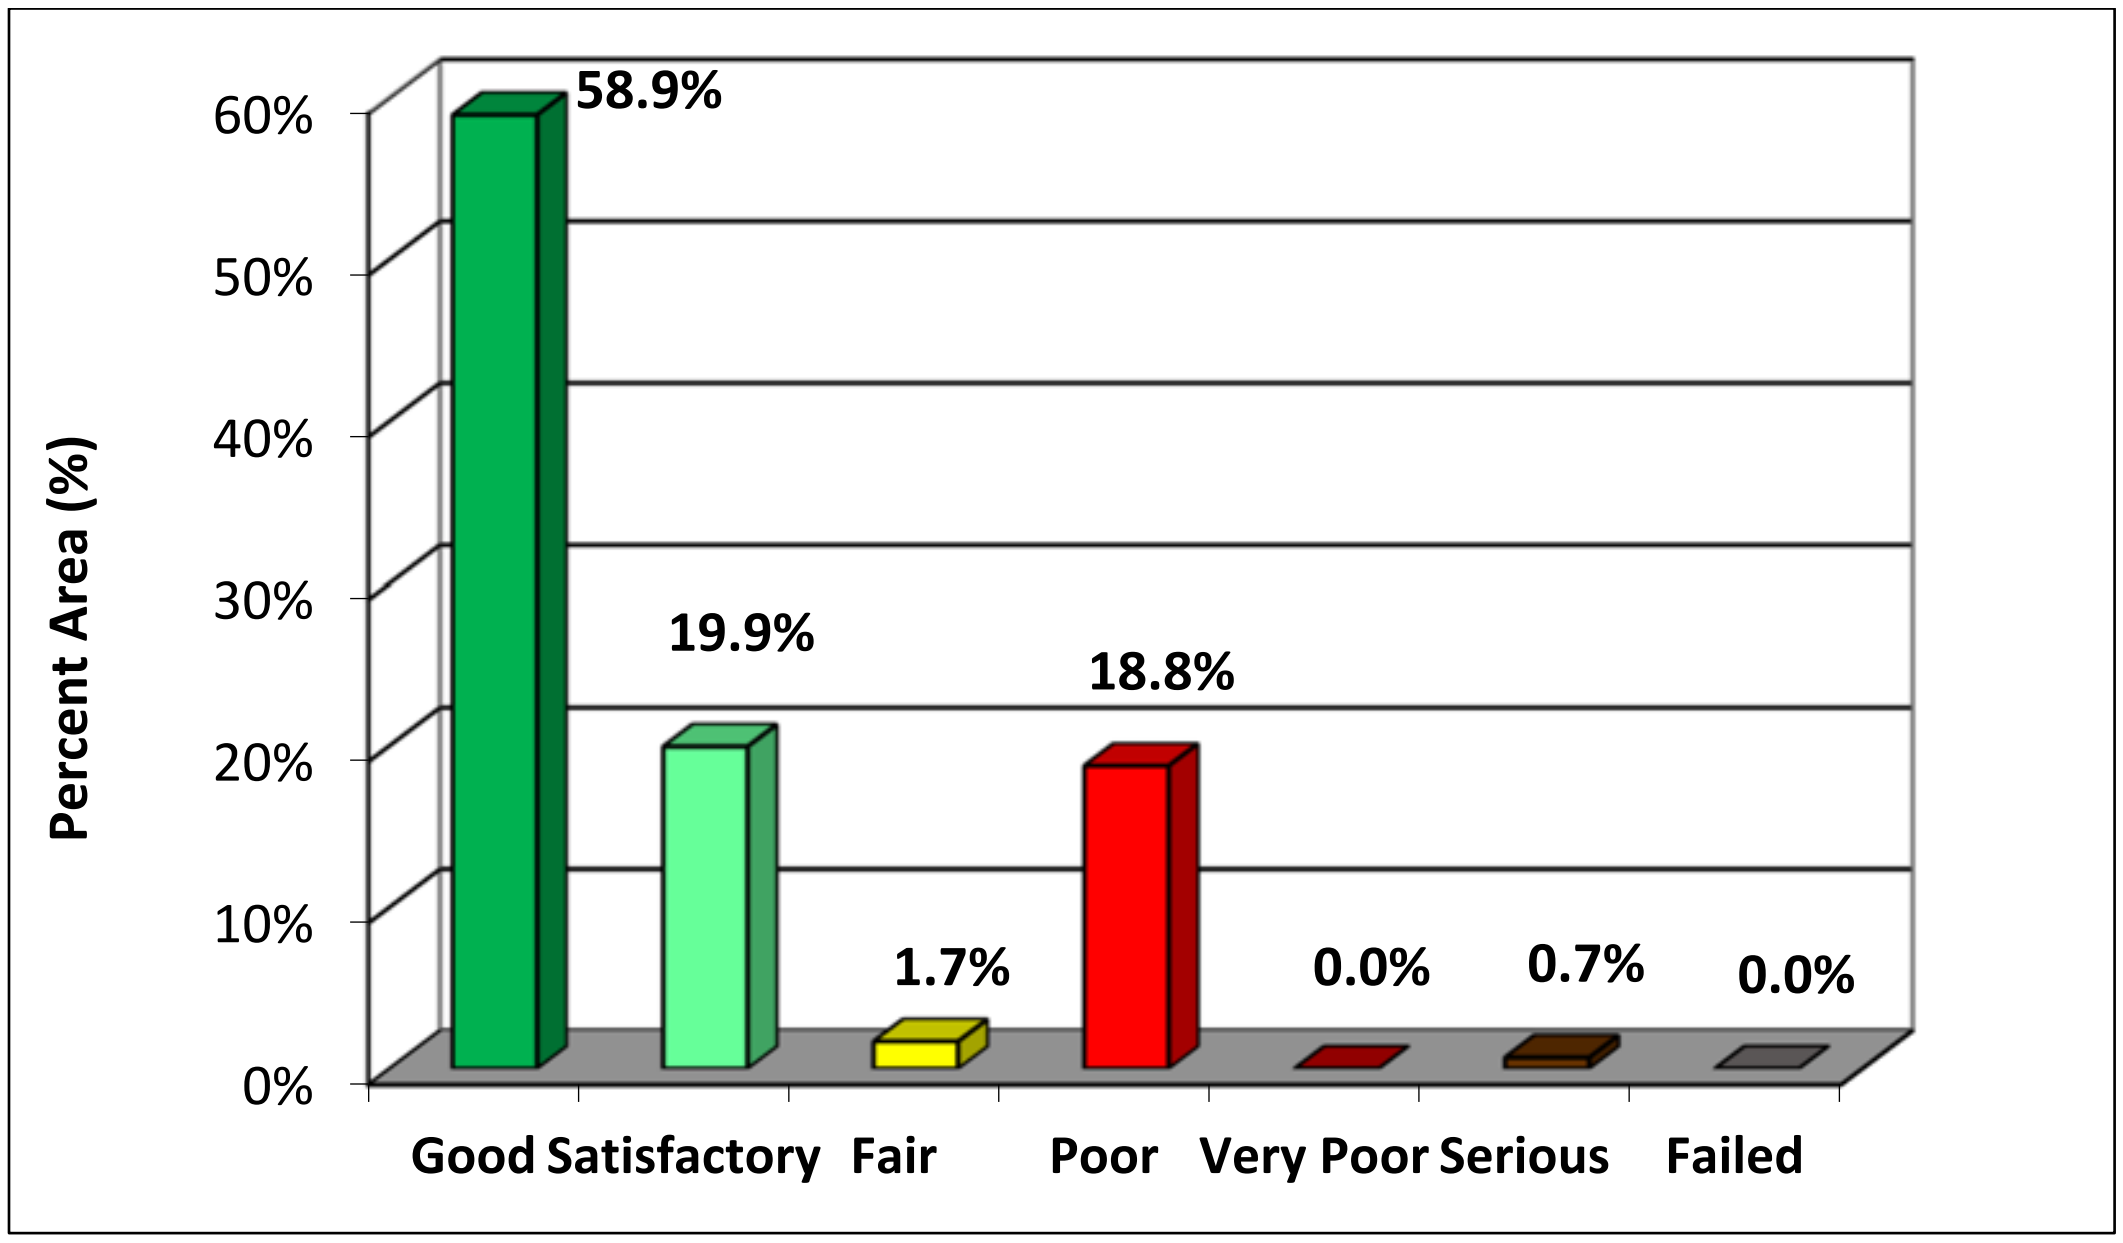
Figure 3.3: Pavement Condition by Percent of Area.

Figure 3.3 shows the distribution of the GAD pavement network by condition. Approximately 20 percent of the network is in "Poor" or worse condition.

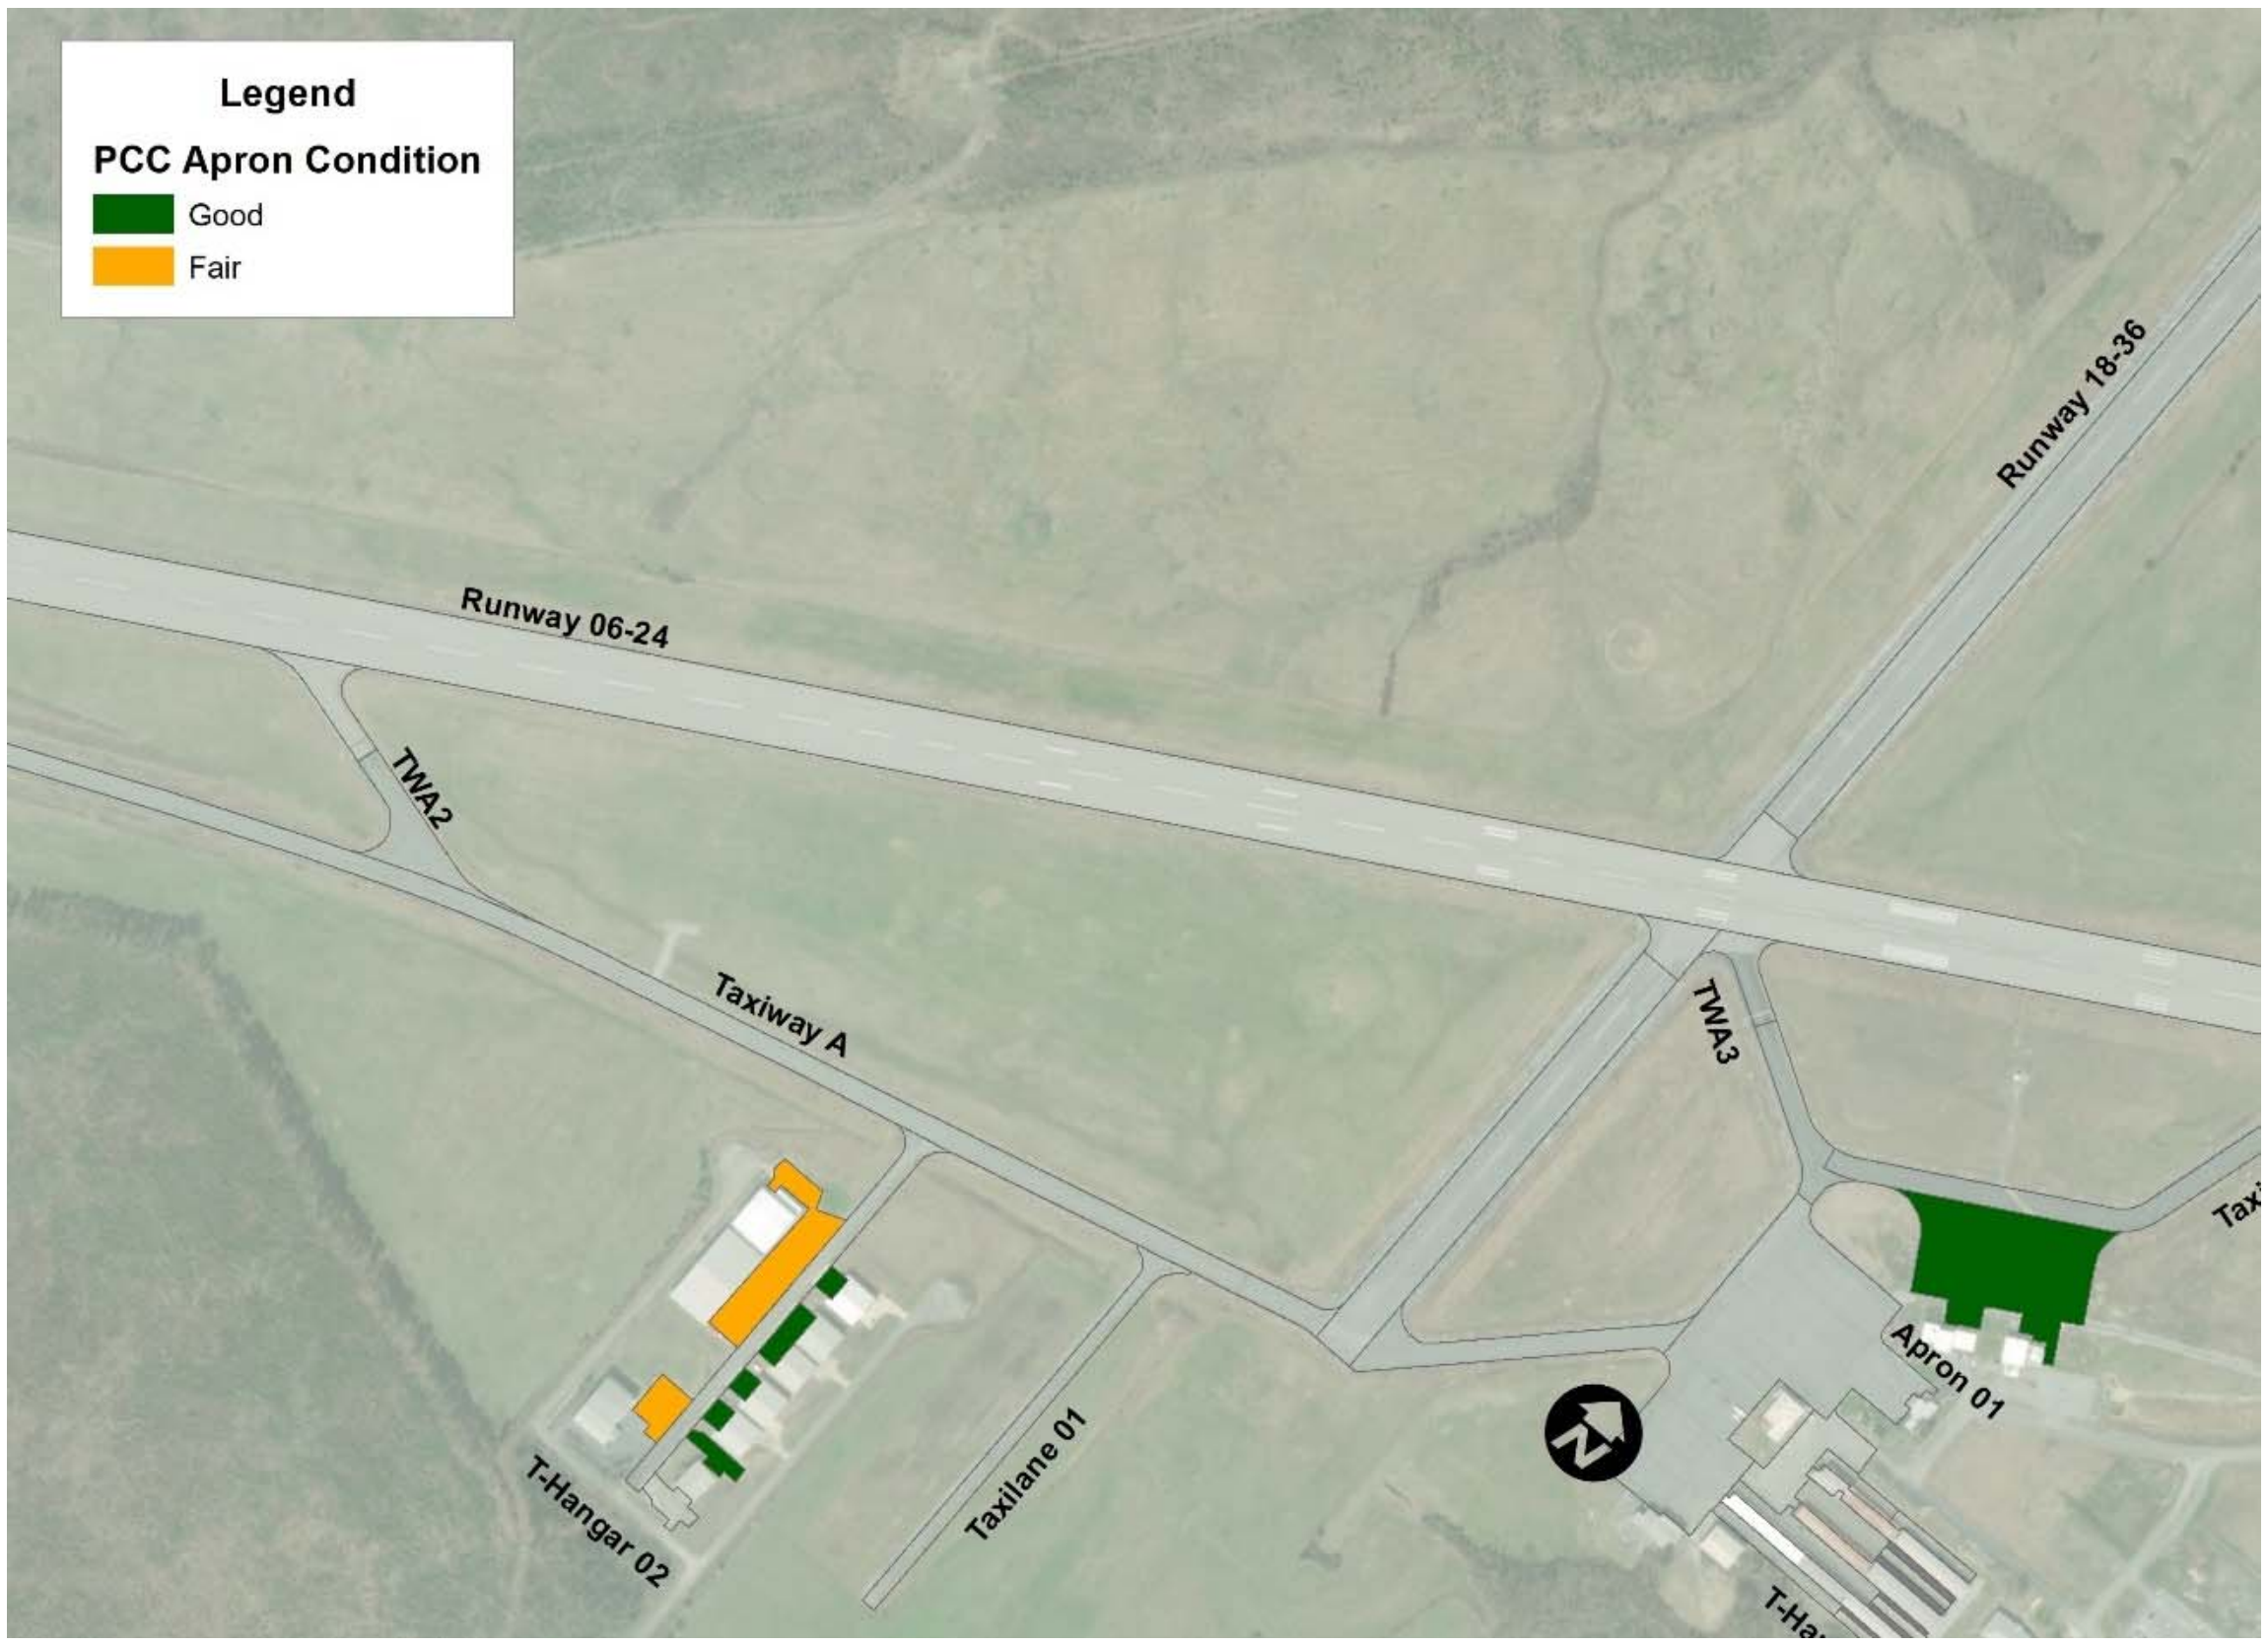
Figure 3.4: PCC Apron Condition Rating.

As stated earlier, the project scope did not include a detailed pavement condition survey for any Portland Cement Concrete (PCC) aprons. For these pavements, a rating of “Good”, “Fair”, or “Poor” was assigned based on the overall pavement condition. Figure 3.4 shows the condition of the PCC aprons at GAD.

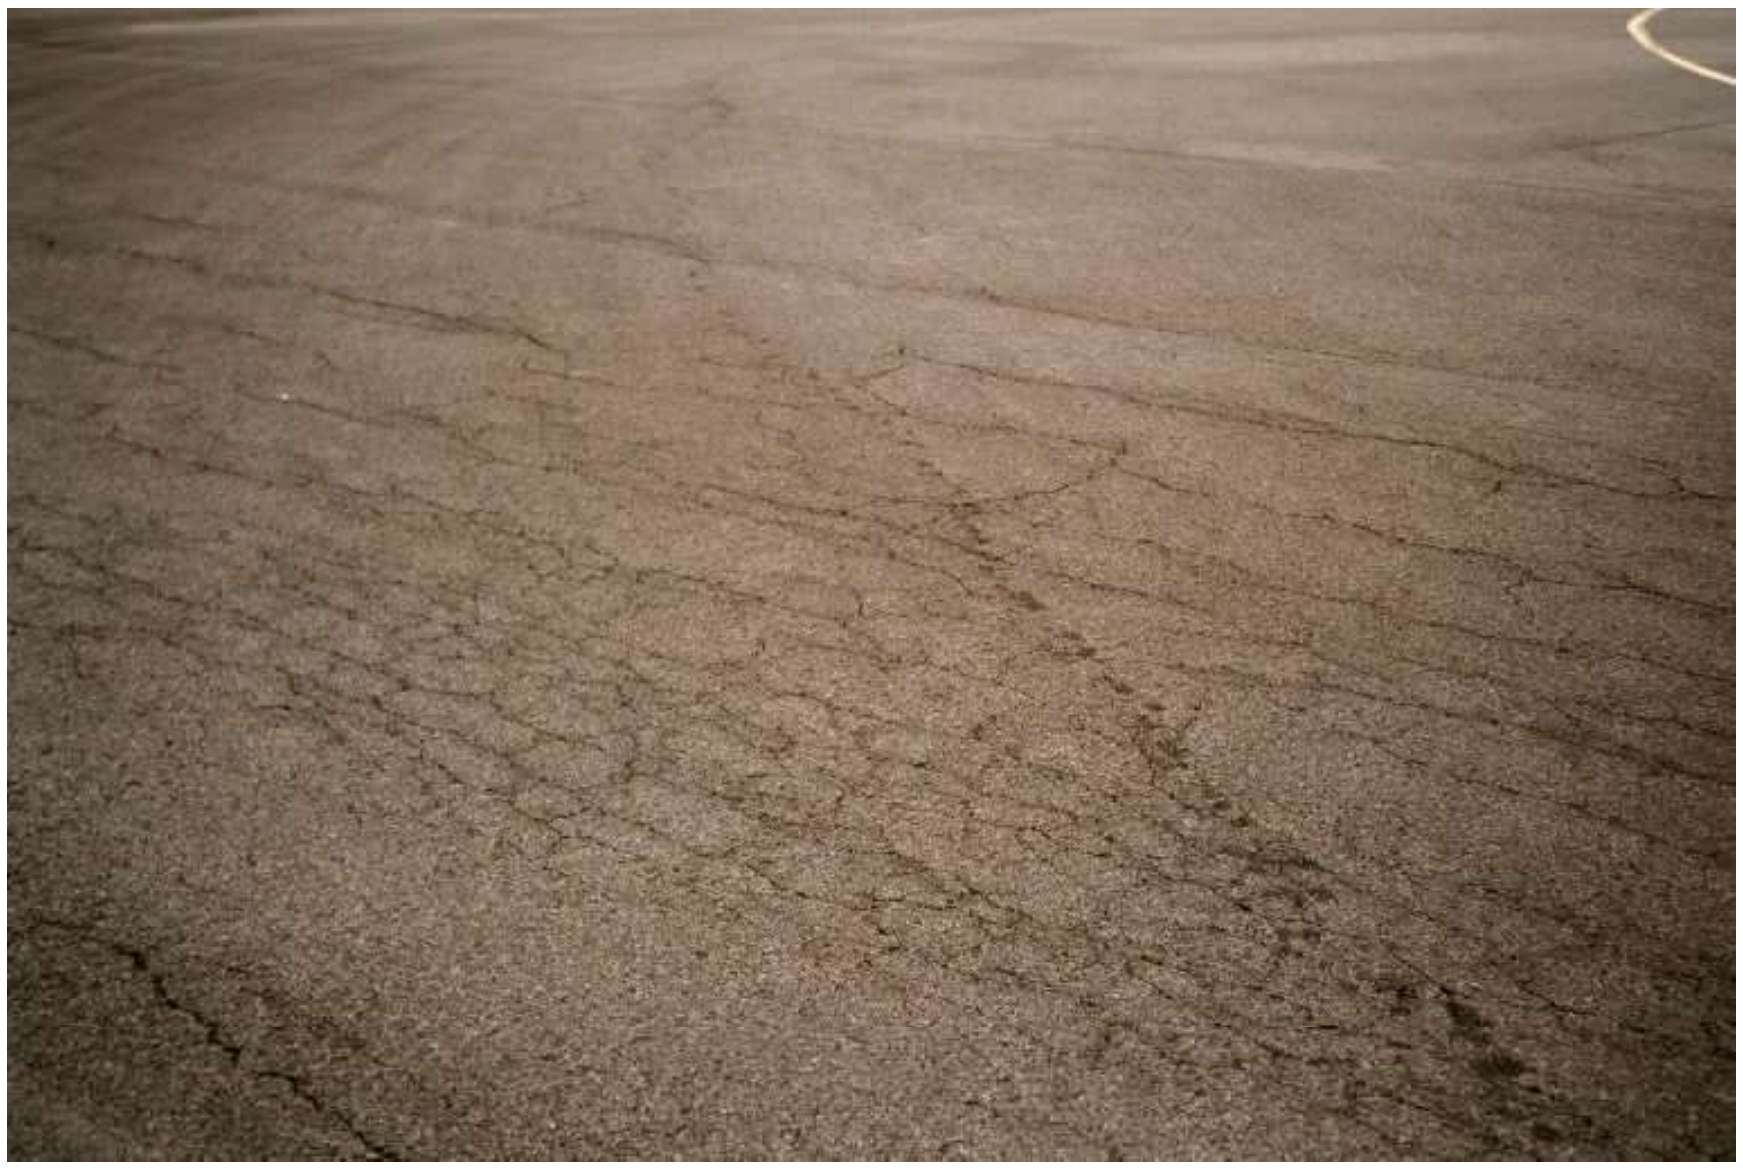
1. Alligator Cracking (AC)

Alligator cracking is a series of interconnecting cracks caused by fatigue failure of the asphalt concrete surface where tensile stress and strain is highest under wheel loads. The cracks propagate to the surface initially as a series of parallel cracks. After repeated traffic loading the cracks connect, forming many sided, sharp angled pieces that develop a pattern resembling chicken wire or the skin of an alligator. The pieces are less than 2 feet long on the longest side. Alligator cracking occurs only in areas that are subjected to repeated traffic loading, such as wheel paths, and is considered a major structural distress.

- **Low - made up of fine, hair-like cracks running parallel to each other with none or only a few inter-connecting cracks. The cracks are not spalled;**
- **Medium - Further development of light alligator cracking into a pattern or network of cracks that may be lightly spalled. Medium-severity alligator cracking is defined by a well-defined pattern of interconnecting cracks, where all pieces are securely held in place (good aggregate interlock between pieces);**
- **High - has progressed so that the pieces are well defined and spalled at the edges. Some of the pieces may rock under traffic and may cause FOD potential.**

- **Low - No action, surface seal or overlay for low severity distress;**
- **Medium - partial or full depth patch, overlay or reconstruct;**
- **High - partial or full depth patch, overlay or reconstruct.**

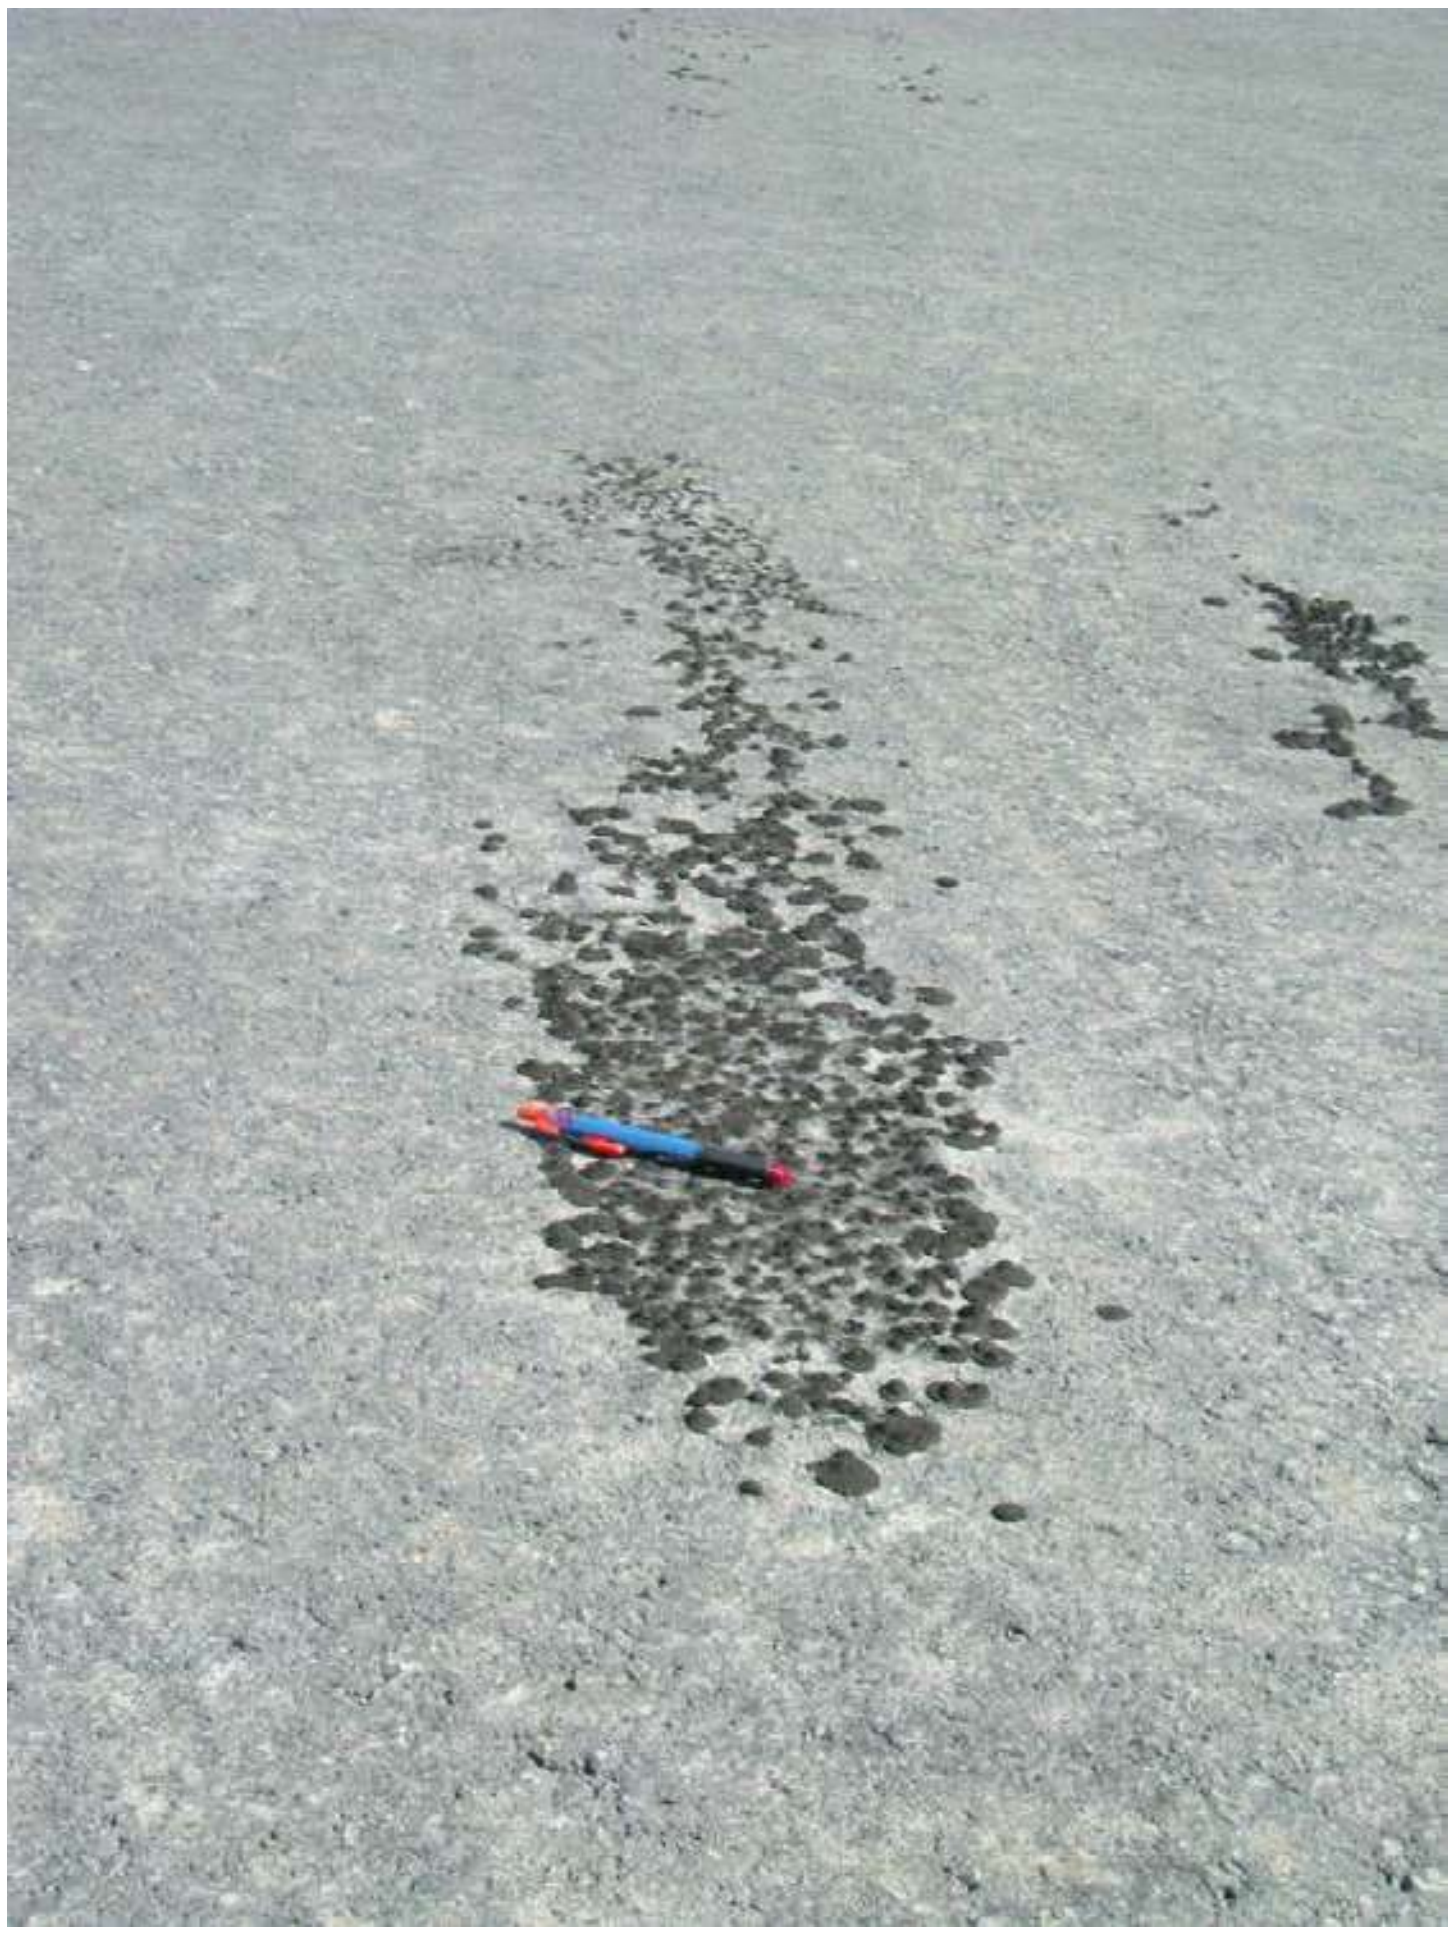
2. Bleeding (AC)

Bleeding is a film of bituminous material on the pavement surface that creates a shiny, glass-like, reflecting surface that usually becomes quite sticky. Bleeding is caused by excessive amounts of asphaltic cement or tars in the mix or low-air void content, or both. It occurs when asphalt fills the voids of the mix during hot weather and then expands out onto the surface of the pavement. Since the bleeding process is not reversible during cold weather, asphalt or tar will accumulate on the surface.

Severities: No degrees of severity are defined. Bleeding should be noted when it is extensive enough to reduce skid resistance.

Repair Policies: Do nothing; sand blot the distressed area by applying heat and roll sand into the areas affected with bleeding, remove the excess material; patch.

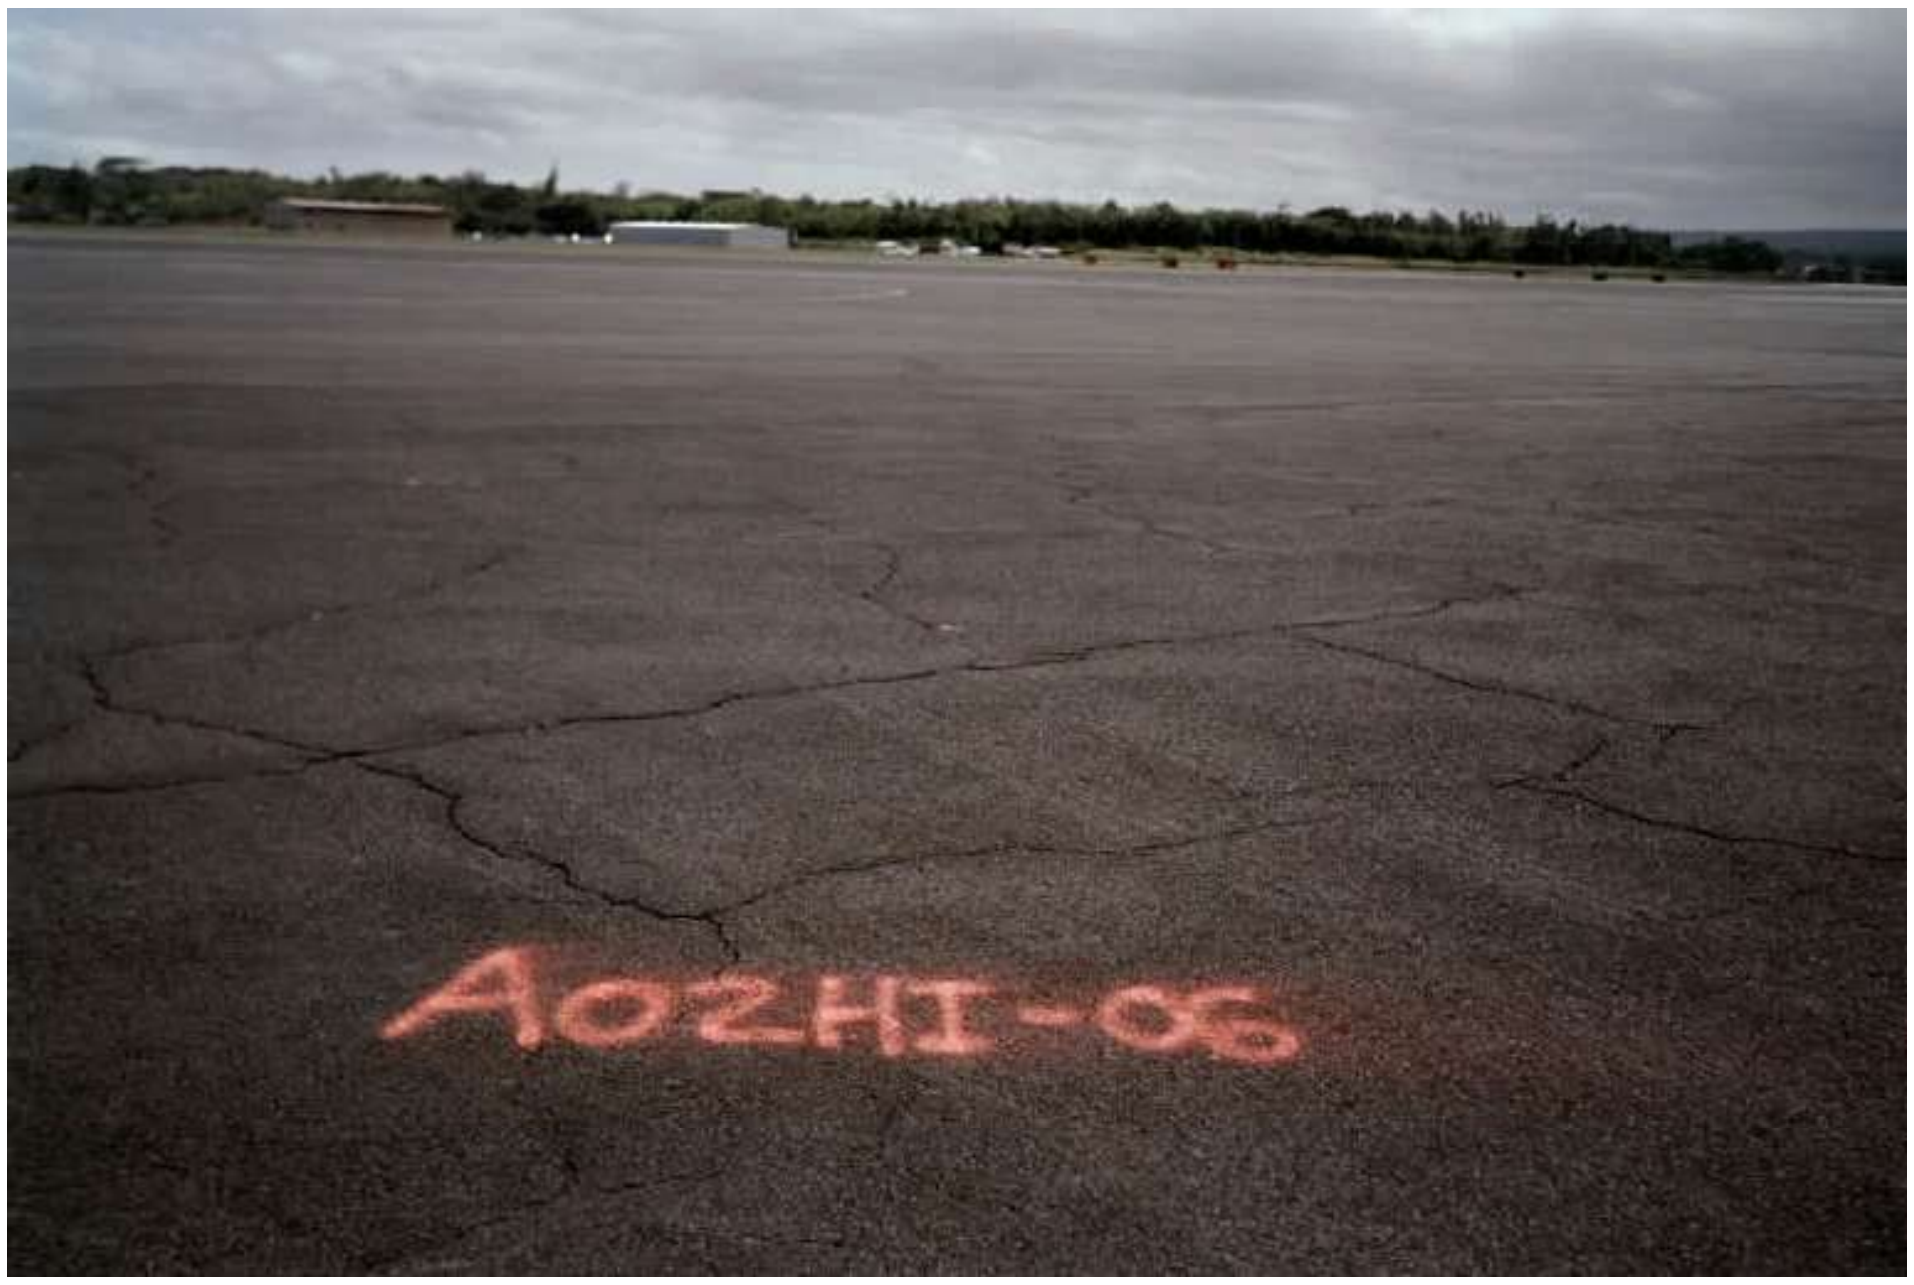
3. Block Cracking (AC)

Block cracks are interconnected cracks that divide the pavement into rectangular shaped pieces. The blocks may range in size from 1 by 1 foot to 10 by 10 feet. Block cracking is caused mainly by shrinkage of the asphalt concrete and is not load associated. The occurrence of block cracking usually indicates that the asphalt has hardened significantly. Block cracking normally occurs over a large proportion of the pavement area, but will sometimes occur only in the non-traffic areas.

- **Low - defined by cracks that are at most lightly spalled, causing no foreign object damage (FOD) potential. Un-filled cracks have 1/4 inch or less mean width, and filled cracks have filler in satisfactory condition;**
- **Medium - defined by cracks that are moderately spalled (some FOD potential), un-filled cracks that are at most lightly spalled, but have a mean width greater than 1/4 inch or filled cracks that are at most lightly spalled but have filler in unsatisfactory condition;**
- **High - defined by cracks that are severely spalled, causing a definite FOD potential.**

- **Low - No action;**
- **Medium - seal cracks, apply rejuvenator, recycle surface or heat scarify and overlay;**
- **High - recycle surface or heat scarify and overlay.**

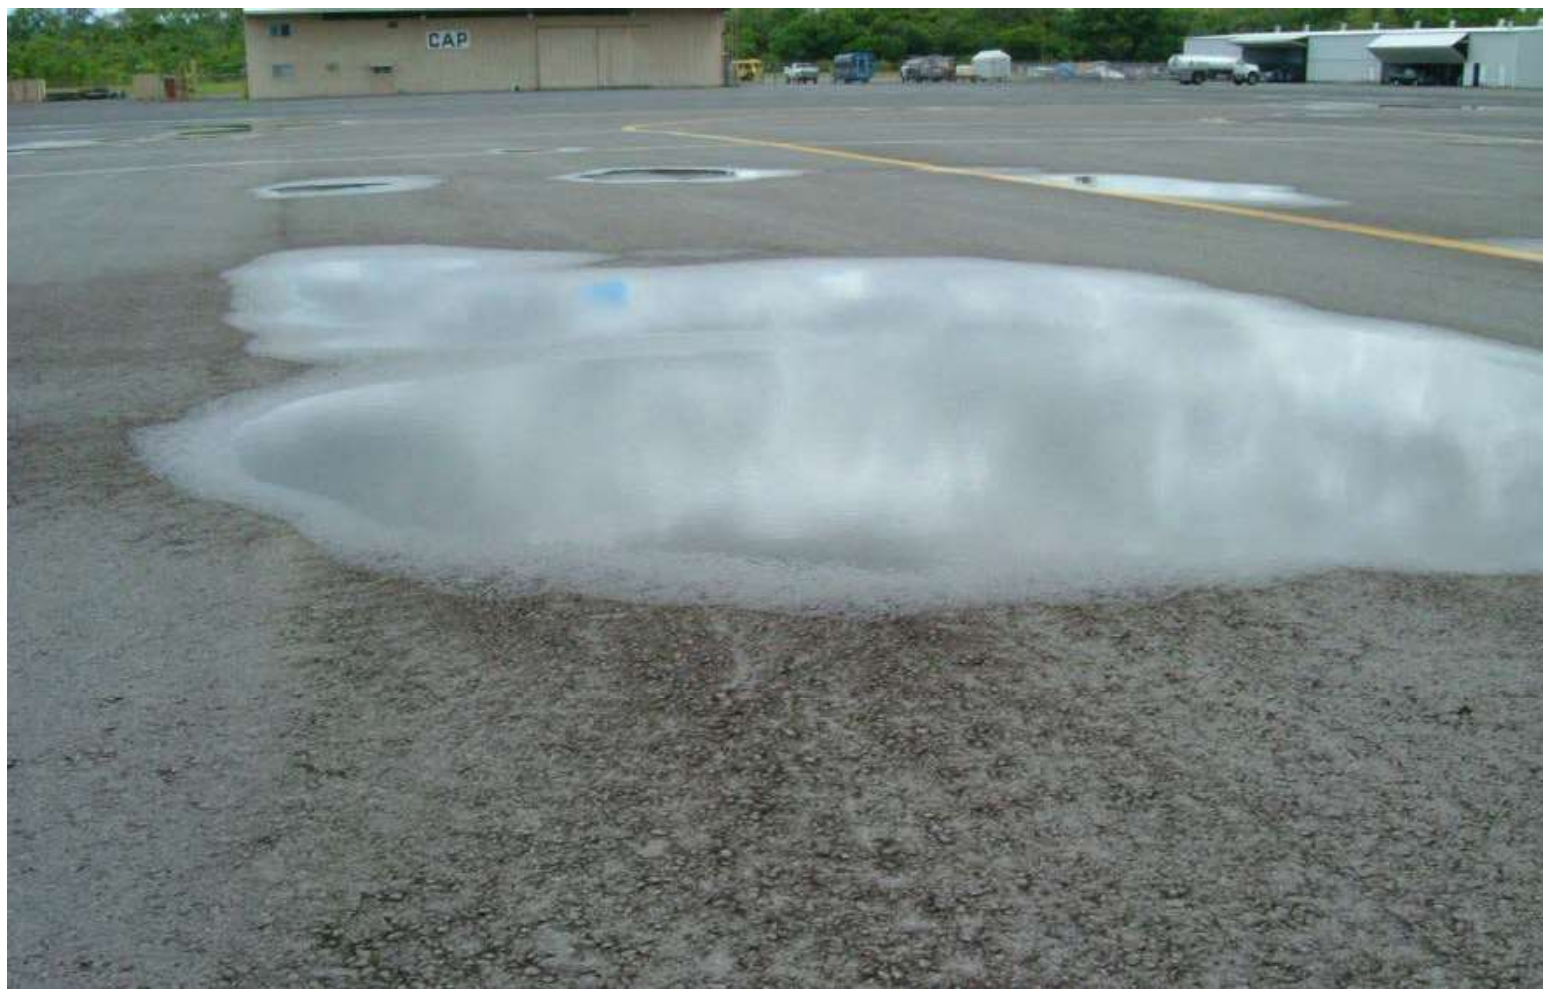
5. Depression (AC)

Depressions are localized pavement surface areas having elevations slightly lower than those of the surrounding pavement. In many instances, light depressions are not noticeable until after a rain, when ponding water creates ñbirdbathò areas; but the depressions can also be located without rain because of stains created by ponding of water. Depressions can be caused by settlement of the foundation soil or can be built during construction. Depressions cause roughness and, when filled with water of sufficient depth, could cause hydroplaning of aircraft.

- **Low - Depression can be observed or located by stained areas, only slightly affects pavement riding quality, and may cause hydroplaning potential on runways. Maximum depth 1/8 to 1/2 inch for runways, 1/2 to 1 inch for taxiways and aprons;**
- **Medium - The depression can be observed, moderately affects pavement riding quality, and causes hydroplaning potential on runways. Maximum depth 1/2 to 1 inch for runways, 1 to 2 inches for taxiways and aprons;**
- **High - The depression can be readily observed, severely affects pavement riding quality, and causes definite hydroplaning potential; Depth greater than 1 inch for runways, greater than 2 inches for taxiways and aprons;.**

- **Low - No action;**
- **Medium - Shallow, partial or full depth patch;**
- **High - Shallow, partial or full depth patch.**

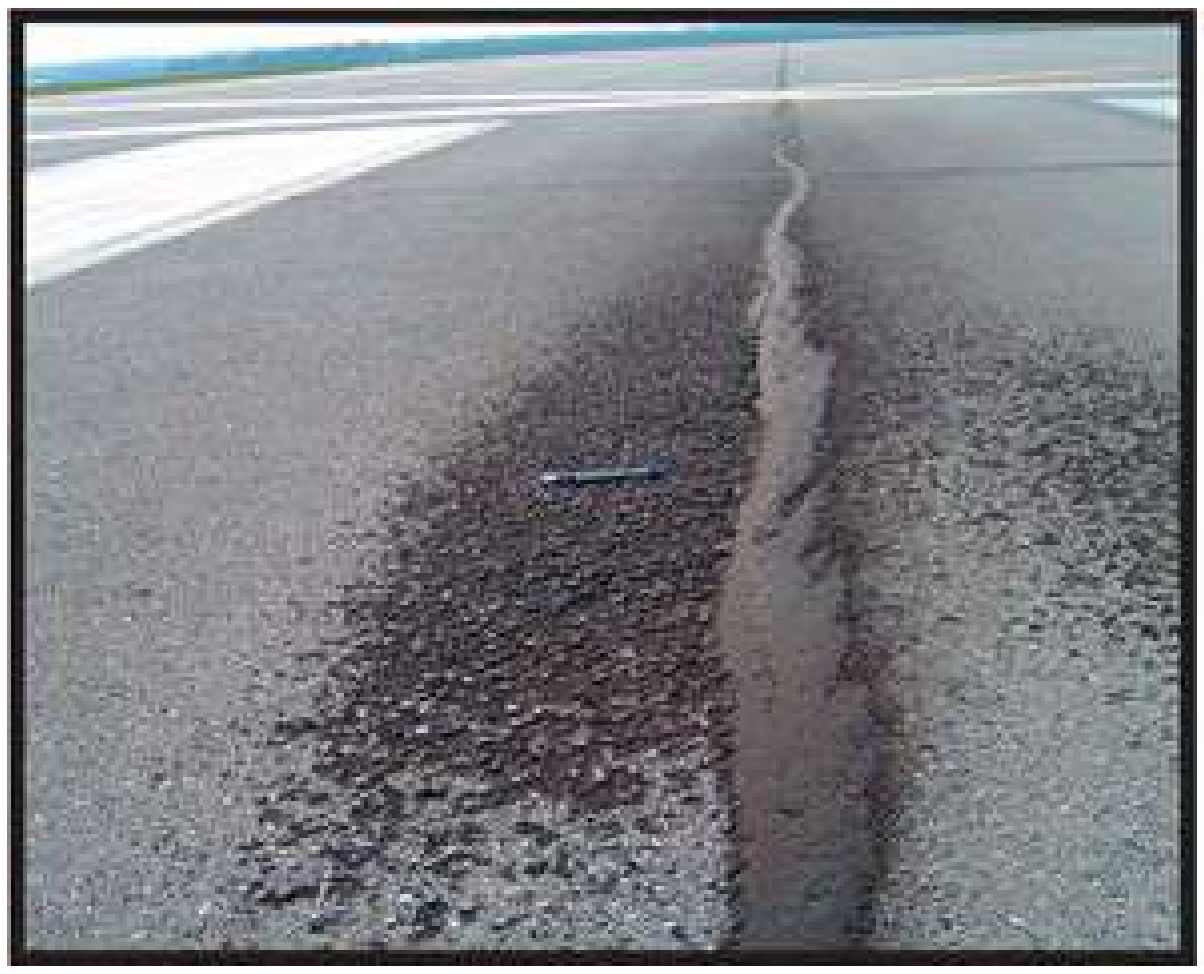
6. Jet Blast (AC)

Jet blast erosion causes darkened areas on the pavement surface when bituminous binder has been burned or carbonized; localized burned areas may vary in depth up to approximately 1/2 inch (13 millimeters).

No degrees of severity are defined. It is sufficient to indicate that jet blast erosion exists.

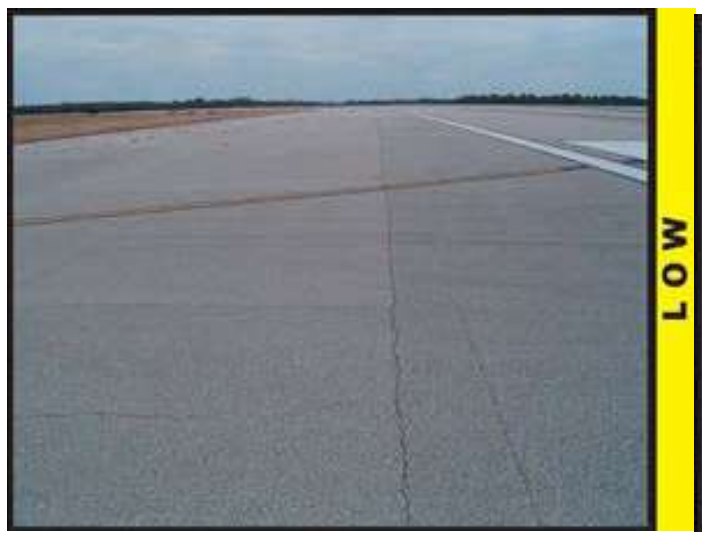
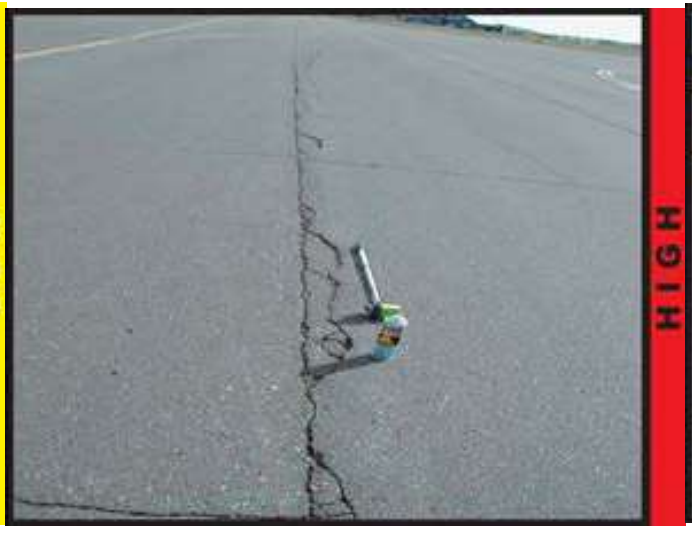
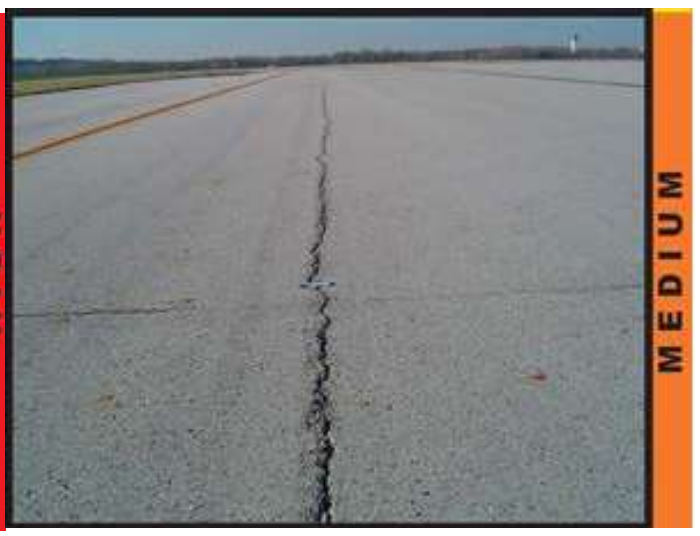
7. Joint Reflection Cracking (AC)

This distress occurs only on pavements having an asphalt or tar surface over a PCC slab. This category does not include reflection cracking from any other type of base (i. e., cement stabilized, lime stabilized); such cracks are listed as longitudinal and transverse cracks. Joint-reflection cracking is caused mainly by movement of the PCC slab beneath the AC surface because of thermal and moisture changes; it is not load related. However, traffic loading may cause a breakdown of the AC near the crack, resulting in spalling and FOD potential. If the pavement is fragmented along a crack, the crack is said to be spalled. A knowledge of slab dimensions beneath the AC surface will help to identify these cracks.

L	Cracks have only light spalling (little or no FOD potential) or no spalling and can be filled or non-filled. If non-filled, the cracks have a mean width of 1/4 inch (6 millimeters) or less. Filled cracks are of any width, but their filler material is in satisfactory condition.
M	One of the following conditions exists: (1) cracks are moderately spalled (some FOD potential) and can be either filled or non-filled of any width; (2) filled cracks are not spalled or are only lightly spalled, but the filler is in unsatisfactory condition; (3) non-filled cracks are not spalled or are only lightly spalled, but the mean crack width is greater than 1/4 inch (6 millimeters); or (4) light random cracking exists near the crack or at the corner of intersecting cracks.
H	Cracks are severely spalled (definite FOD potential) and can be either filled or non-filled of any width.

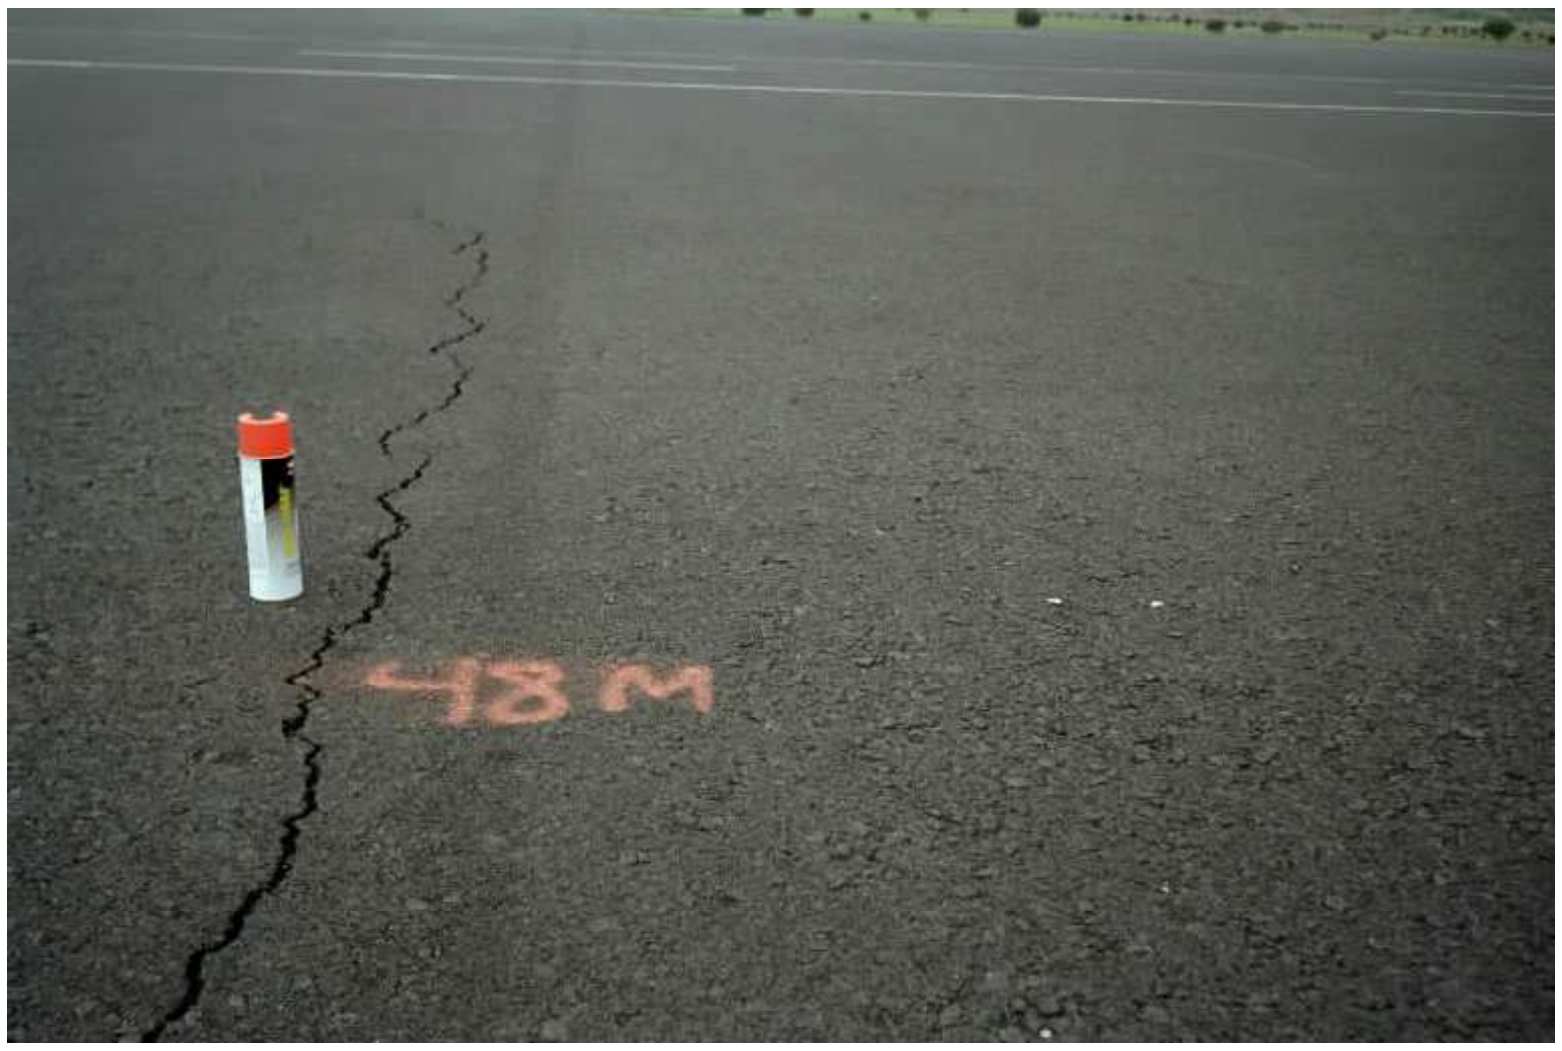
8. Longitudinal and Transverse Cracking (AC)

Longitudinal and transverse (L&T) cracks are parallel to the pavementôs centerline or laydown direction. They may be caused by: 1) a poorly constructed paving lane joint, 2) shrinkage of the AC surface due to hardening of the asphalt, or 3) a reflective crack caused by cracks beneath the surface course. Transverse cracks extend across the pavement perpendicularly to the pavement centerline or laydown direction, and may be caused by items 2) or 3) as stated above. These types of cracks are not usually load related.

- **Low - have either minor spalling or no spalling. The cracks can be filled or un-filled. Un-filled cracks have a mean width of 1/4 inch or less. Filled cracks are any width but their filler is in satisfactory condition;**
- **Medium - one of the following conditions exists: 1) cracks are moderately spalled and can be either filled or un-filled of any width; 2) filled cracks are not spalled or only lightly spalled, but the filler is in unsatisfactory condition; 3) un-filled cracks are not spalled or only lightly spalled, but the crack width exceeds 1/4 inch; or 4) light random cracking exists near the crack or at the corner of the intersecting cracks;**
- **High - severely spalled with a definite FOC potential. They can be either filled or un-filled.**

- **Low - No action;**
- **Medium - seal cracks;**
- **High - seal cracks or perform a full depth patch.**
