Alabama Statewide Airport Pavement Management Program Update

Northeast Alabama Regional Airport (GAD)

Final Report

February 2022

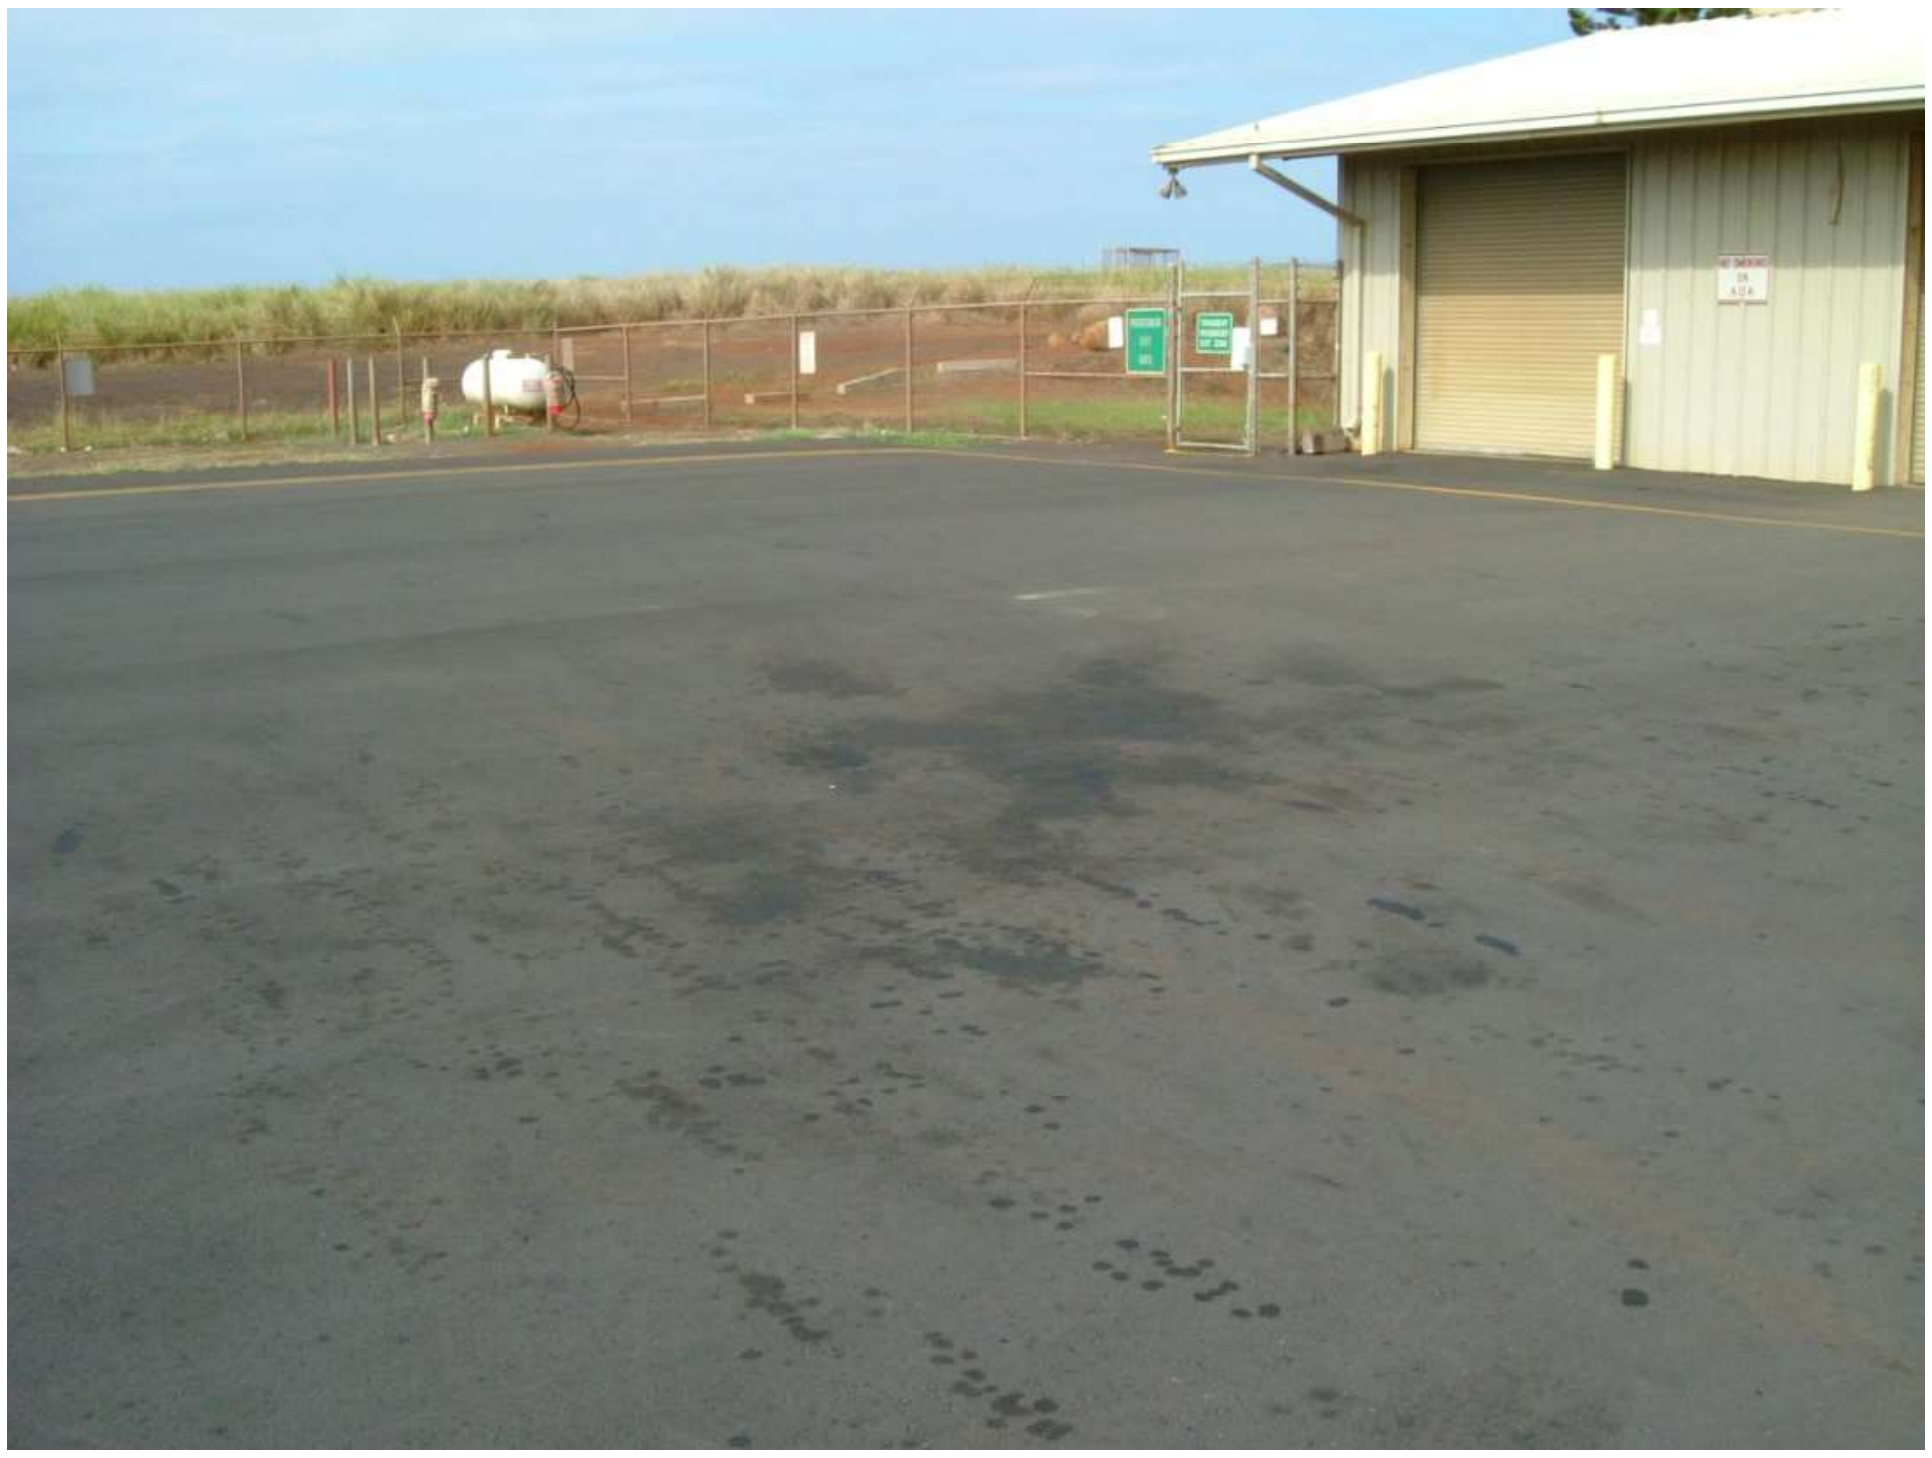
9. Oil Spillage (AC)

Oil spillage is the deterioration or softening of the pavement surface caused by the spilling of oil, fuel, or other solvents.

- ♦ **Do nothing;**
- ♦ **Partial or full depth patch.**

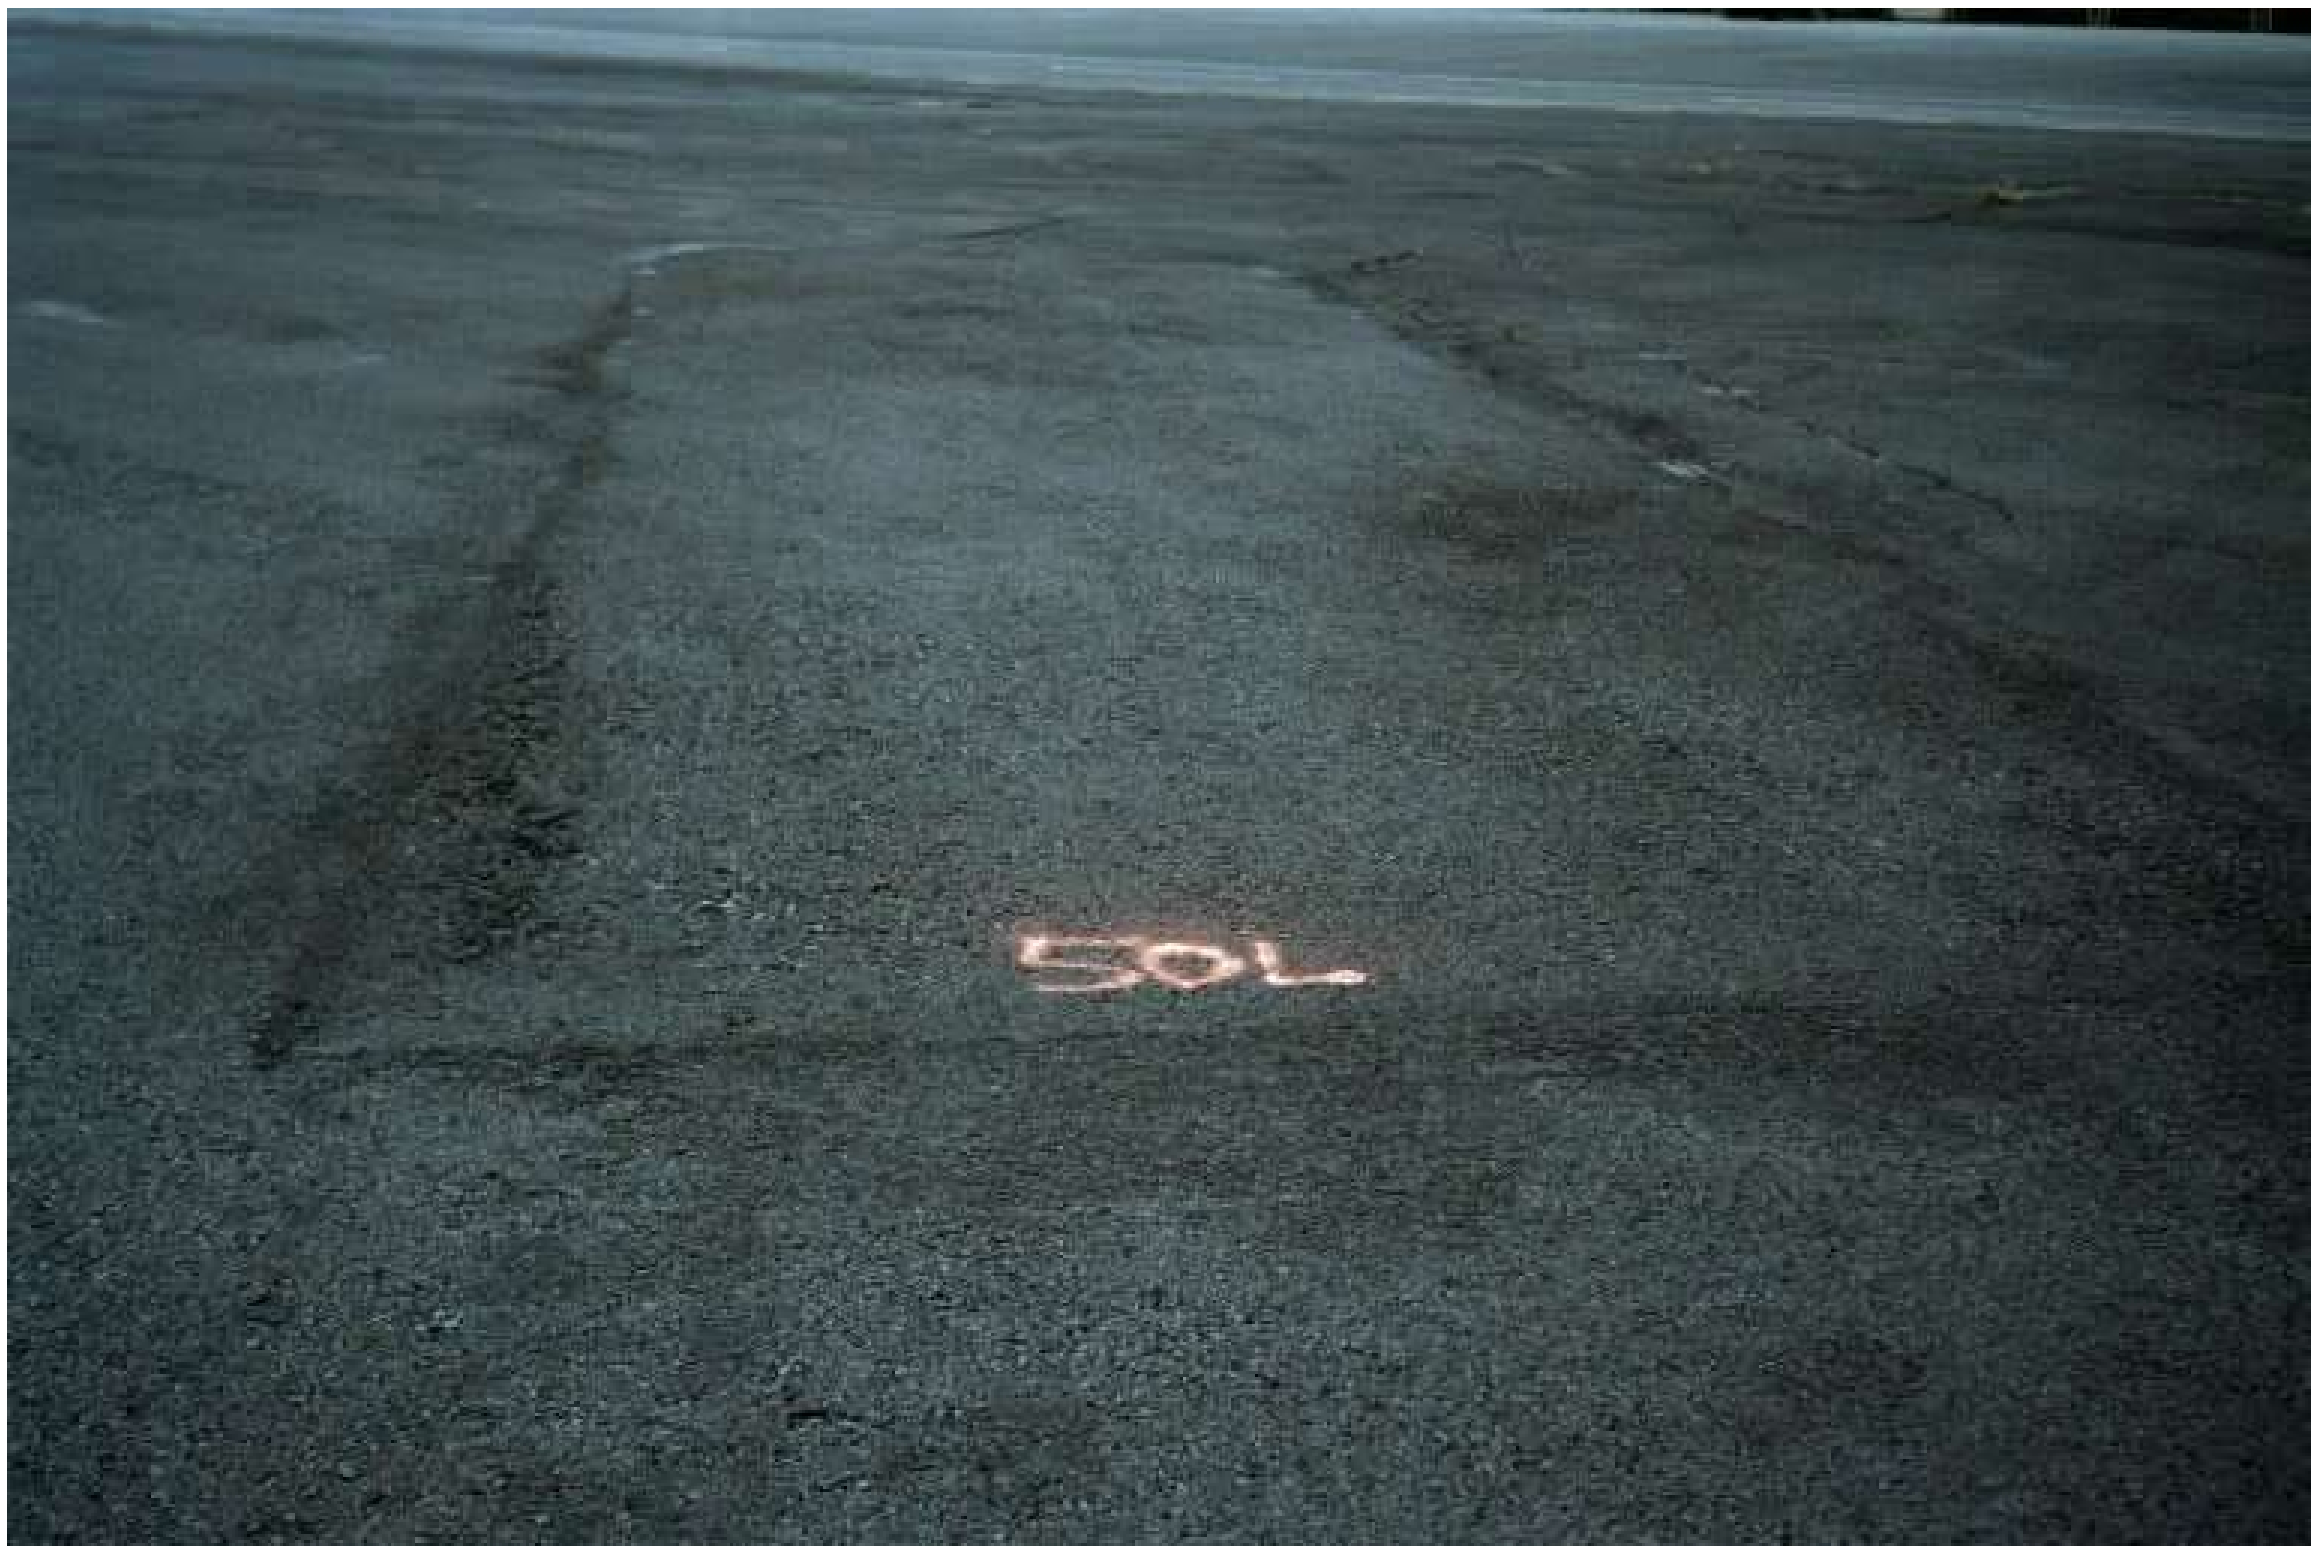
Figure C.7: Asphalt Patching.

Repair patching and utility cut patching is considered a defect, regardless of how well it performs or was constructed.

- **Low - in good condition and is performing satisfactorily;**
- **Medium - is somewhat deteriorated and affects riding quality to some extent;**
- **High - is badly deteriorated and affects riding quality significantly or has high FOD potential.**

- **Low - No action;**
- **Medium - seal cracks, repair the distresses in the patch or replace the patch;**
- **High - replace the patch.**

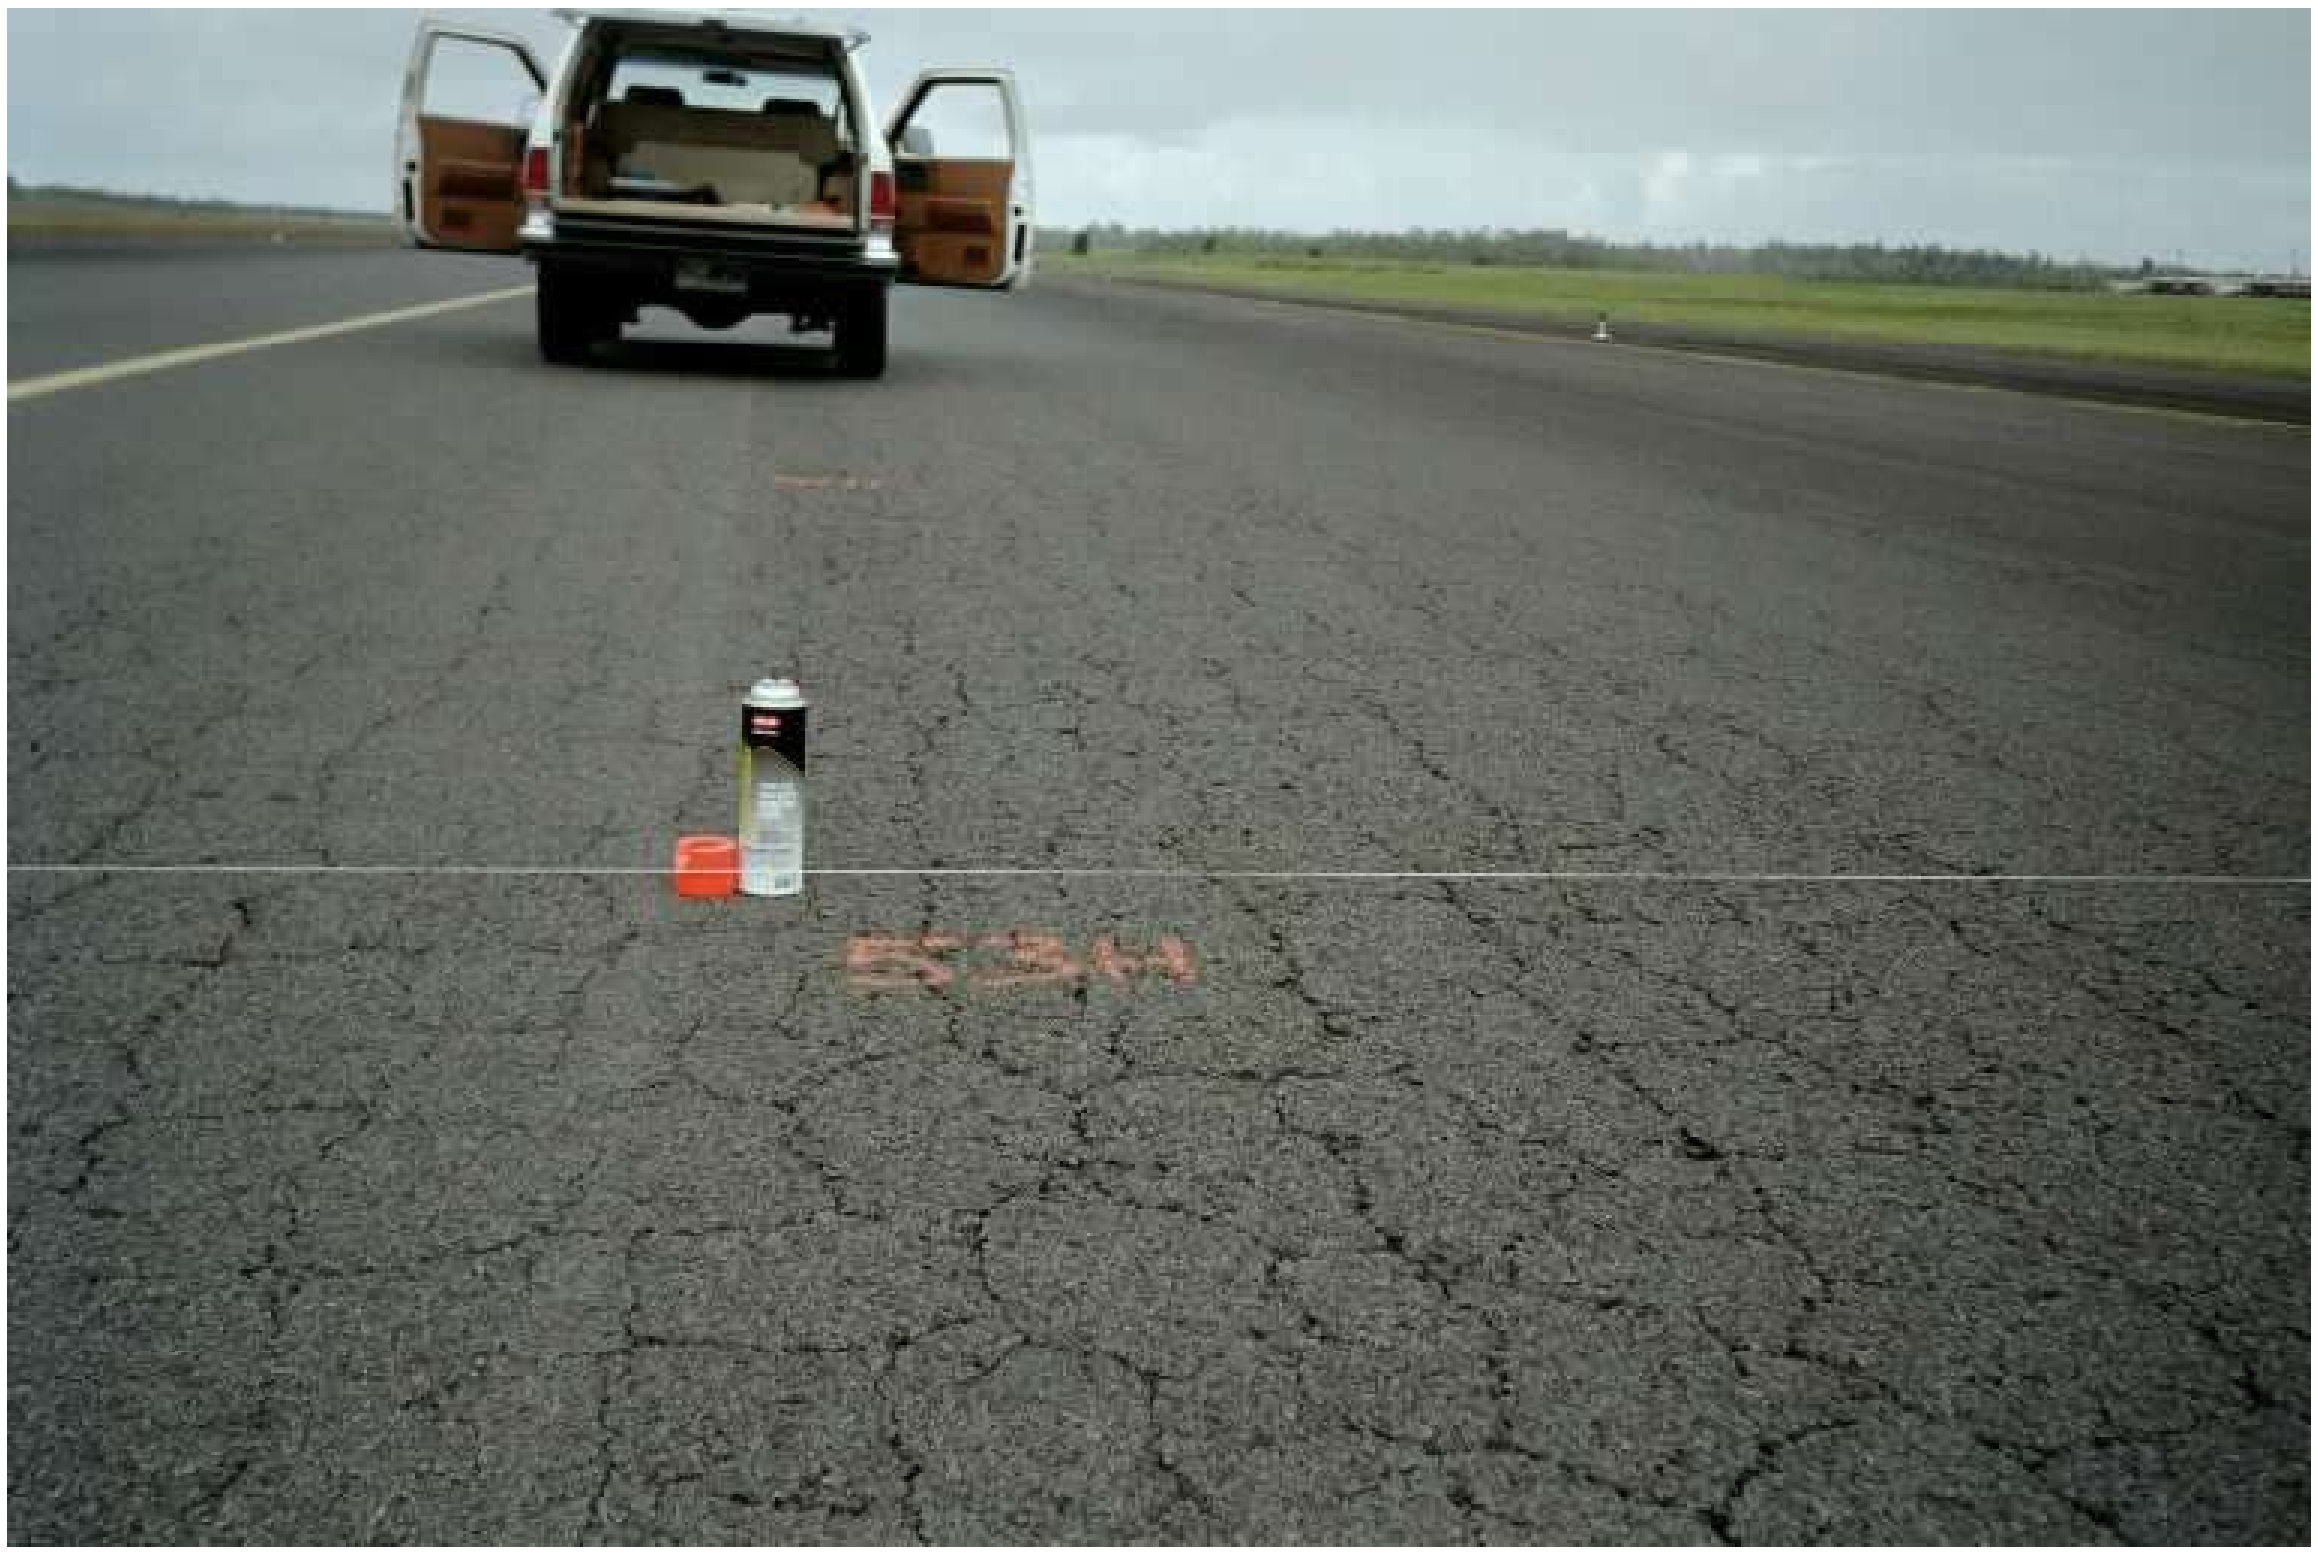
Figure C.9: AC Rutting.

A rut is a surface depression in the wheel path; however, in many instances ruts are noticeable only after a rainfall, when the wheel paths are filled with water. Pavement uplift may occur along the sides of the rut. Rutting stems from a permanent deformation in any of the pavement layers or sub-grade, usually caused by consolidation or lateral movement of the materials due to traffic loads. Significant rutting can lead to major structural failure of the pavement.

- **Low - No action;**
- **Medium - patch and/or overlay;**
- **High - patch and/or overlay.**

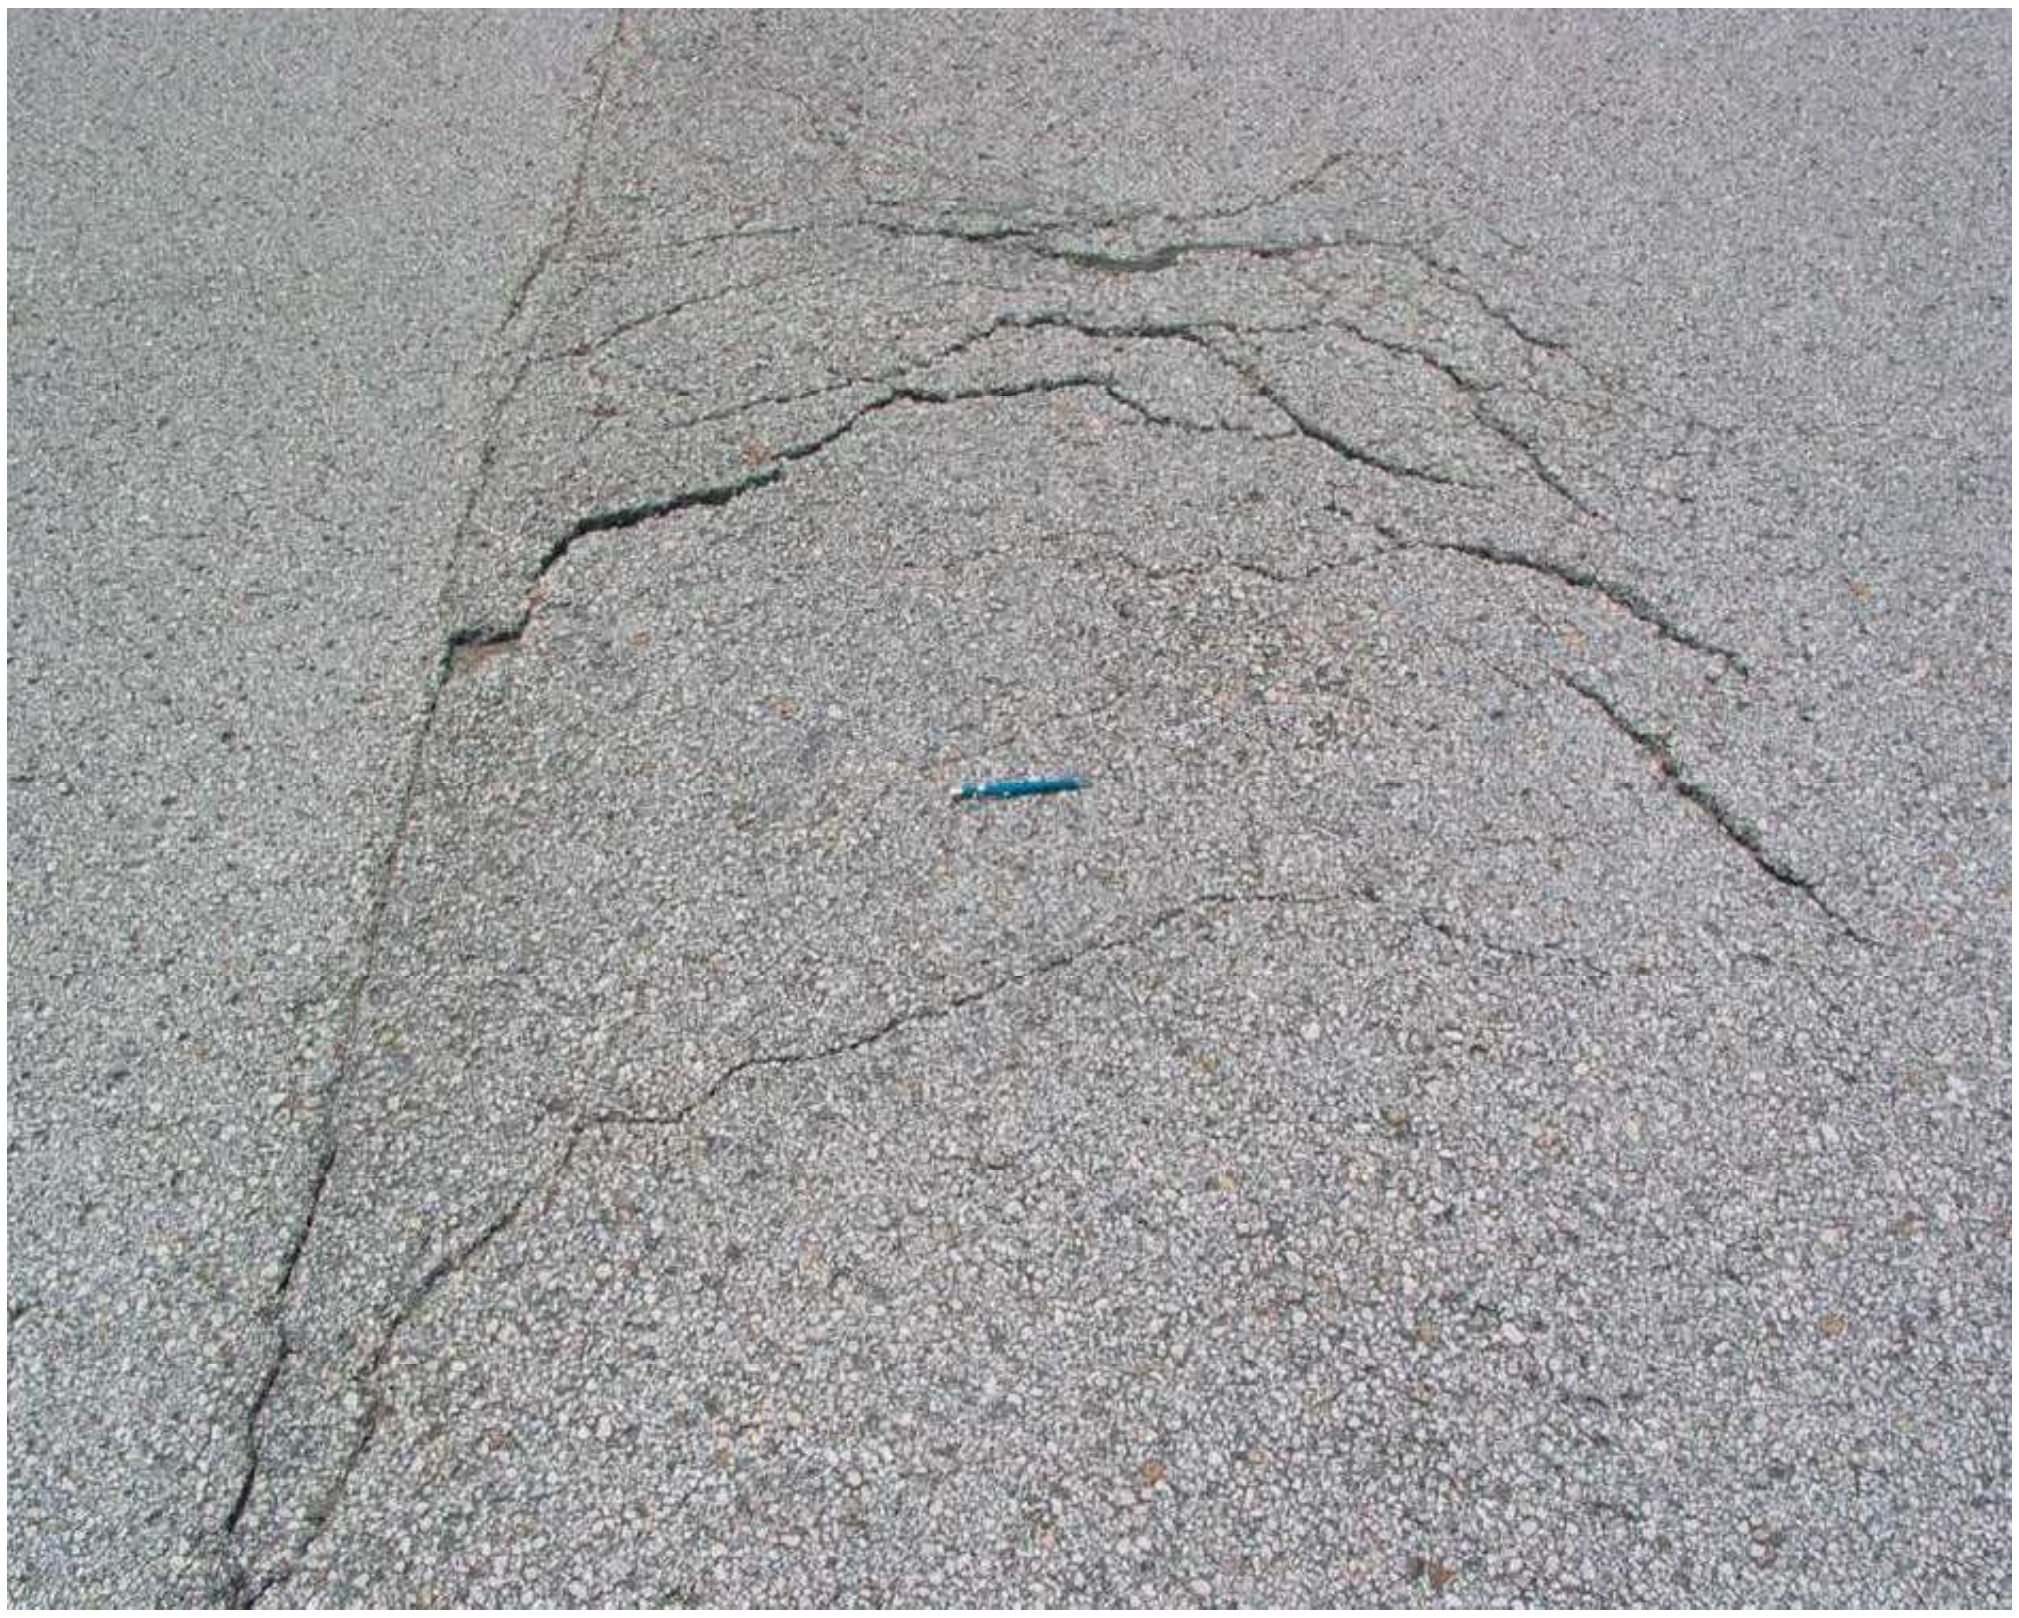
Figure C.10: Slippage Cracking.

Slippage cracks are crescent- or half-moon shaped cracks having two ends pointed away from the direction of traffic. They are produced when braking or turning wheels cause the **pavement surface to slide and deform. This usually occurs when there is a low-strength surface mix or poor bond between the surface and next layer of pavement structure.**

Severities: No degrees of severity are defined. It is sufficient to indicate that a slippage **crack exists.**

- **Do nothing;**
- **Partial or full depth patch.**

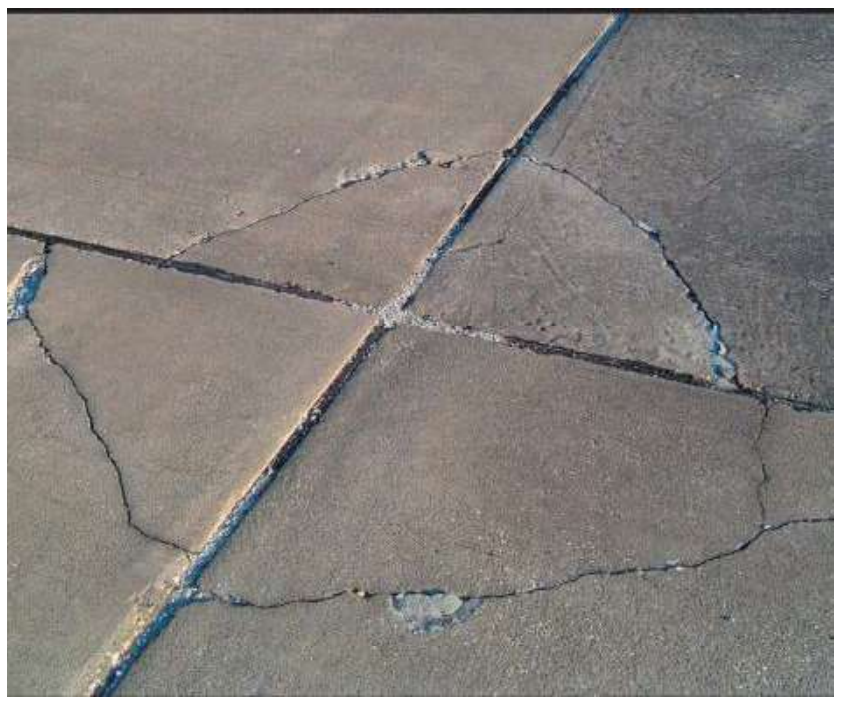
Figure C.11: PCC Corner Break.

A corner break is a crack that intersects the joints at a distance less than or equal to one-half the slab length on both sides, measured from the corner of the slab. For example, a slab with dimensions of 25 by 25 feet that has a crack intersecting the joint 5 feet from the corner on one side and 17 feet on the other side is not considered a corner break; it is a diagonal crack. However, a crack that intersects 7 feet on one side and 10 feet on the other is considered a corner break. A corner break differs from a corner spall in that the crack extends vertically through the entire slab thickness, while a corner spall intersects the joint at an angle. Load repetition combined with loss of support and curling stresses usually causes corner breaks.

- **Low** - Crack has either no spalling or minor spalling (no foreign object damage (FOD) potential). If non-filled, it has a mean width less than approximately 1/8 inch (3 millimeters); a filled crack can be of any width, but the filler material must be in satisfactory condition. The area between the corner break and the joints is not cracked;

- **Medium** - One of the following conditions exists: (1) filled or non-filled crack is moderately spalled (some FOD potential); (2) a non-filled crack has a mean width between 1/8 inch (3 millimeters) and 1 inch (25 millimeters); (3) a filled crack is not spalled or only lightly spalled, but the filler is in unsatisfactory condition; (4) the area between the corner break and the joints is lightly cracked with loose or missing particles;

- **High** - One of the following conditions exists: (1) filled or non-filled crack is severely spalled, causing definite FOD potential; (2) a non-filled crack has a mean width greater than approximately 1 inch (35 millimeters), creating a tire damage potential; or (3) the area between the corner break and the joints is severely cracked.

- **Low** - No action or seal cracks;
- **Medium** - seal cracks;
- **High** - seal cracks, apply a full depth patch or replace the slab.

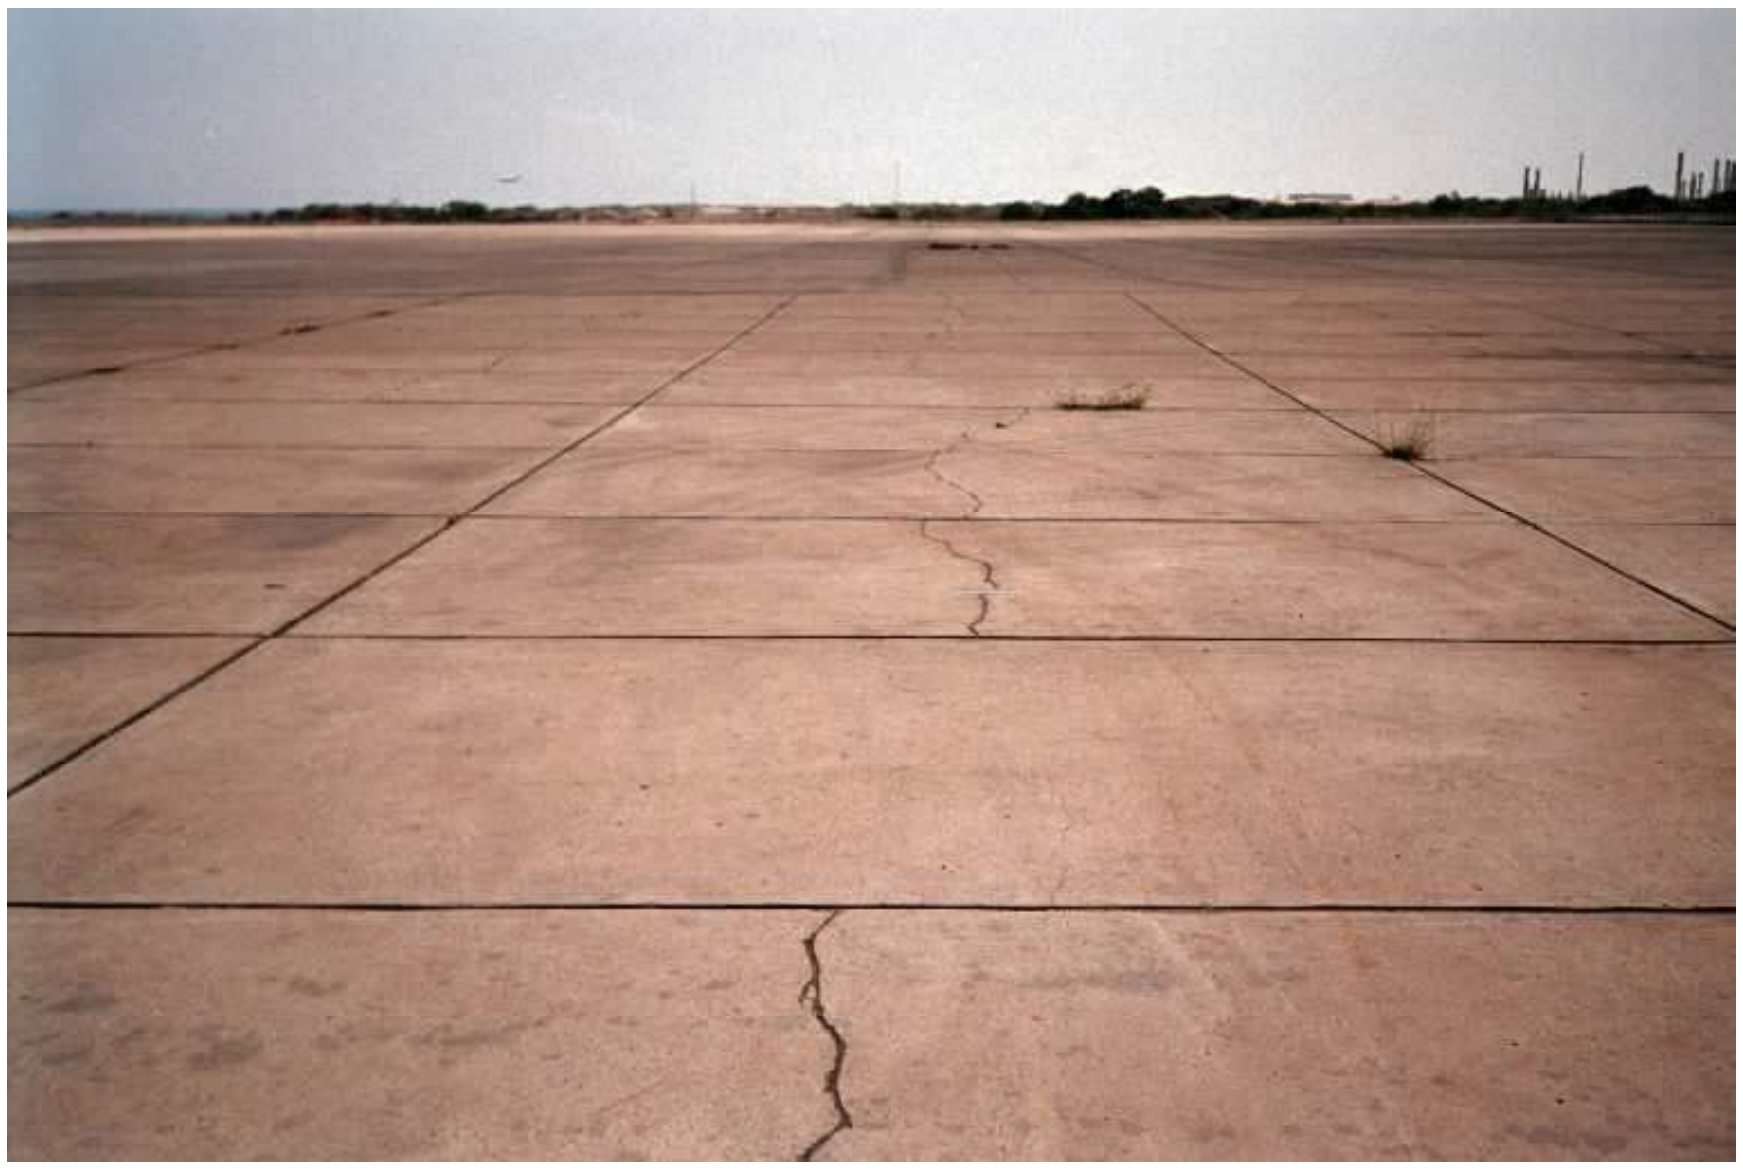
Figure C.12: PCC Transverse Cracks.

These cracks divide the slab into two or three pieces, and are usually caused by a combination of load repetition, curling stresses, and shrinkage stresses. Low severity cracks are not considered major structural distresses. Medium or high severity cracks are usually working cracks and are considered major structural distresses.

- **Low - 1) unfilled cracks 1/4 inch to 1/2 inch wide with no faulting or spalling; 2) cracks less than 1/2 inch wide with low severity spalling; or 3) filled cracks of any width, with filter performing in a satisfactory manner and no faulting or spalling;**
- **Medium - 1) un-filled cracks between 1/2 to 1 inch wide with no faulting or spalling or 2) filled cracks of any width faulting less than 1/8 inch or medium severity spalling;**
- **High - 1) un-filled cracks with a width greater than 1 inch; 2) un-filled cracks of any width with faulting greater than 1/2 inch or medium severity faulting; or 3) filled cracks of any width faulting greater than 1/2 inch or high severity faulting.**

- **Low - No action or seal cracks;**
- **Medium - seal cracks;**
- **High - seal cracks, apply a full depth patch or replace the slab.**

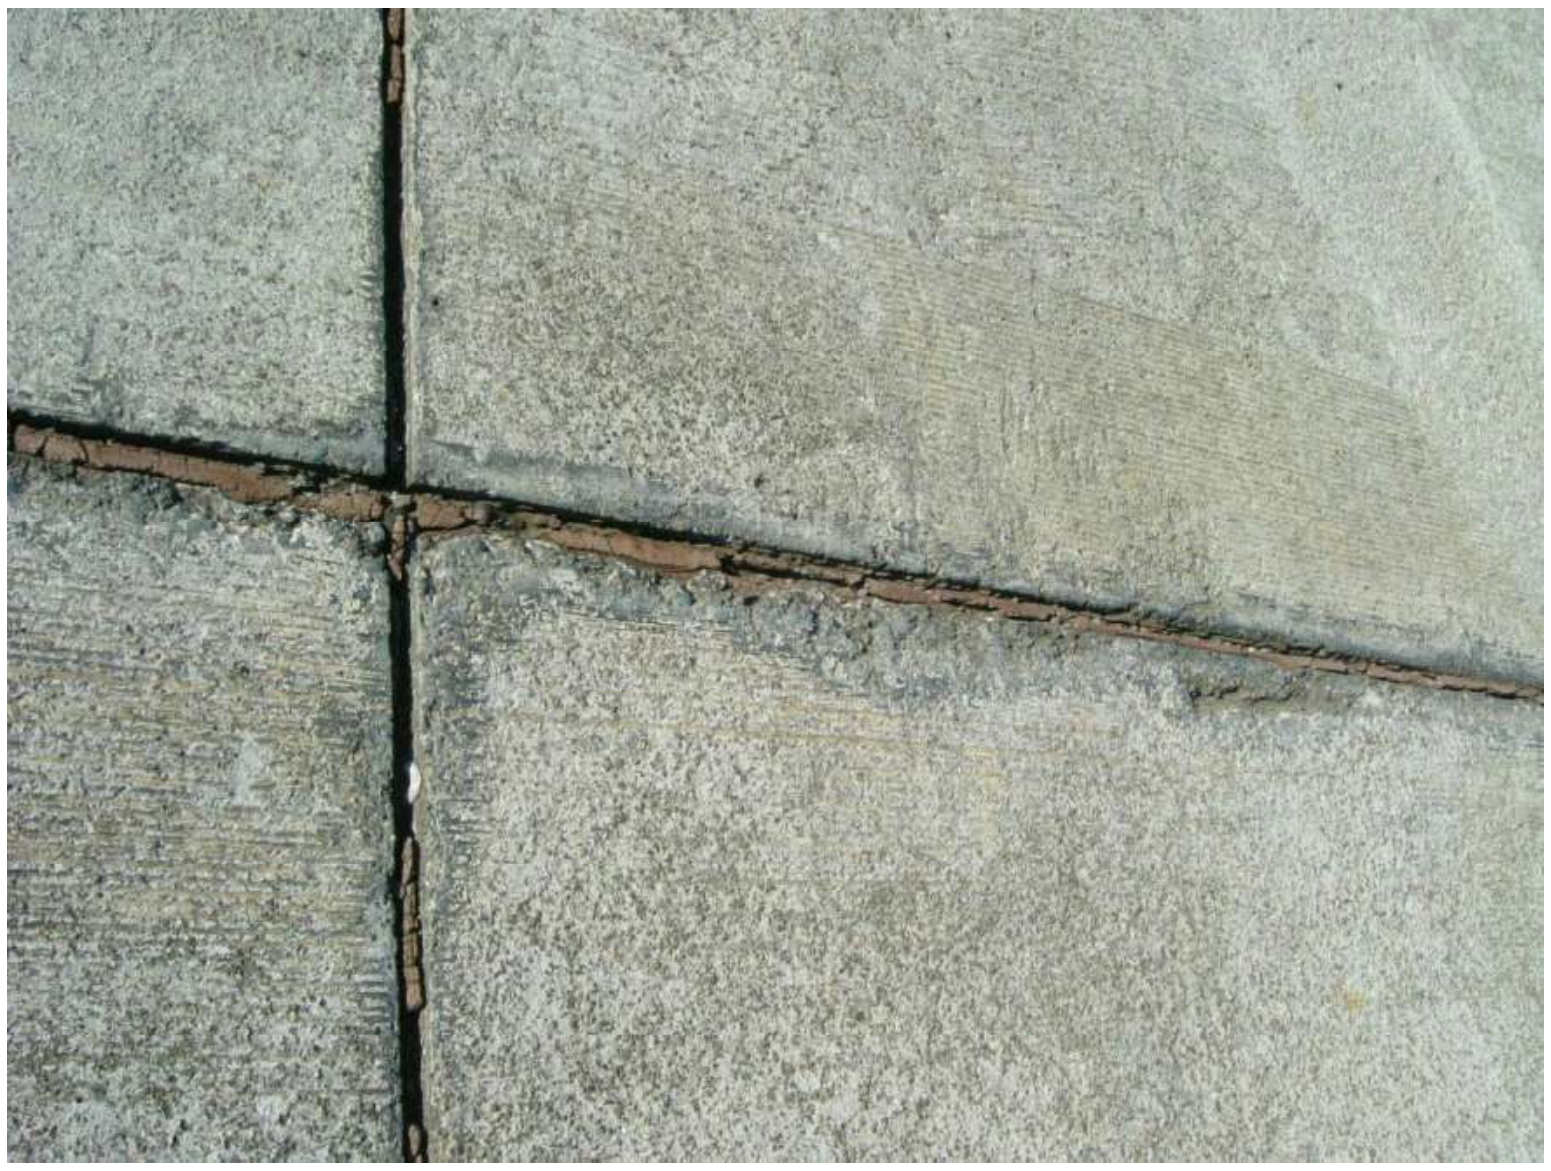
Figure C.13: PCC Joint Seal Damage.

Joint seal damage is any condition, which enables soil or rocks to accumulate in the joints or allow significant infiltration of water. Accumulation of incompressible materials in the joint prevents the slab from expanding and may result in buckling, shattering, or spalling. Pliable joint filler bonded to the edges of the slabs protects joints from the accumulation of materials and also prevents water from seeping down and softening the foundation supporting the slab. Typical types of joint seal damage are: 1) stripping the joint sealant; 2) extrusion of joint sealant; 3) weed growth; 4) hardening of the filler; 5) loss of bond to the slab edges; and 6) lack or absence of sealant in the joint.

- **Low - in generally good condition throughout the section. Sealant is performing well with only a minor amount of any of the above types of damage present;**
- **Medium - in generally fair condition throughout the section, with one or more of any of the above types of damage present occurring to a moderate degree. Sealant needs immediate replacement within 2 years;**
- **High - in generally poor condition throughout the section, with one or more of any of the above types of damages present, occurring to a severe degree. Sealant needs immediate replacement.**

- **Low - No action;**
- **Medium - seal joints;**
- **High - seal joints.**

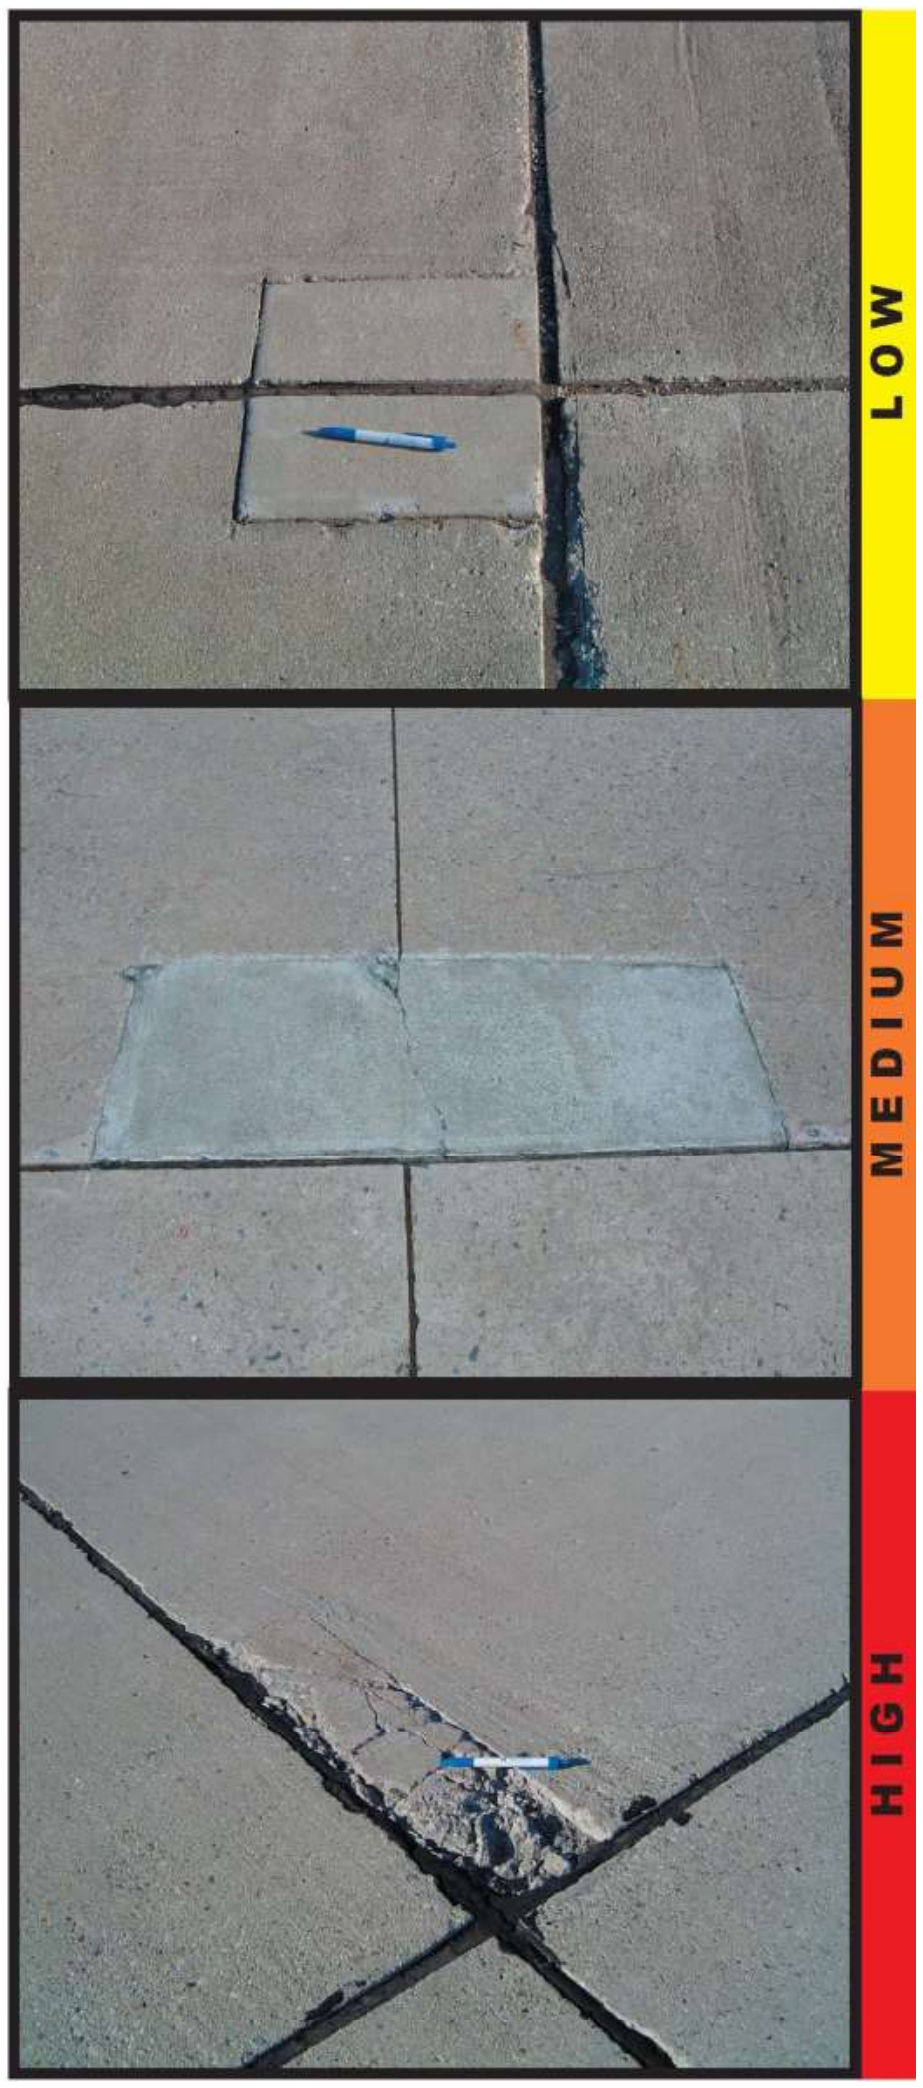
Figure C.14: PCC Small Patch.

A patch is an area where the original pavement has been removed and replaced by a filler **material. For condition evaluation, patching is divided into two types: small (less than 5 square feet) and large (over 5 square feet). Large patches are described in the next section.**

- **Low - Patch is functioning well, with little or no deterioration;**
- **Medium - Patch has deteriorated, and/or moderate spalling can be seen around the edges. Patch material can be dislodged, with considerable effort (minor FOD potential);**
- **High - Patch has deteriorated, either by spalling around the patch or cracking within the patch, to a state which warrants replacement.**

- **Low ï Do Nothing;**
- **Medium - Replace patch or replace the slab;**
- **High ï Replace patch or replace the slab.**
