Alabama Statewide Airport Pavement Management Program Update

Northeast Alabama Regional Airport (GAD)

Final Report

February 2022

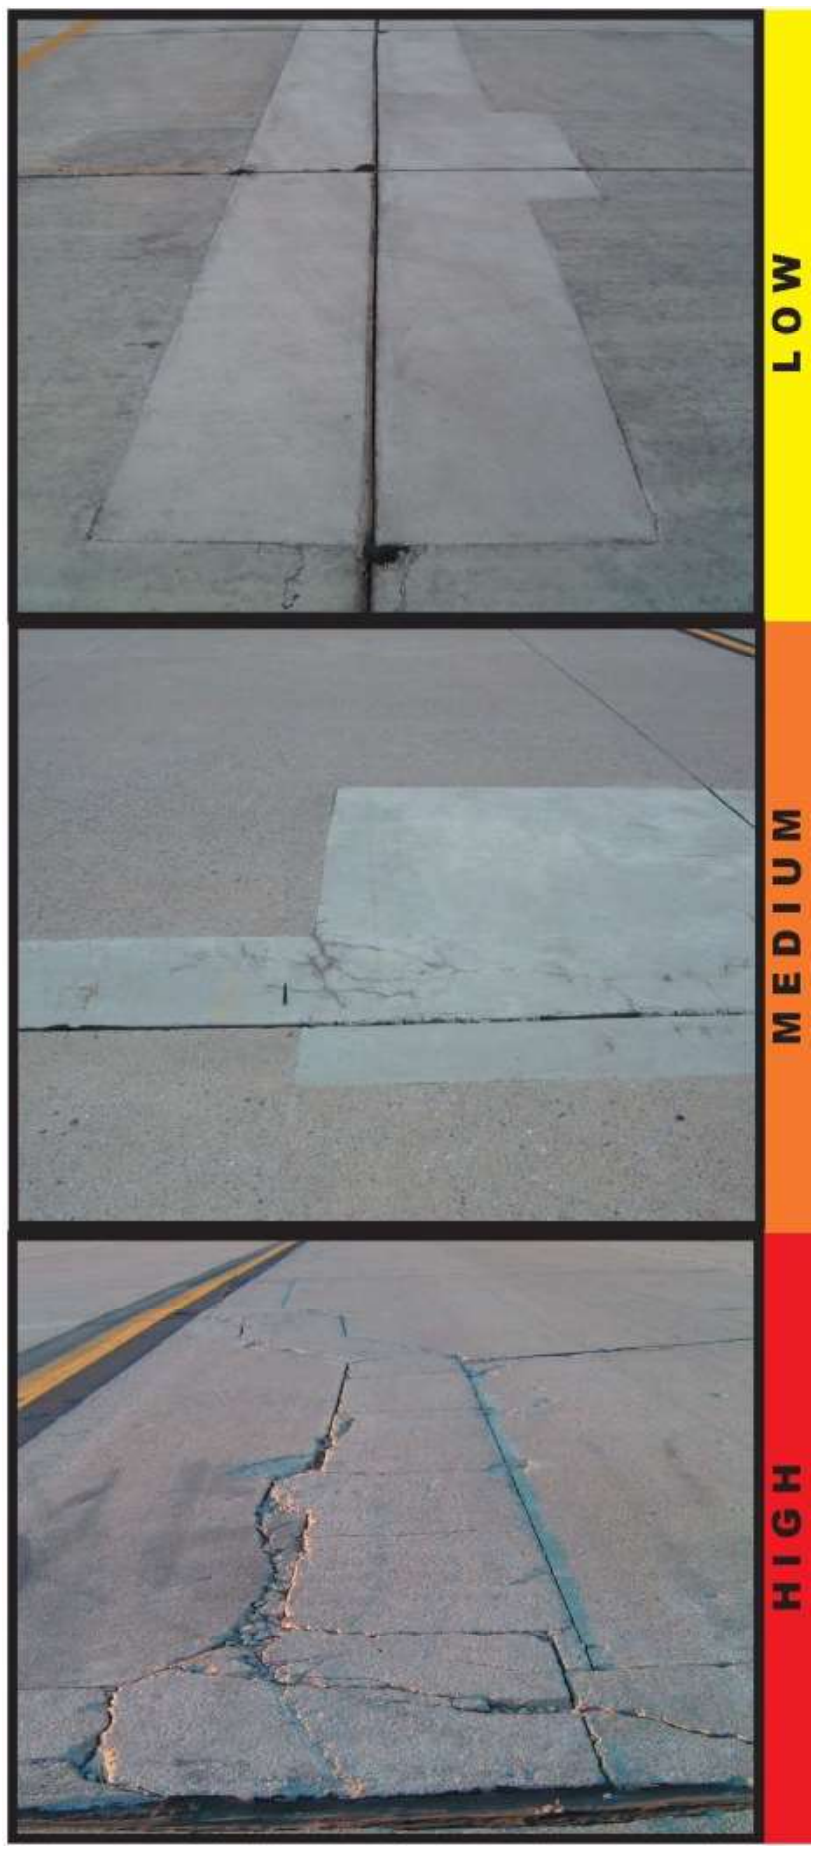
Figure C.15: PCC Large Patch.

Patching is the same as defined **for a small patch; however, the area of the patch is more than 5 square feet. A utility cut is a patch that has replaced the original pavement because of placement of underground utilities. The severity levels of a utility cut are the same as those for regular patching..**

- **Low - Patch is functioning well, with little or no deterioration;**
- **Medium - Patch has deteriorated, and/or moderate spalling can be seen around the edges. Patch material can be dislodged, with considerable effort (minor FOD potential);**
- **High - Patch has deteriorated, either by spalling around the patch or cracking within the patch, to a state which warrants replacement.**

- **Low ï Do Nothing;**
- **Medium - Replace patch or replace the slab;**
- **High ï Replace patch or replace the slab.**

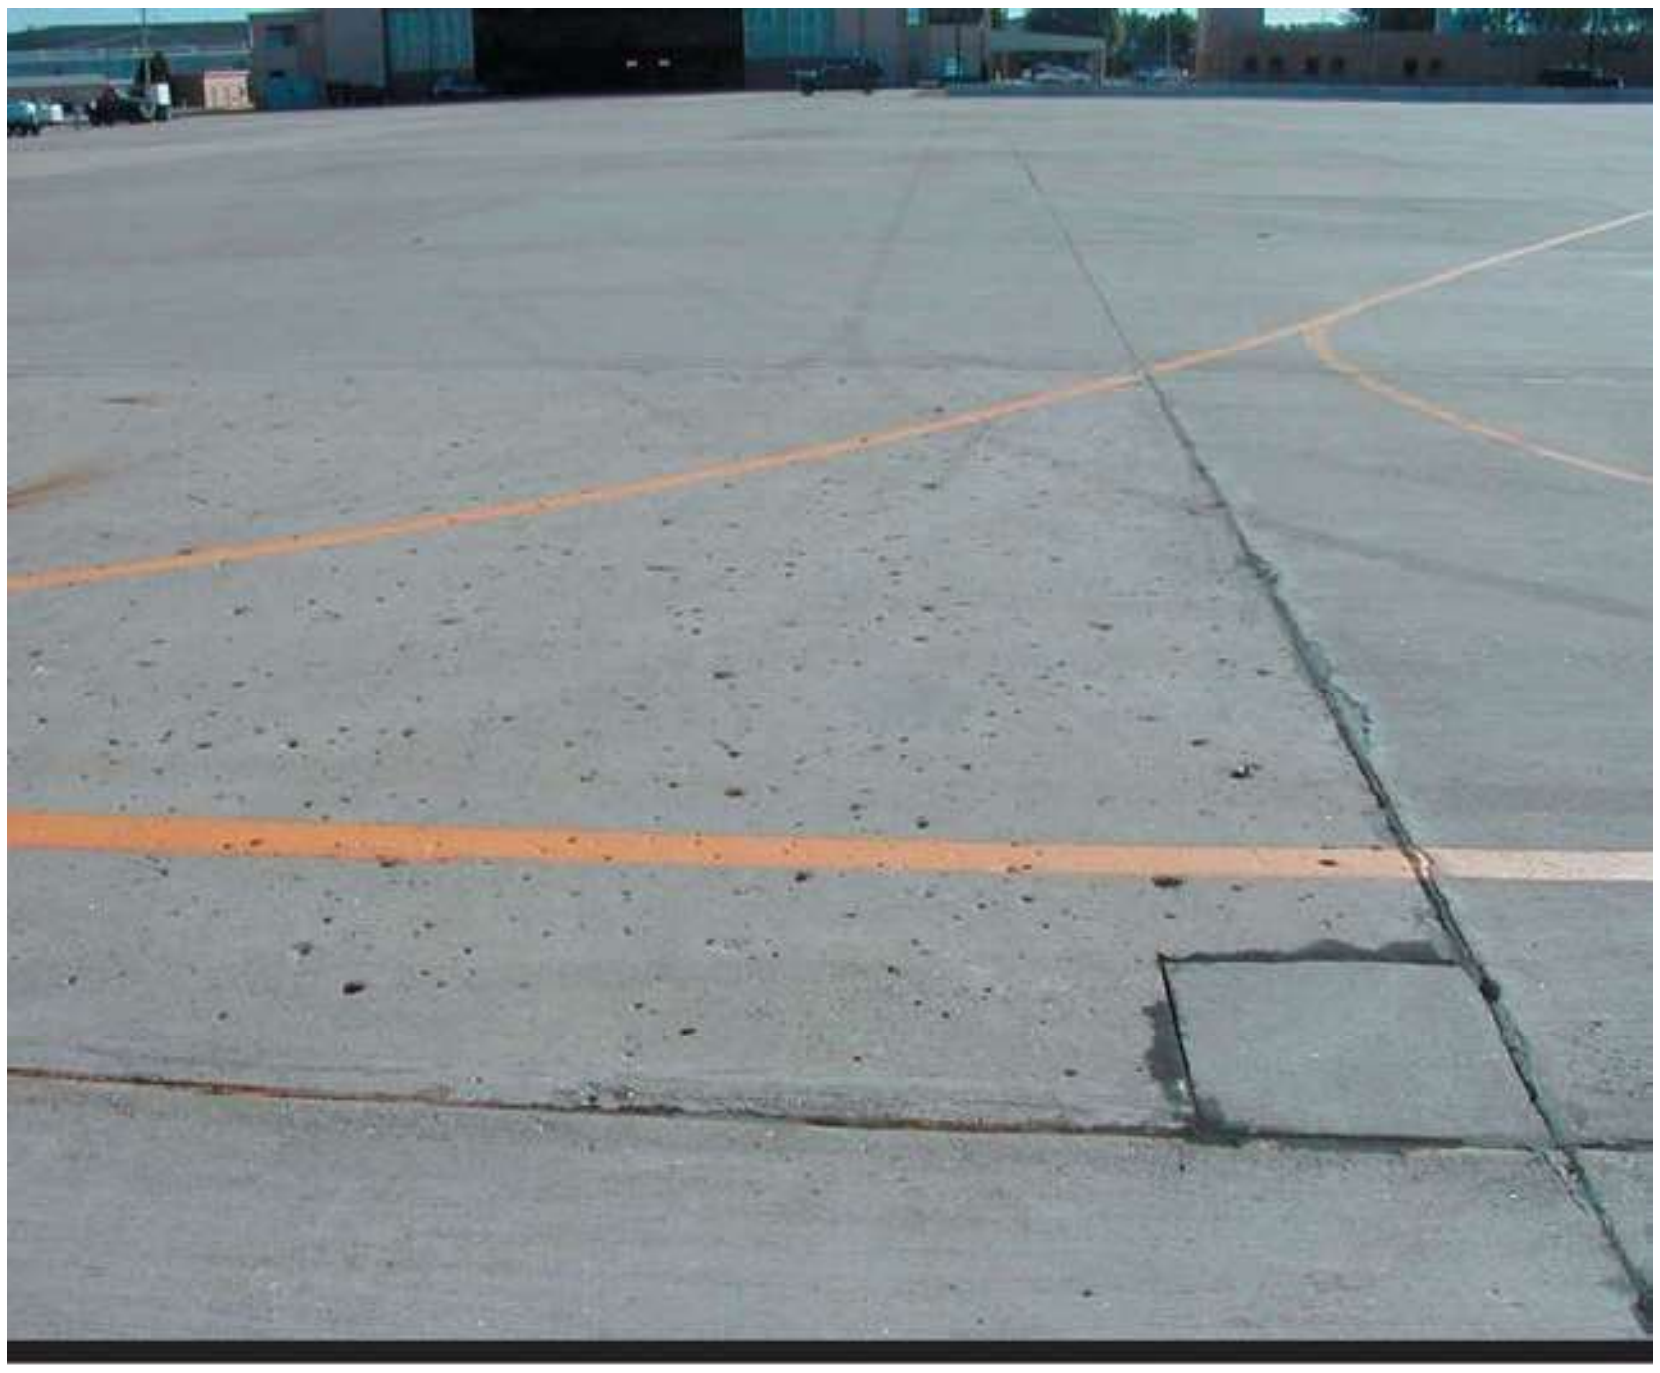
Figure C.16: Popouts.

A popout is a small piece of pavement that breaks loose from the surface due to freeze-thaw action in combination with expansive aggregates. Popouts usually range from approximately 1 inch to 4 inches in diameter and from 1/2 inch to 2 inches deep..

No degrees of severity are defined for popouts. **However, popouts must be extensive before they are counted as a distress; i.e., average popout density must exceed approximately three popouts per square yard over the entire slab area.**

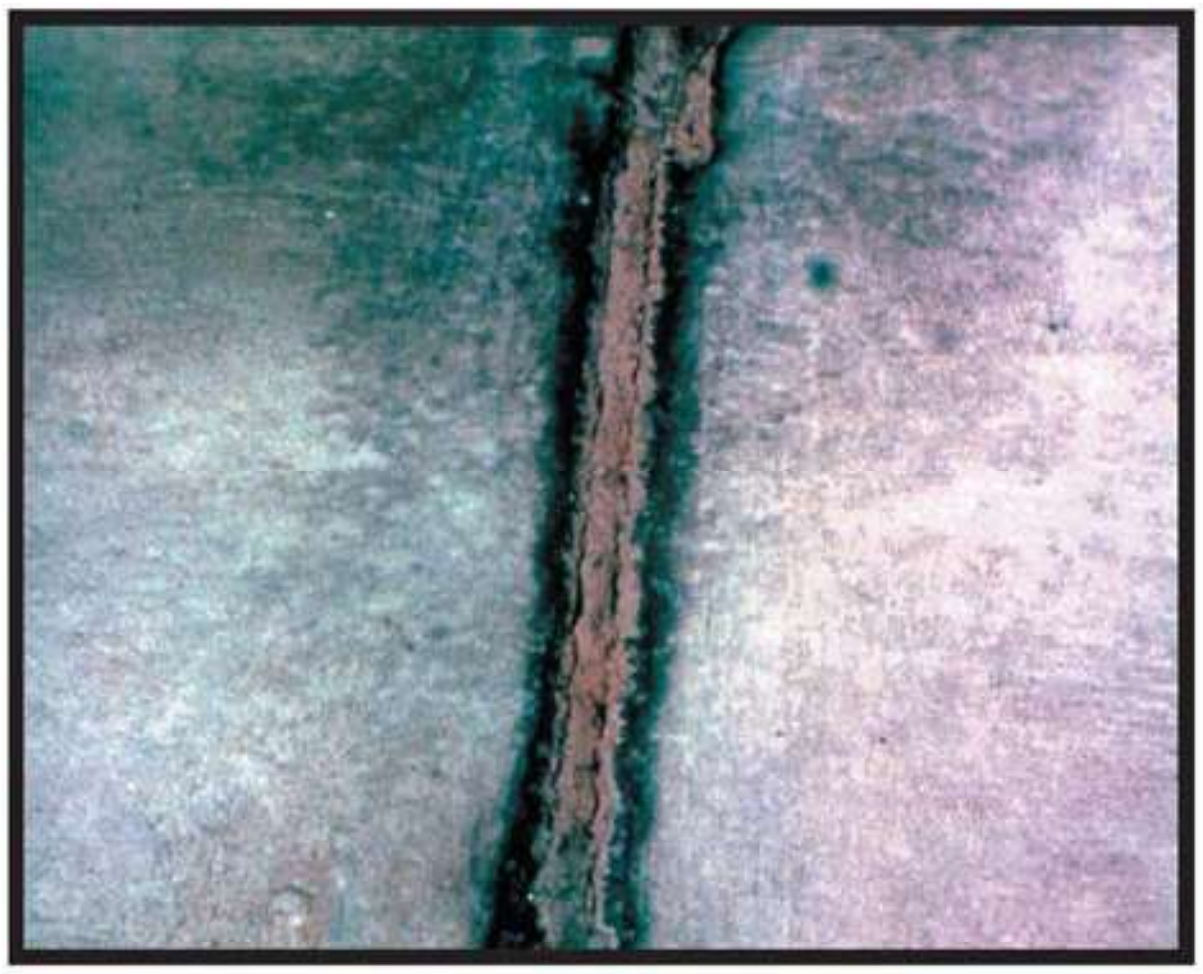
Pumping is the ejection of material by water through joints or cracks caused by deflection of the slab under passing loads. As the water is ejected, it carries particles of gravel, sand, clay, or silt and results in a progressive loss of pavement support. Surface staining and base or subgrade material on the pavement close to joints or cracks are evidence of pumping. Pumping near joints indicates poor joint sealer and loss of support which will lead to cracking under repeated loads.

No degrees of severity are defined. It is sufficient to indicate that pumping exists.

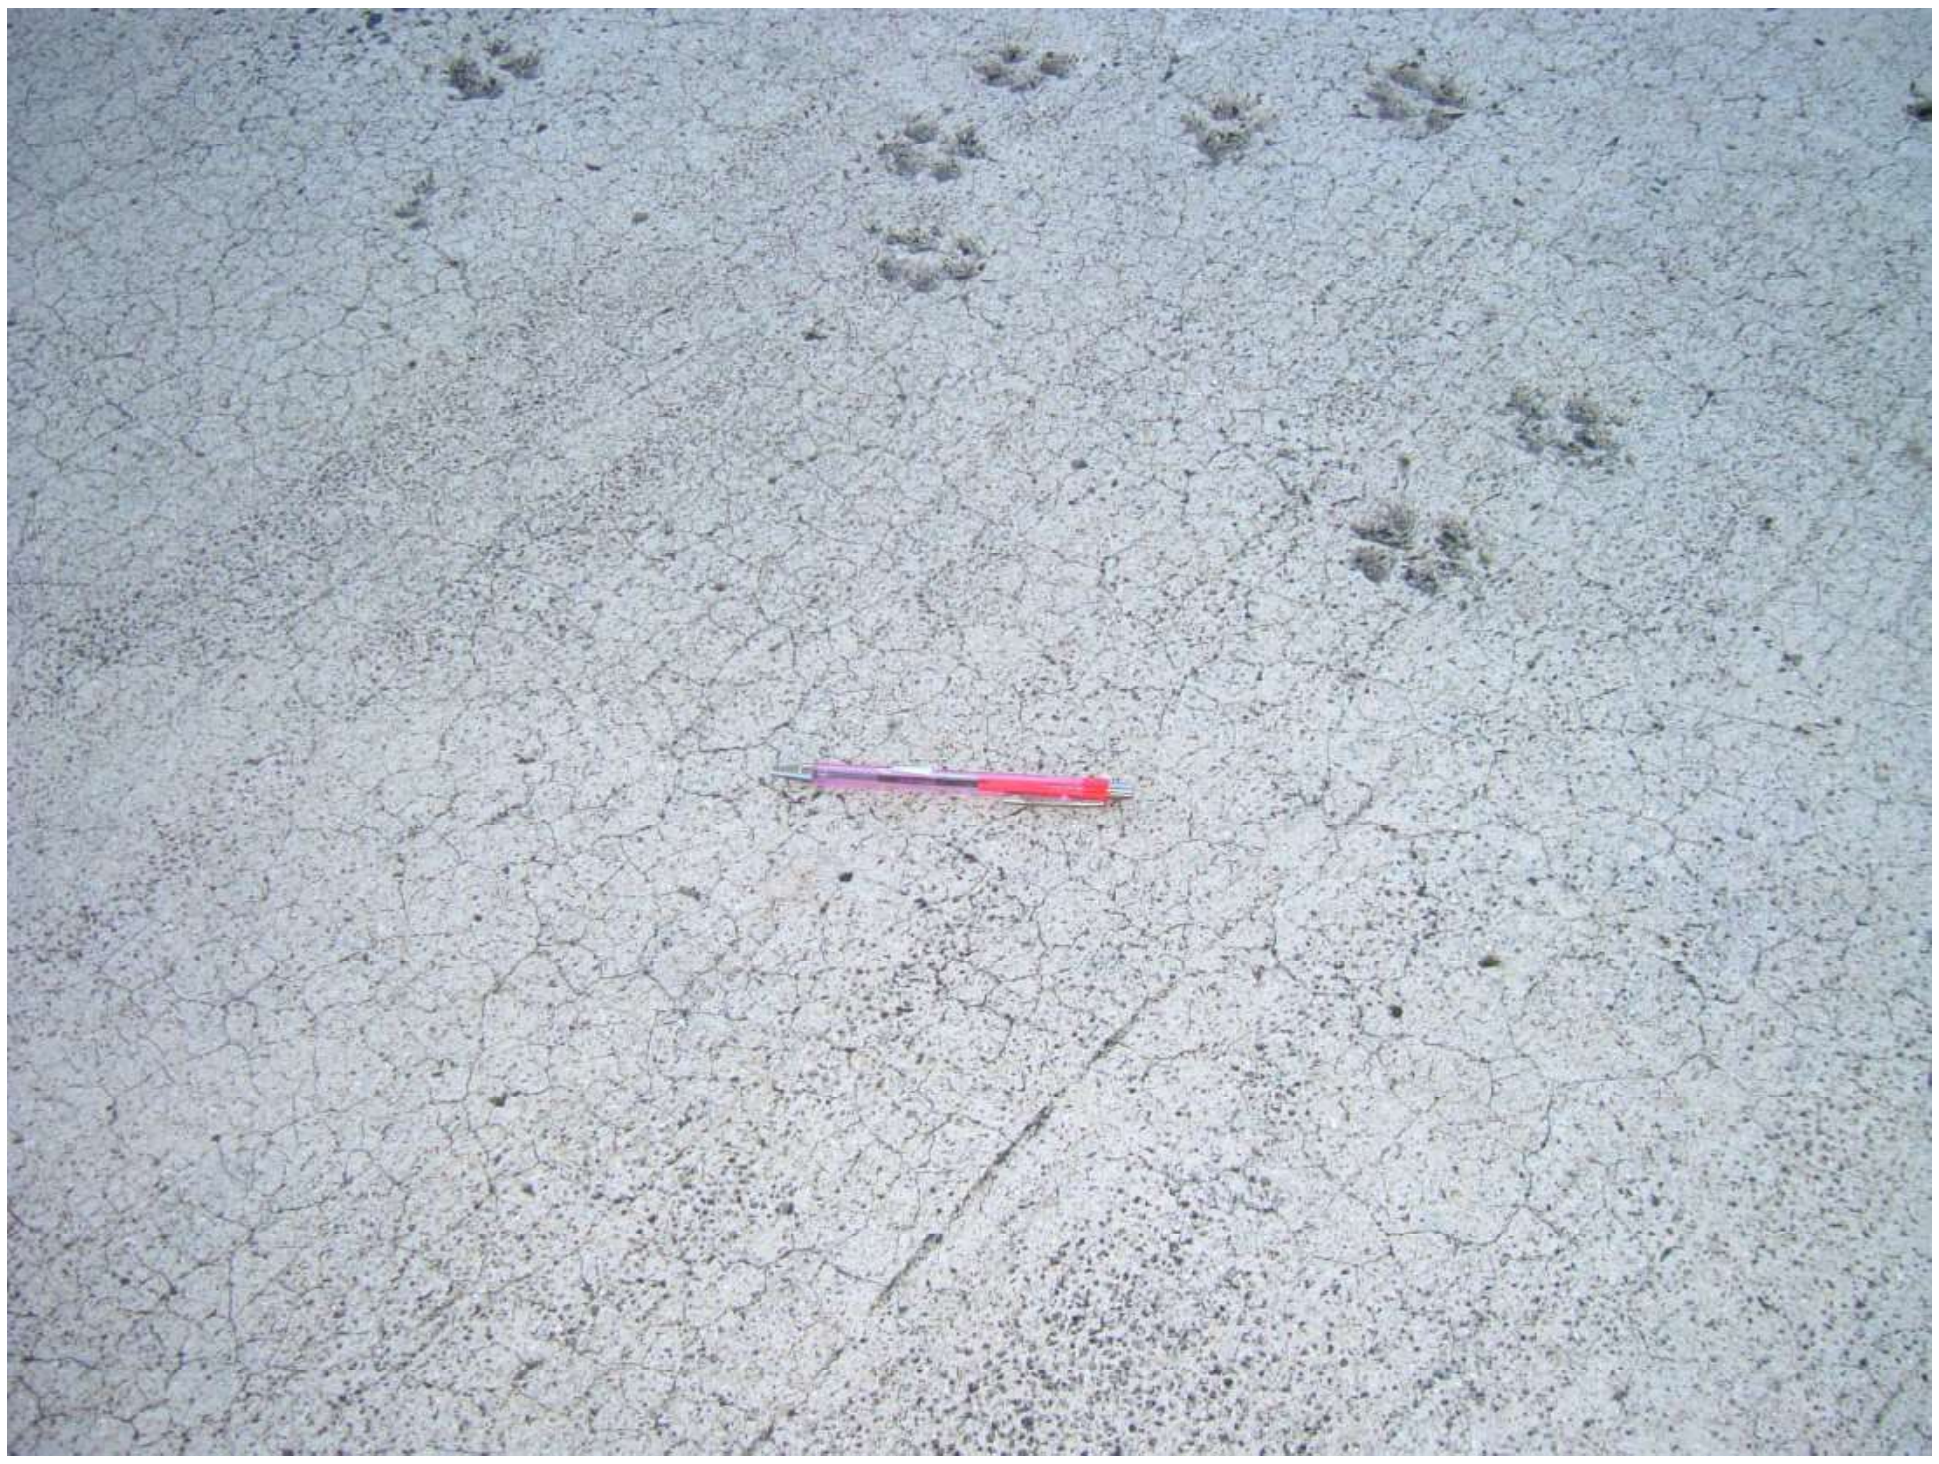
26. Scaling (PCC)

Map cracking or crazing refers to a network of shallow, fine, or hairline cracks that extend only through the upper surface of the concrete. The cracks tend to intersect at angles of 120 degrees. Map cracking or crazing is usually caused by over finishing the concrete and may lead to scaling of the surface, which is the breakdown of the slab surface to a depth of approximately 1⁄4 to 1⁄2 in**ch. Scaling may also be caused by improper construction and poor aggregate. Another recognized source of distress is the reaction between the alkalis (Na2O and K2O) in some cements and certain minerals in some aggregates. Products formed by the reaction between the alkalis and aggregate result in expansions that cause a breakdown in the concrete.**

- **Low - Crazing or map cracking exists over significant slab area. The surface is in good condition with no scaling. The crack pattern must be well defined and easily recognized;**
- **Medium - Slab is scaled over approximately 5% or less of the surface with some FOD potential;**
- **High - Slab is severely scaled causing a high FOD potential. Usually, more than 5% of the surface is affected.**

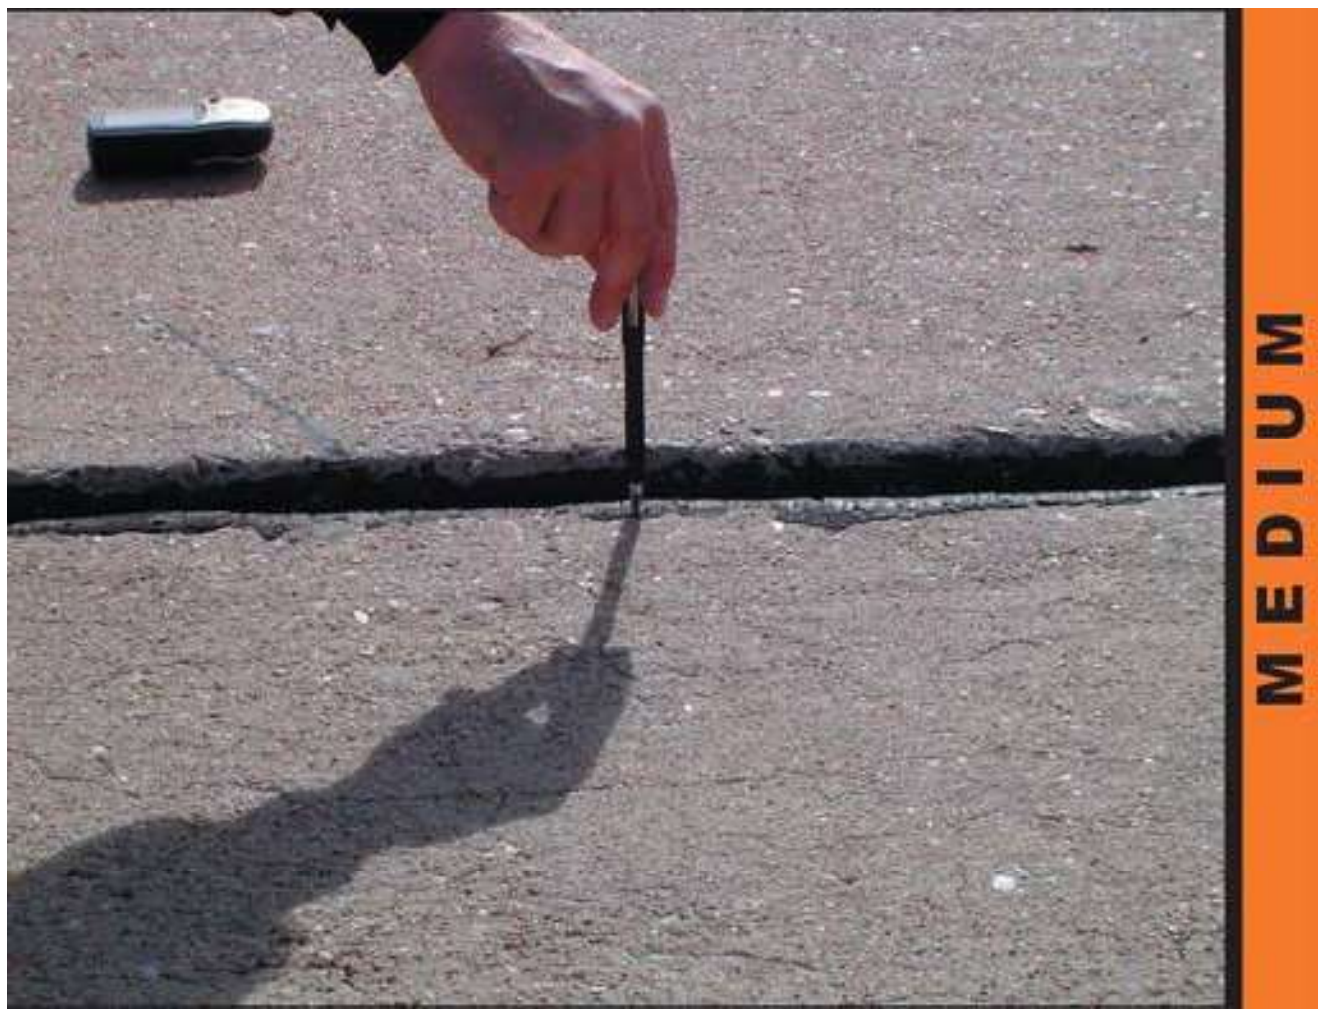
27. Faulting (PCC)

Settlement or faulting is a difference of elevation at a joint or crack caused by upheaval or consolidation.

- **Low - No action;**
- **Medium ï Grinding along the joint;**
- **High ï Grinding or joint load transfer restoration.**

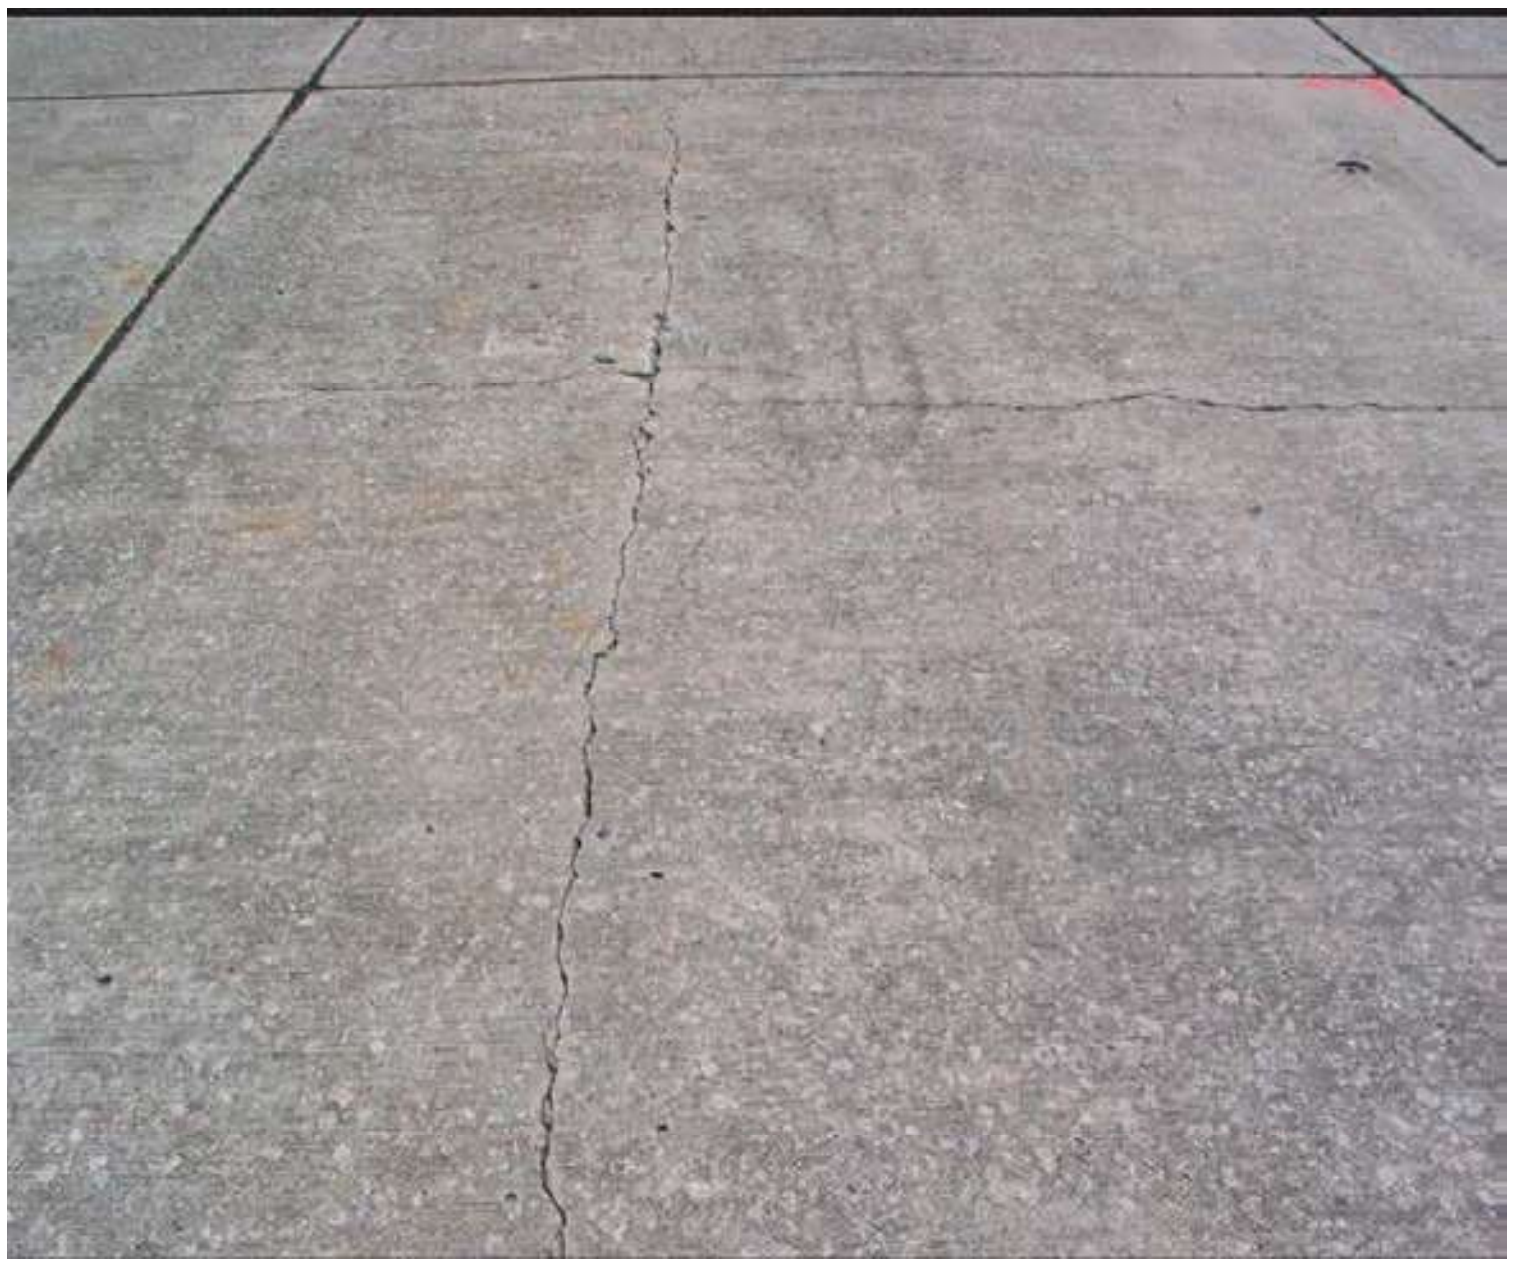
28. Shattered Slab (PCC)

Intersecting cracks are cracks that break into four or more pieces because of overloading and/or inadequate support. The high-severity level of this distress type, as defined below, **is referred to as a shattered slab. If all pieces or cracks are contained within a corner break, the distress is categorized as a severe corner break.**

- **Low -** Slab is broken into four or five pieces with the vast majority of the cracks **(over 85 percent) of low-severity;**
- **Medium -** (1) Slab is broken into four or five pieces with over 15 percent of the **cracks of medium severity (no high-severity cracks); or (2) slab is broken into six or more pieces with over 85 percent of the cracks of low-;**
- **High - At this level of severity, the slab is called shattered: (1) slab is broken into** four or five pieces with some or all of the cracks of high severity; (2) slab is **broken into six or more pieces with over 15 percent of the cracks of medium- or high-severity.**

- **Low ï Seal Cracks;**
- **Medium - Full depth patch or replace the slab;**
- **High - Full depth patch or replace the slab.**

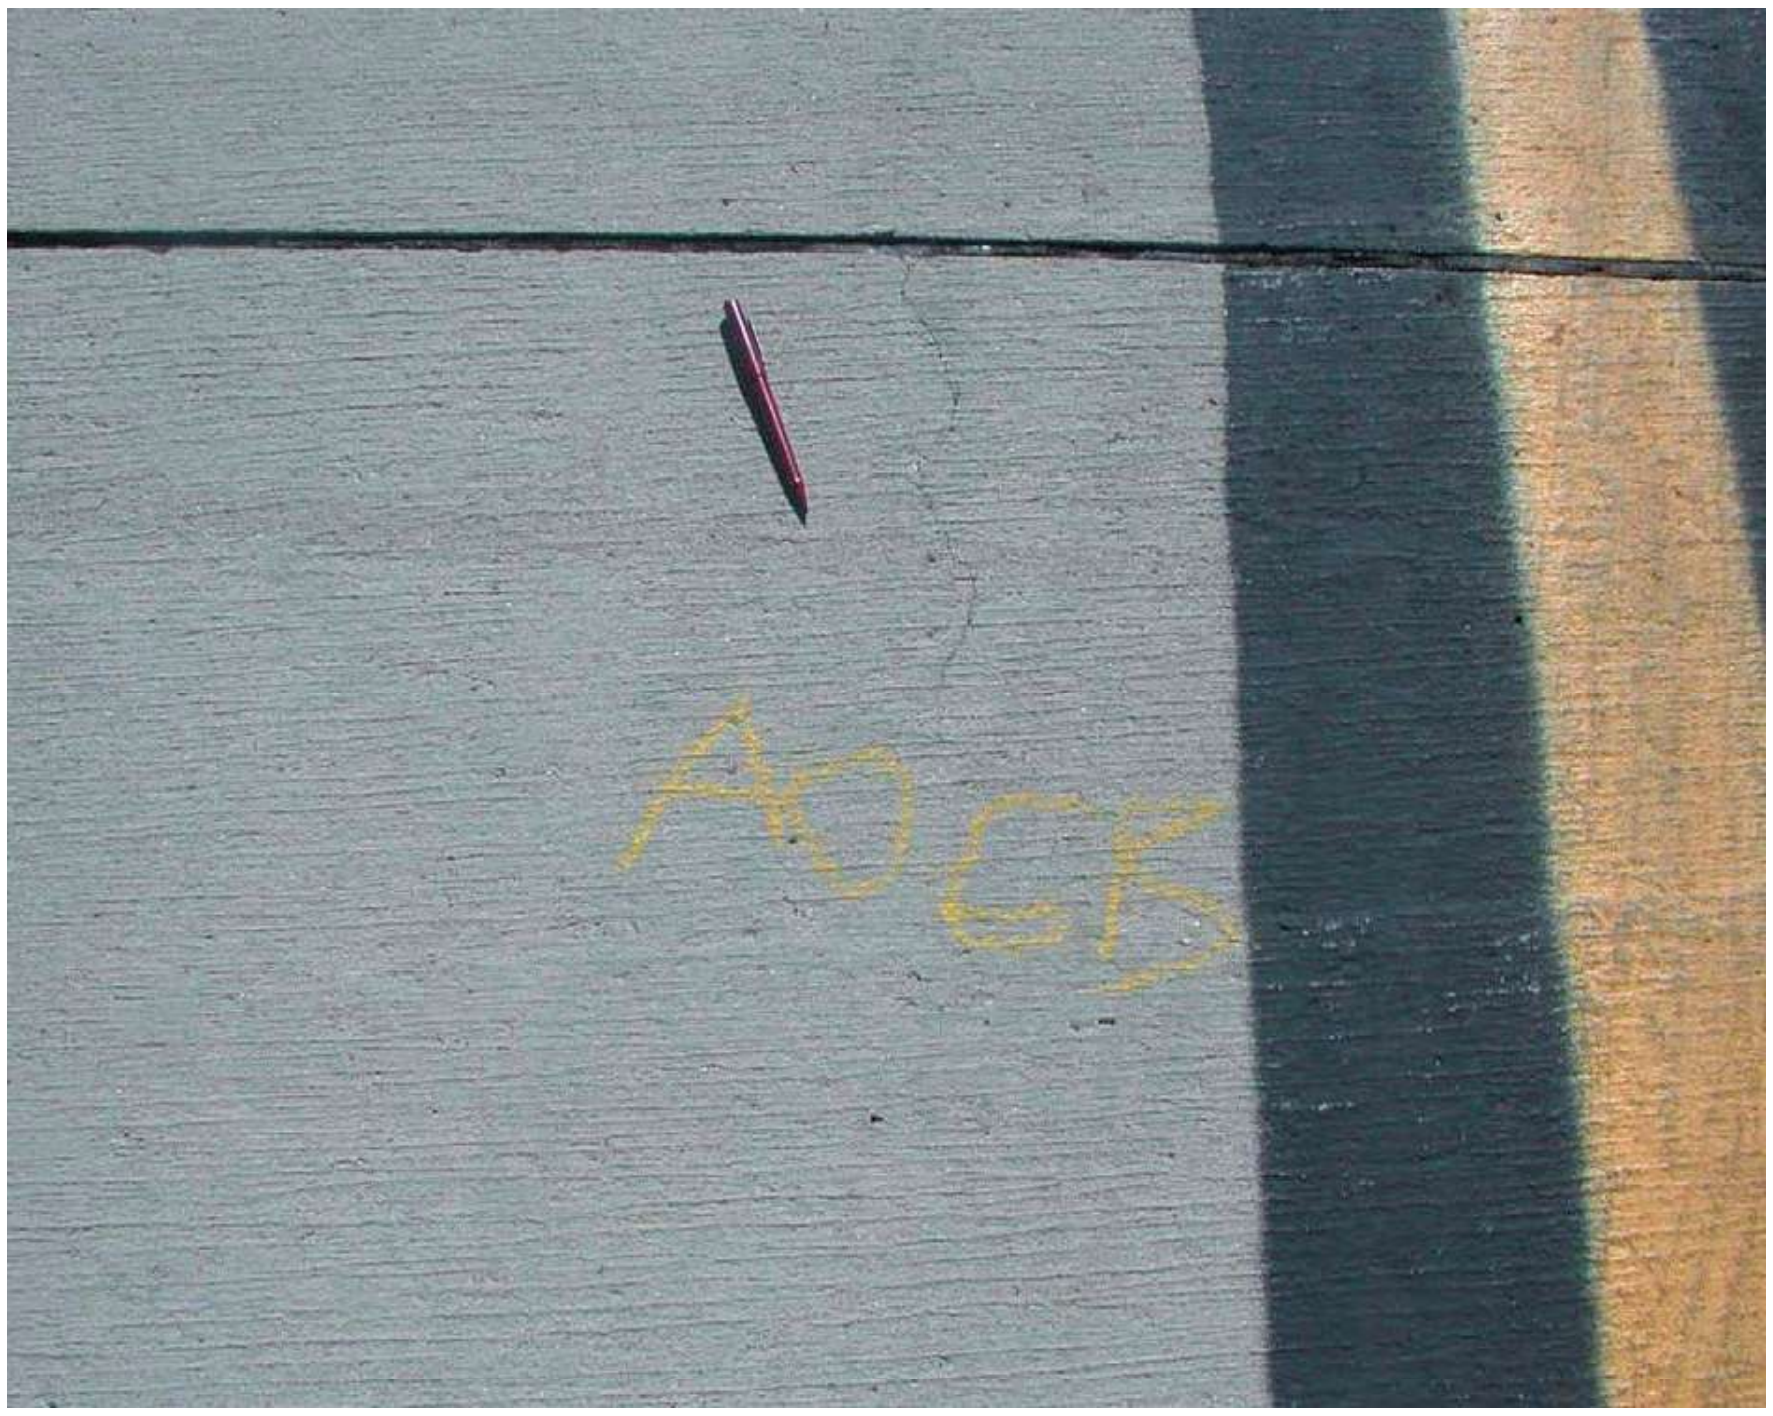
29. Shrinkage Crack (PCC)

Shrinkage cracks are hairline cracks that are usually only a few feet long and do not extend across the entire slab. They are formed during the setting and curing of the concrete and usually do not extend through the depth of the slab.

No degrees of severity are defined. It is sufficient to indicate that shrinkage cracks exist.

- **Do Nothing**

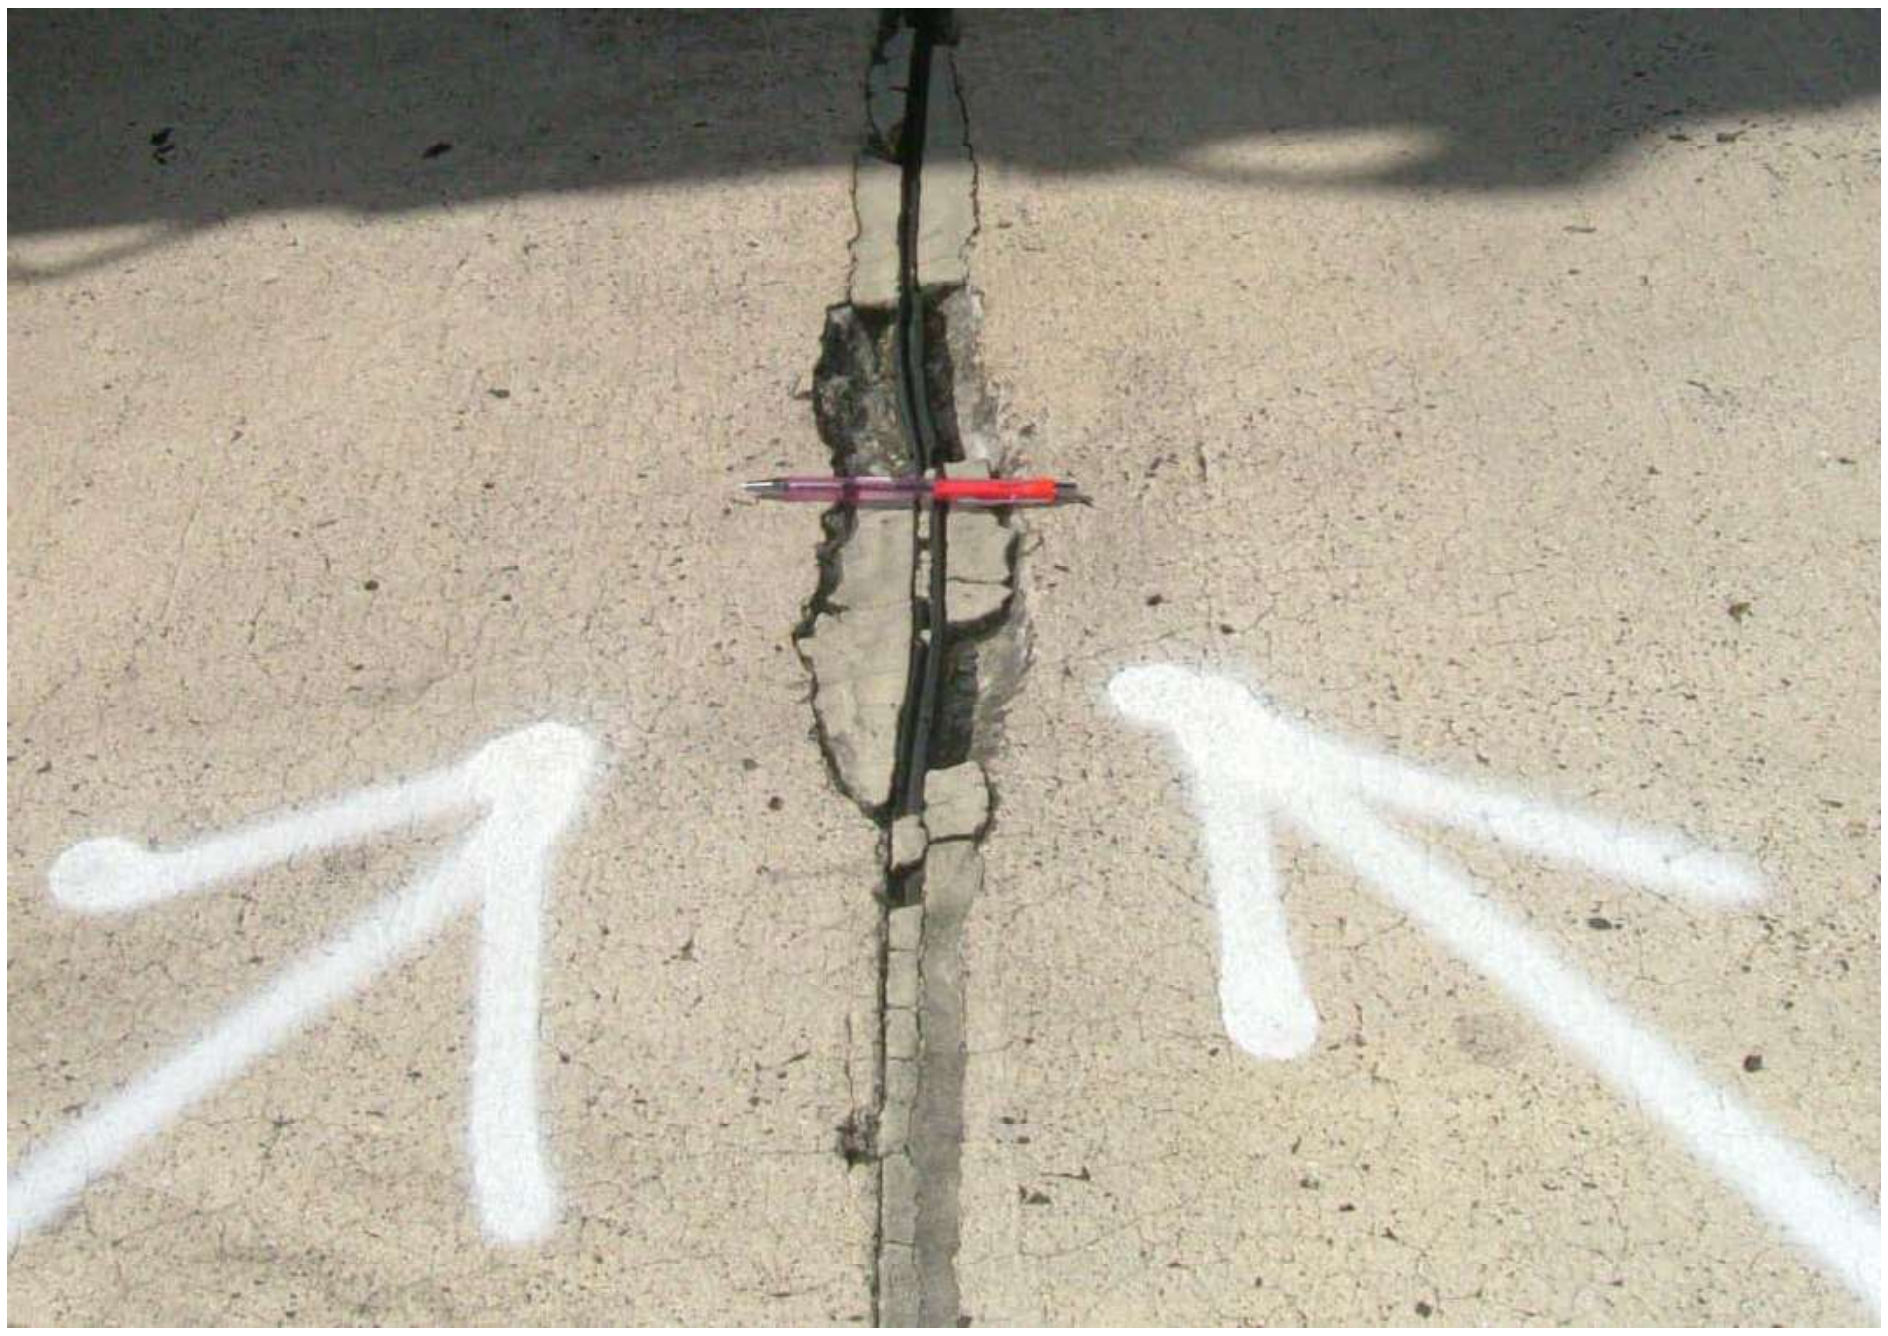
30. Joint Spalls (PCC)

Joint spalling is the disintegration of the slab edges within 2 feet of the side of the joint. A joint spall usually does not extend vertically through the slab, but intersects the joint at an angle. Spalling results from excessive stresses at the joint crack caused by infiltration of incompressible materials or traffic loads. Weak concrete at the joint (caused by overworking) combined with traffic loads is another cause of spalling.

- **Low - over 2 feet long and is broken into no more than three pieces defined by low or medium severity cracks, with little or no FOD potential, or is 2) less than 2 feet long and is broken into more than three pieces, with little FOD or tire damage potential;**
- **Medium - over 2 feet long and is broken into more than 3 pieces defined by light or medium cracks or some FOD potential existing, or is 2) less than 2 feet long and is broken into pieces or fragmented, with some of the pieces loose or absent, causing considerable FOD or tire damage potential;**
- **High - over 2 feet long and is broken into more than three pieces defined by one or more high severity cracks with high FOD potential.**

- **Low - No action;**
- **Medium - perform a partial depth patch;**
- **High - perform a partial depth patch.**

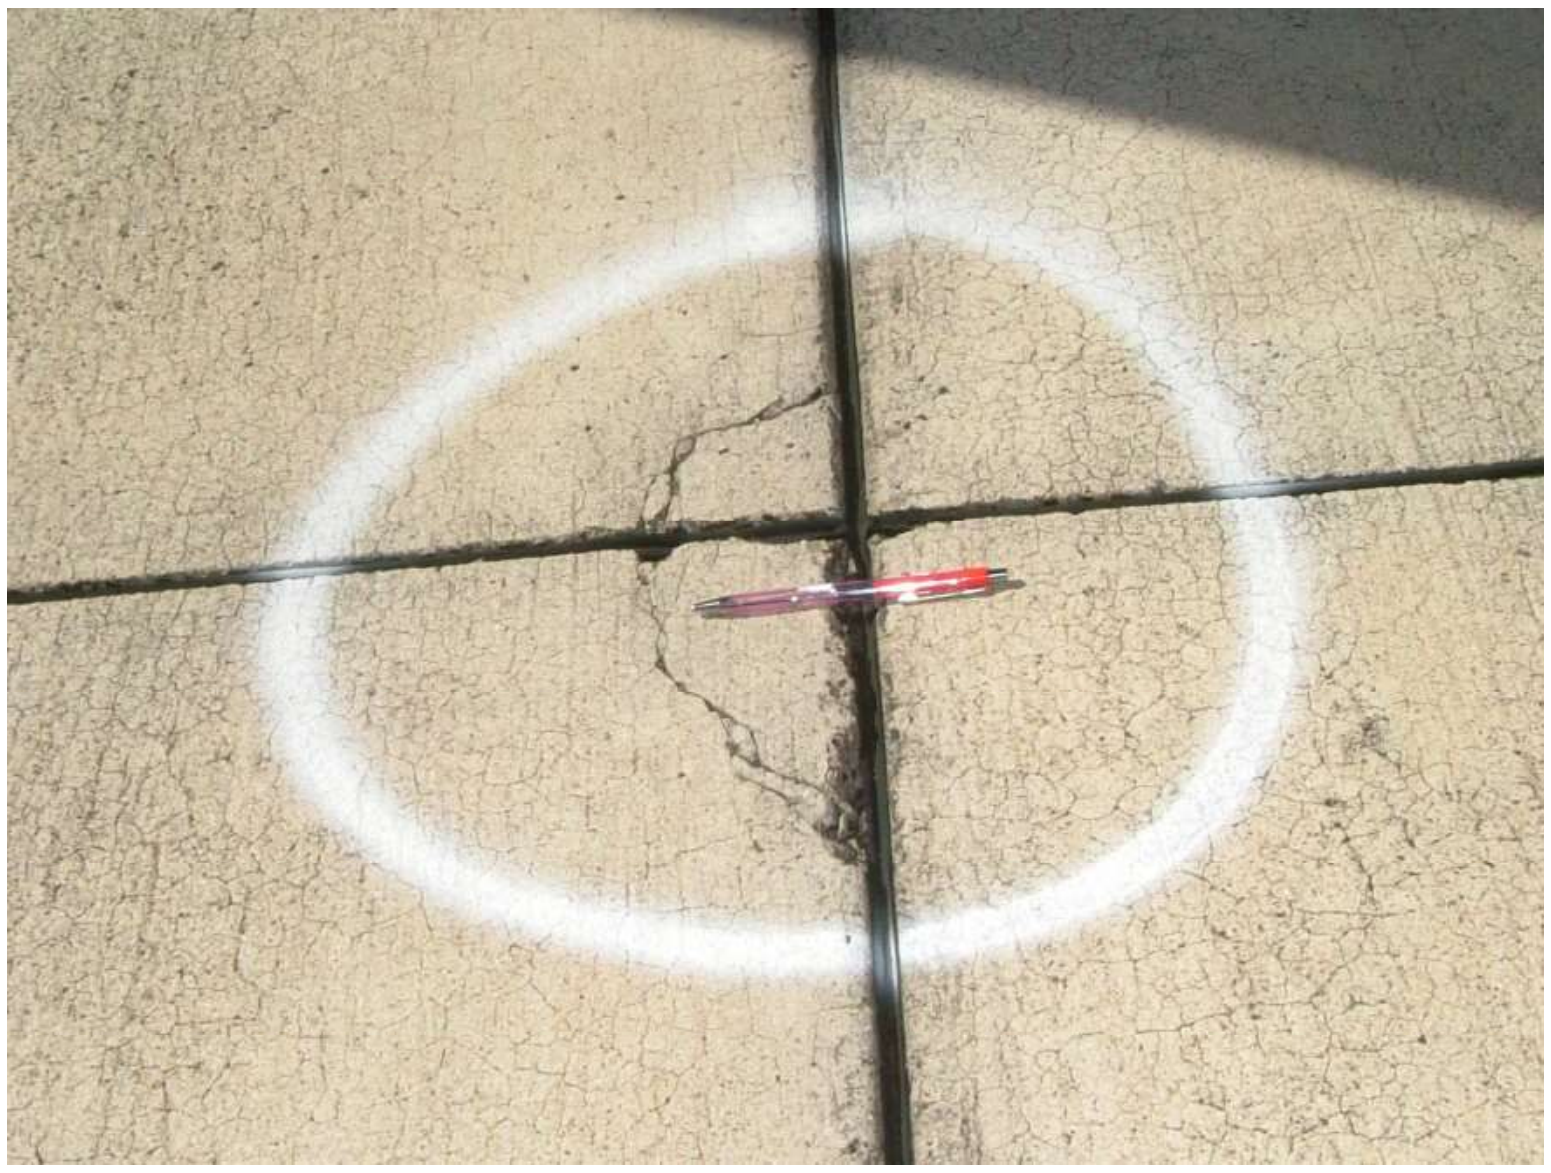
31. Corner Spalls (PCC)

Corner spalling is the raveling or breakdown of the slab within approximately 2 feet of the corner. A corner spall differs from a corner break in that the spall angles downward to intersect the joint while the break extends vertically through the slab.

- **Low - either 1) the spall is broken into one or two pieces defined by low severity cracks with little or no FOD potential; or 2) the spall is defined by one medium severity crack with little or no FOD potential;**
- **Medium ï 1) the spall is broken into two or more pieces defined by medium severity cracks, and a few small fragments may be absent or loose; 2) the spall is defined by one severe, fragmented crack that may be accompanied by a few hairline cracks or 3) the spall has deteriorated to the point where loose material is causing FOD potential;**
- **High ï 1) the spall has broken into two or more pieces defined by high severity fragmented cracks, with loose or absent fragments; 2) pieces of the spall have been displaced to the extent that tire damage hazard exists, or 3) the spall has deteriorated to the point where loose material is causing high FOD potential.**

- **Low - No action;**
- **Medium - partial depth patch;**
- **High - partial depth patch.**

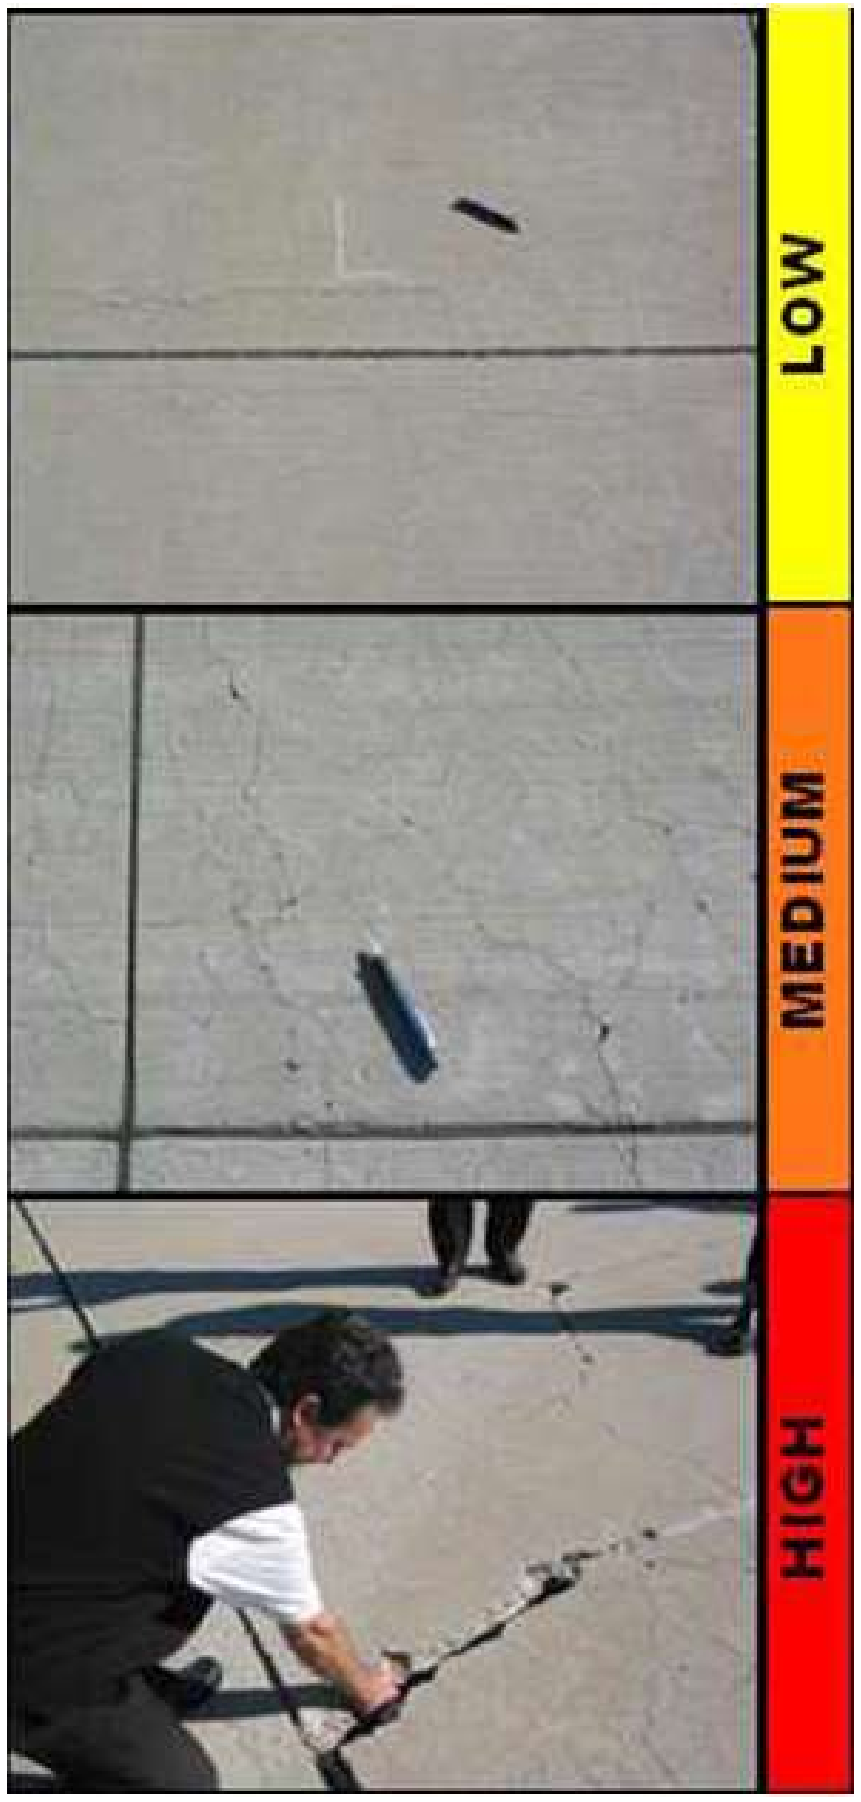
32. ASR (PCC)

ASR is caused by chemical reaction between alkalis and certain reactive silica minerals which form a gel. The gel absorbs water, causing expansion which may damage the concrete and adjacent structures. Alkalis are most often introduced by the portland cement within the pavement. ASR cracking may be accelerated by chemical pavement deicers.

1. **Cracking of the concrete pavement (often in a map pattern)**
2. **White, brown, gray or other colored gel or staining may be present at the crack surface**
3. **Aggregate popouts**
4. **Increase in concrete volume (expansion) that may result in distortion of adjacent or integral structures or physical elements. Examples of expansion include shoving of asphalt pavements, light can tilting, slab faulting, joint misalignment, and extrusion of joint seals or expansion joint fillers.**

L	Minimal to no Foreign Object Damage (FOD) potential from cracks, joints or ASR related popouts; cracks at the surface are tight (predominantly 1 mm or less). Little to no evidence of movement in pavement or surrounding structures or elements.
M	Some FOD potential; increased sweeping or other FOD removal methods may be required. May be evidence of slab movement and/ or some damage to adjacent structures or elements. Medium ASR distress is differentiated from low by having one or more of the following: increased FOD potential, increased cracking of the slab, some fragments along cracks or at crack intersections present, surface popouts of concrete may occur, pattern of wider cracks (predominantly 1 mm or wider) that may be subdivided by tighter cracks.
H	One or both of the following exist: 1) Loose or missing concrete fragments which pose high FOD potential, 2) Slab surface integrity and function significantly degraded and pavement requires immediate repair; may also require repairs to adjacent structures or elements.
