Alabama Statewide Airport Pavement Management Program Update

Guntersville Municipal – Joe Starnes Field (8A1)

Final Report

February 2022

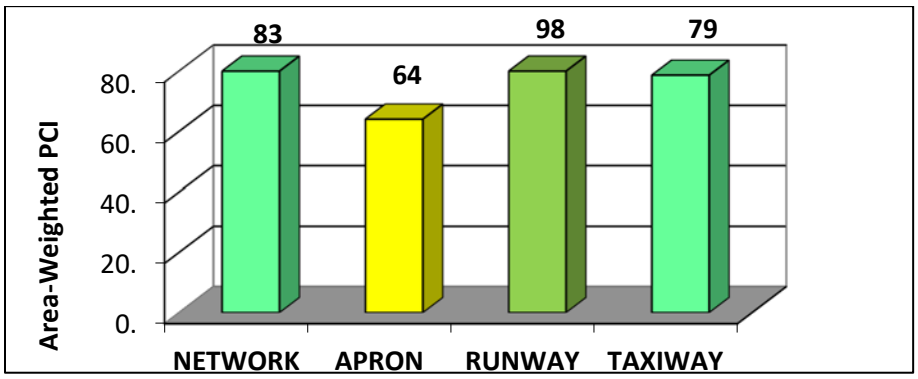
Figure 3.2: Pavement Condition by Branch Use.

Figure 3.2 presents the area-weighted PCI by use and the overall airside network.

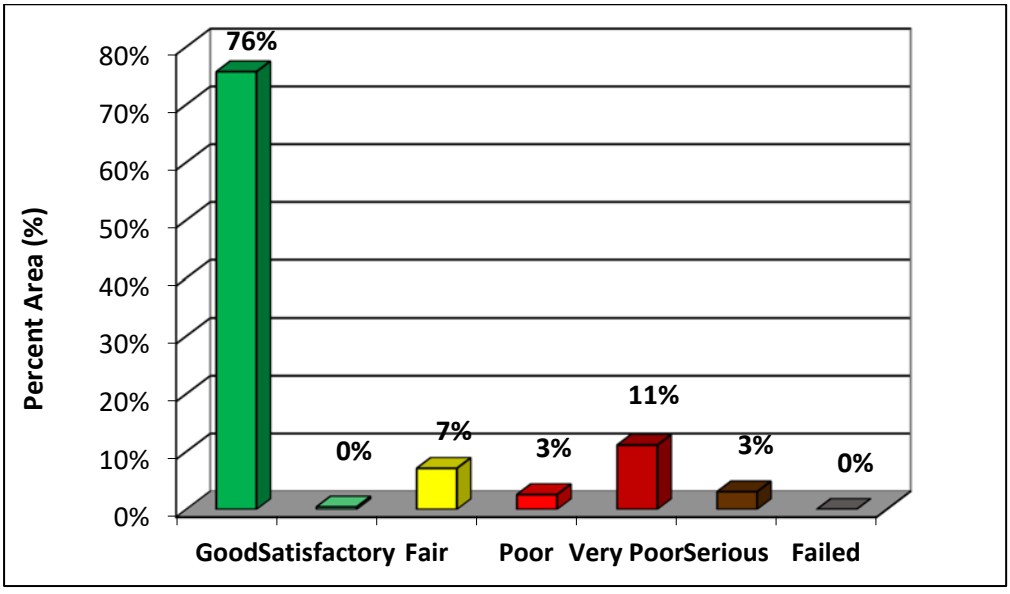
Figure 3.3: Pavement Condition by Percent of Area.

Figure 3.3 shows the distribution of the 8A1 pavement network by condition. Approximately 17 percent of the network is in "Poor" or worse condition.

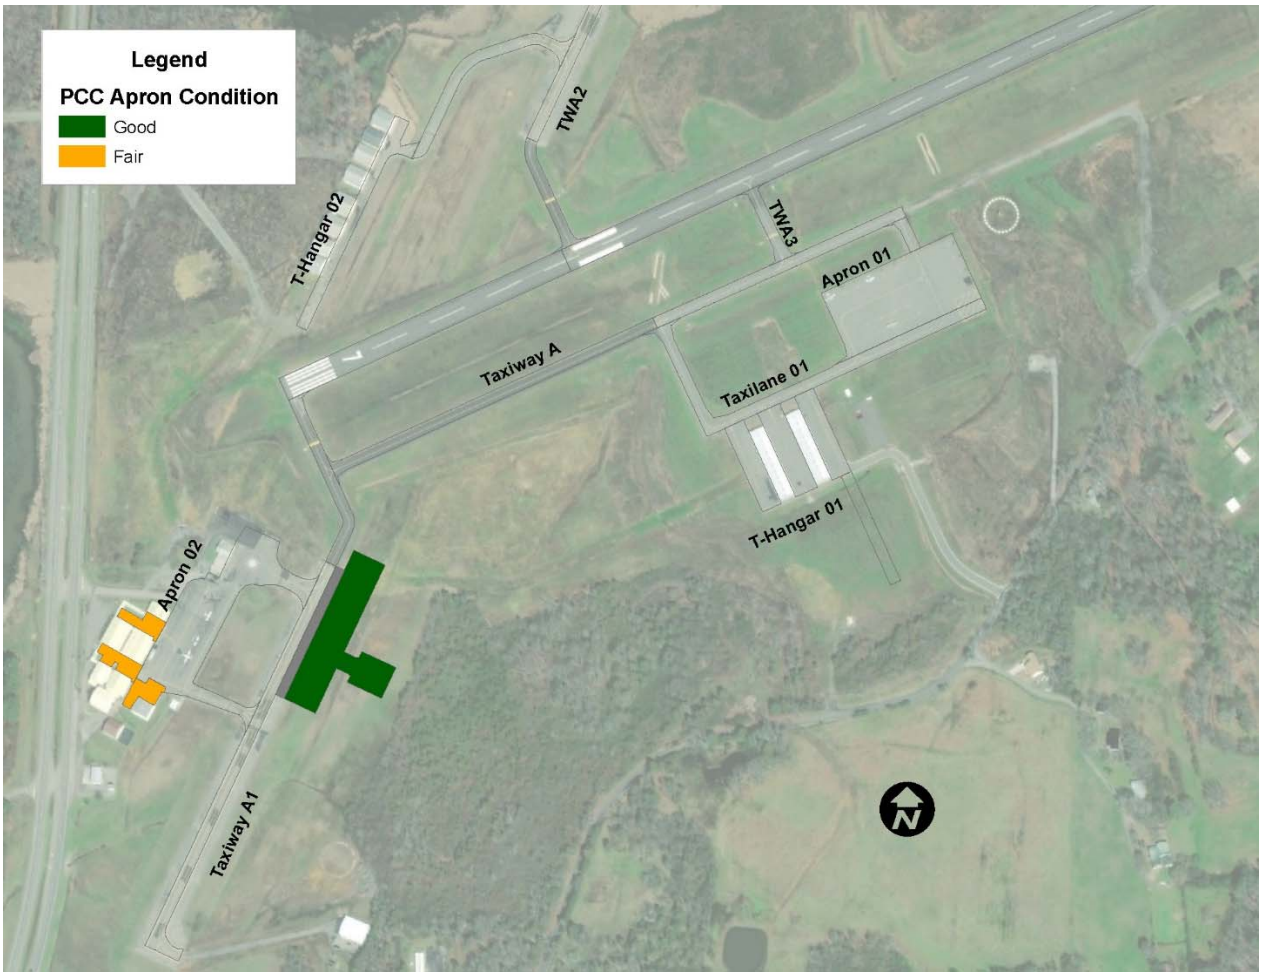
Figure 3.4: PCC Apron Condition Rating.

As stated earlier, the project scope did not include a detailed pavement condition survey for any Portland Cement Concrete (PCC) aprons. For these pavements, a rating of “Good”, “Fair”, or “Poor” was assigned based on the overall pavement condition. Figure 3.4 shows the condition rating for the PCC aprons at 8A1.

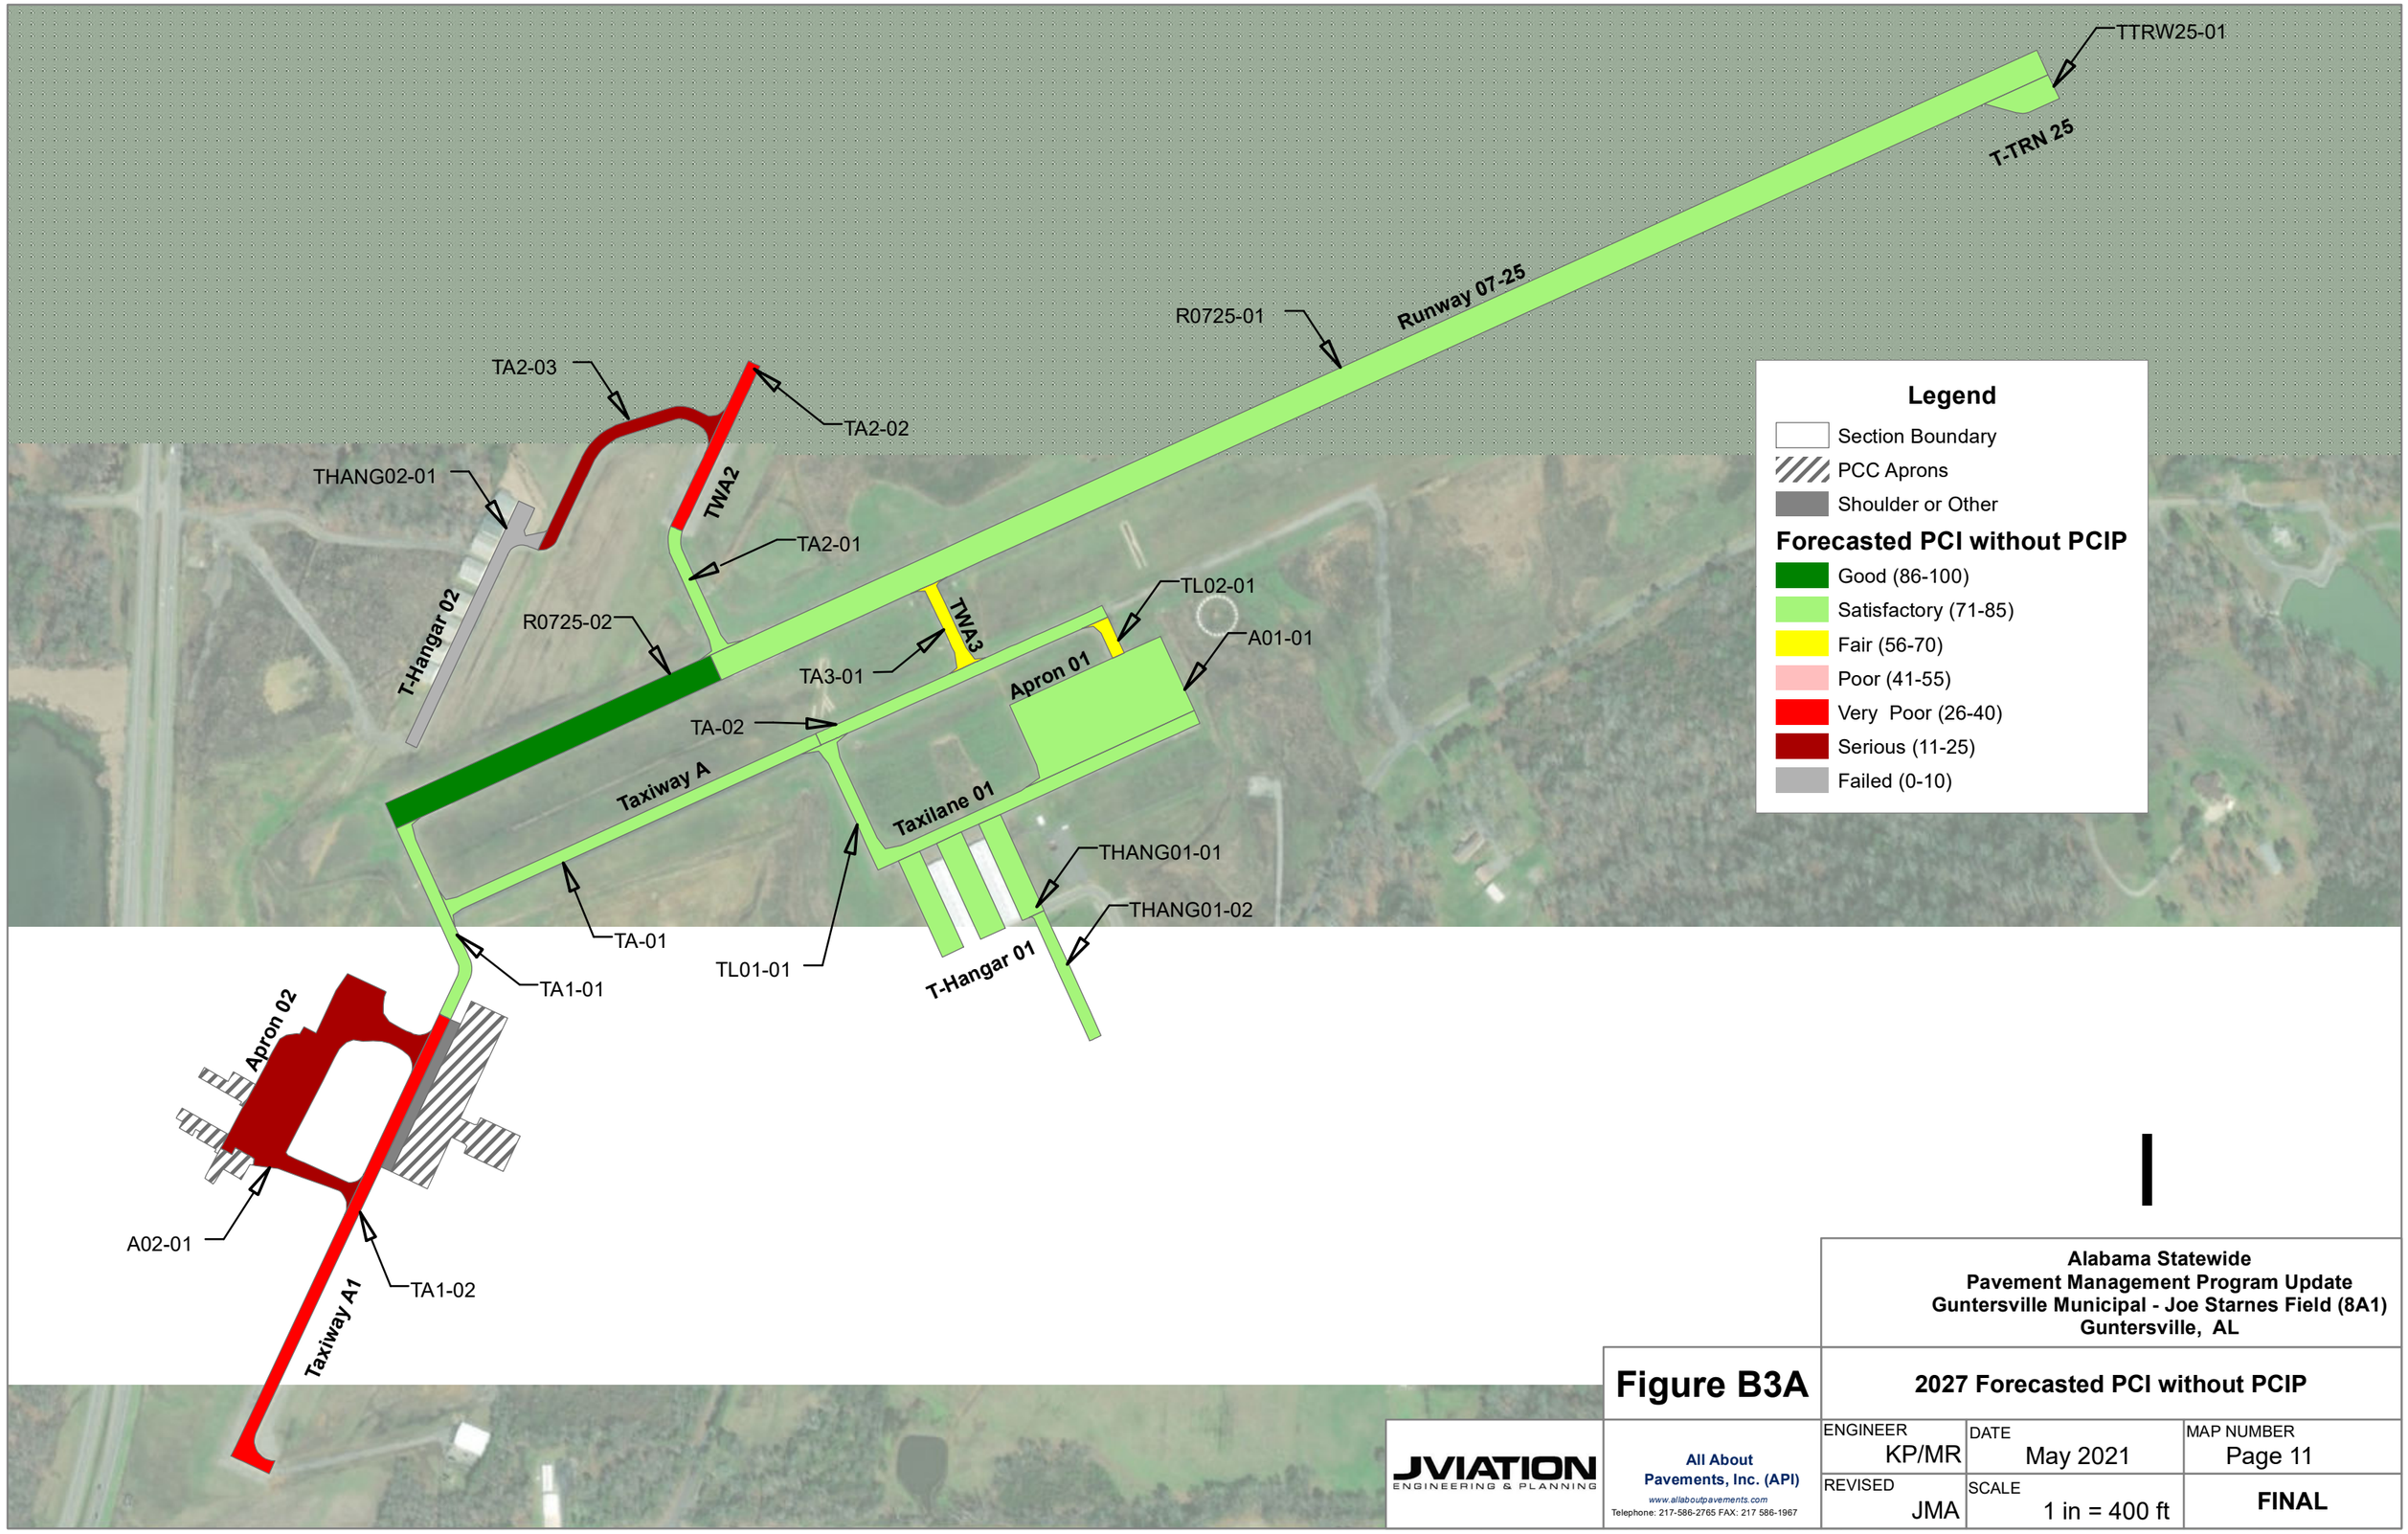
Figure B3A

Map B3A in Appendix B presents the 2027 forecasted PCI by section when the M&R activities recommended in the CIP are not conducted.
