Alabama Statewide Airport Pavement Management Program Update

Bessemer Airport (EKY)

Final Report

February 2022

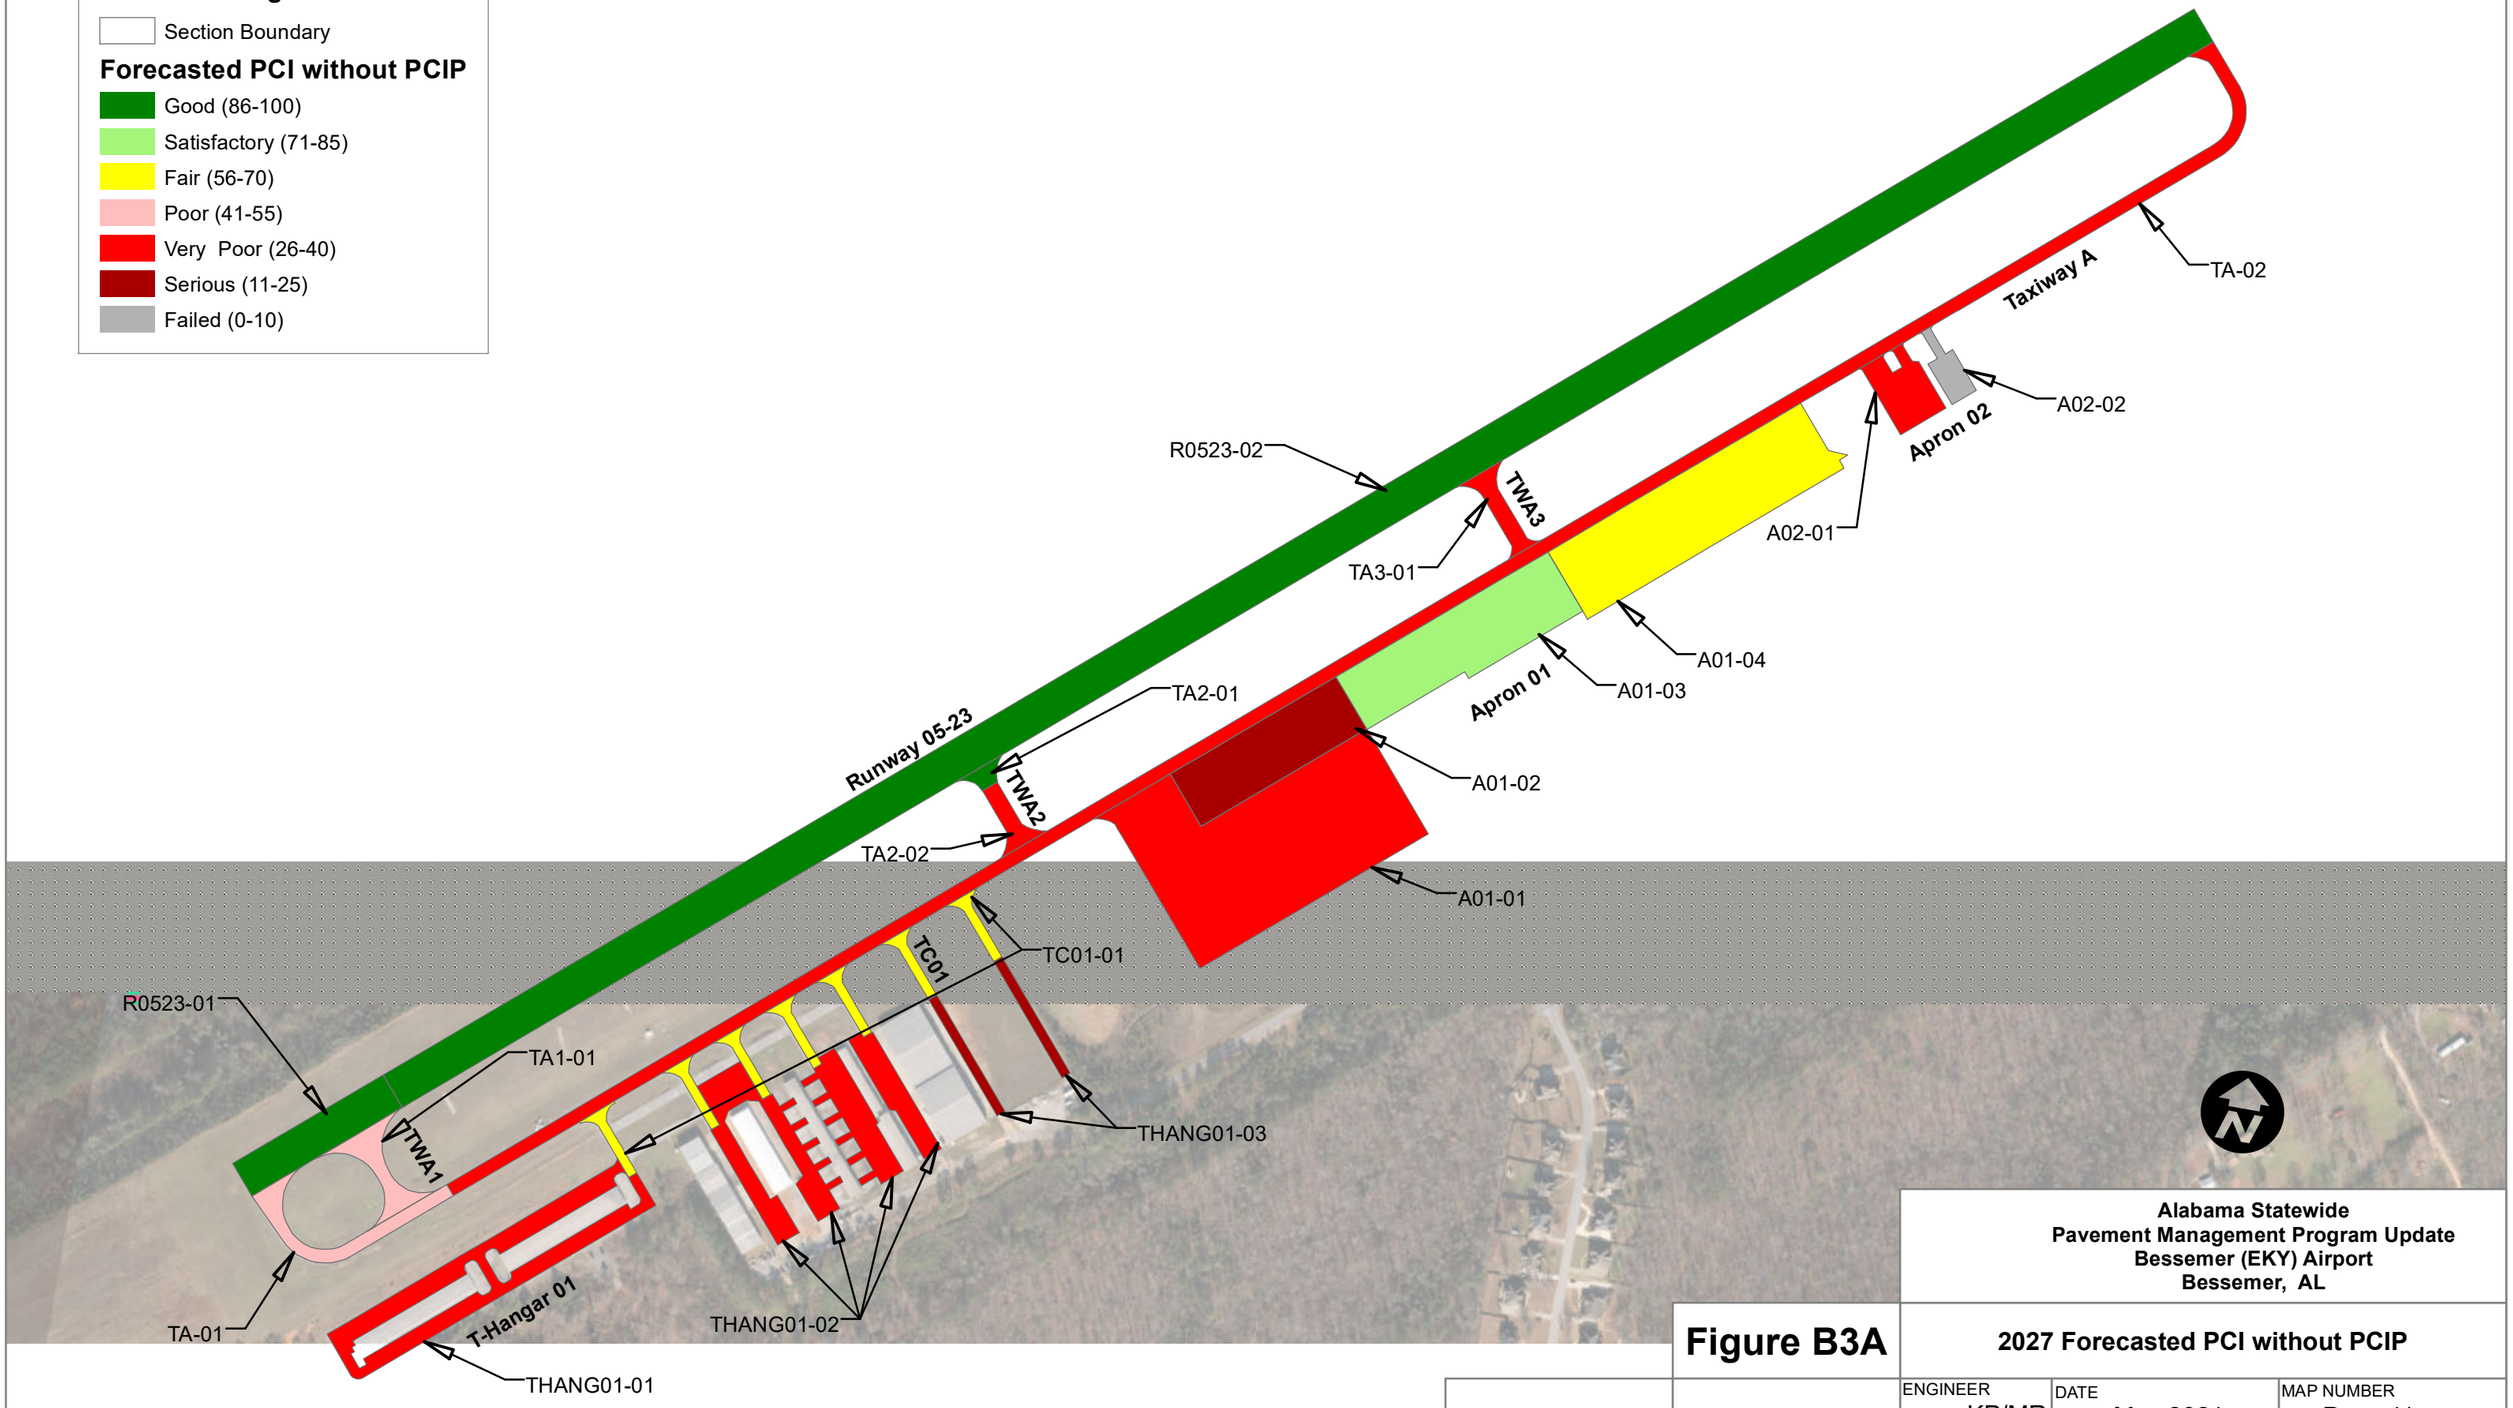
Figure B3A

Map B3A in Appendix B presents the 2027 forecasted PCI by section when the M&R activities recommended in the CIP are not conducted.
