Annual Inspection Report Bibb County Airport (0A8)

Annual Inspection Report July 19, 2019

Bibb County Airport (0A8) Centreville, Alabama

July 19, 2019

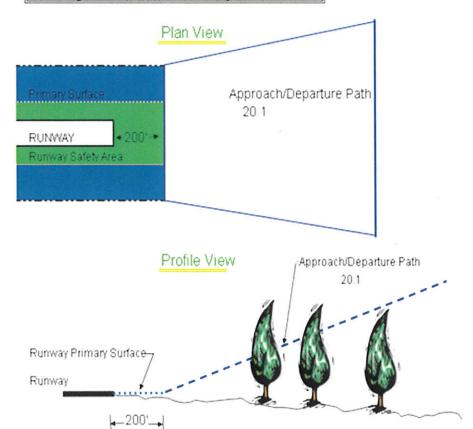
APPENDIX 1

Approach and Departure Path Dimensions				
Inner	Outer			
Width	Width	Length	Acreage	
250 Feet	450 Feet	1,000 Feet	8.04 Acres	
Primary Surface Dimensions				
250 Feet Wide Centered Along Runway Centerline				
Extending 200 Feet Past the Runway End				
Rurway Safety Area Dimensions				
120 Feet Wide Centered Along Runway Centerline				
Extending 200 Feet Past the Runway End
