**Subject: Annual Inspection Report**  
**Robbins Field Airport (20A)**

## Alabama Department of Transportation Aeronautics Bureau—Annual Airport Inspection Report

In accordance with the provisions of the Code of Alabama 23-1-357, an inspection of the **Robbins Field Airport (20A)** was conducted by **Mr. Bennett Head** with the Alabama Department of Transportation Aeronautics Bureau on **May 31, 2023**.

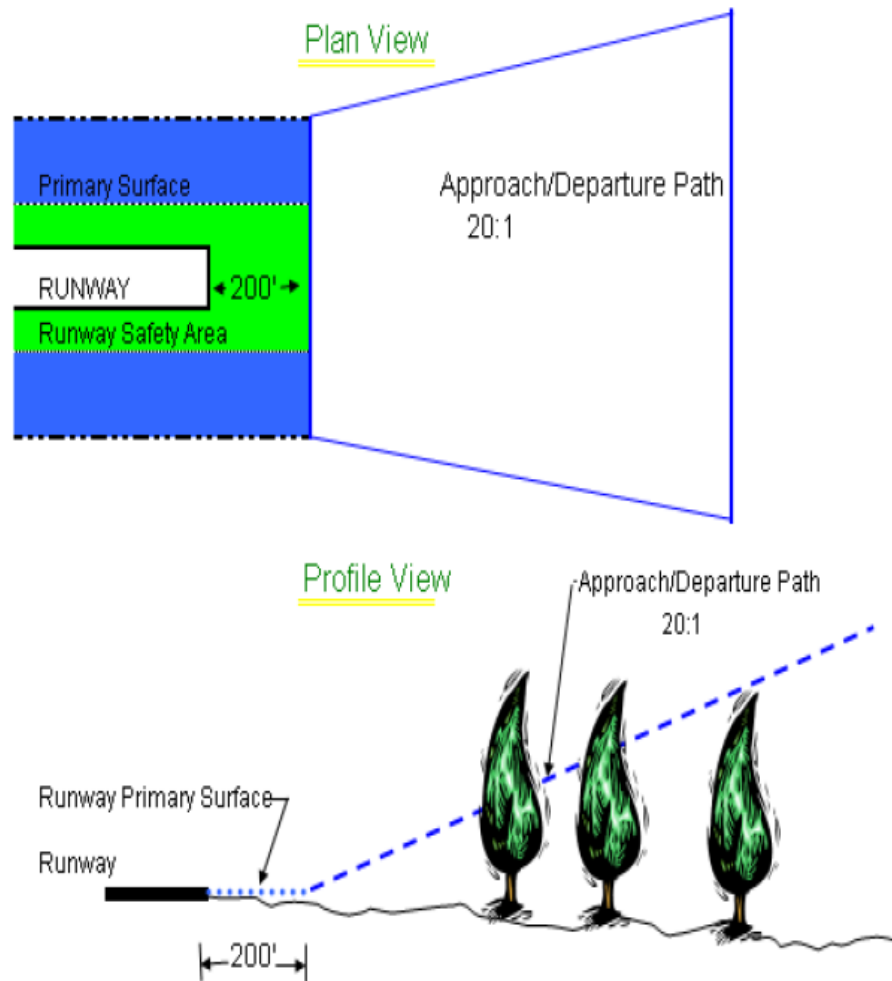
APPENDIX #2

No obstructions located in the ALDOT Approach/Departure Path of Runway 6. However, there were FAA part 77 penetrations found. Please see Appendix #2 for more information.

ROBBINS FIELD AIRPORT  
ONEONTA, AL  
MAY 31, 2023  
RUNWAY 6 OBSTRUCTION EVALUATION

○ Penetrates FAA Part 77 Approach path  
But NOT an ALDOT violation.  
● Controlling Obstruction
