Subject: Annual Inspection Report
Northeast Alabama Regional Airport (GAD)

**Annual Inspection Report
Northeast Alabama Regional Airport (GAD)
Gadsden, Alabama**

May 21, 2021

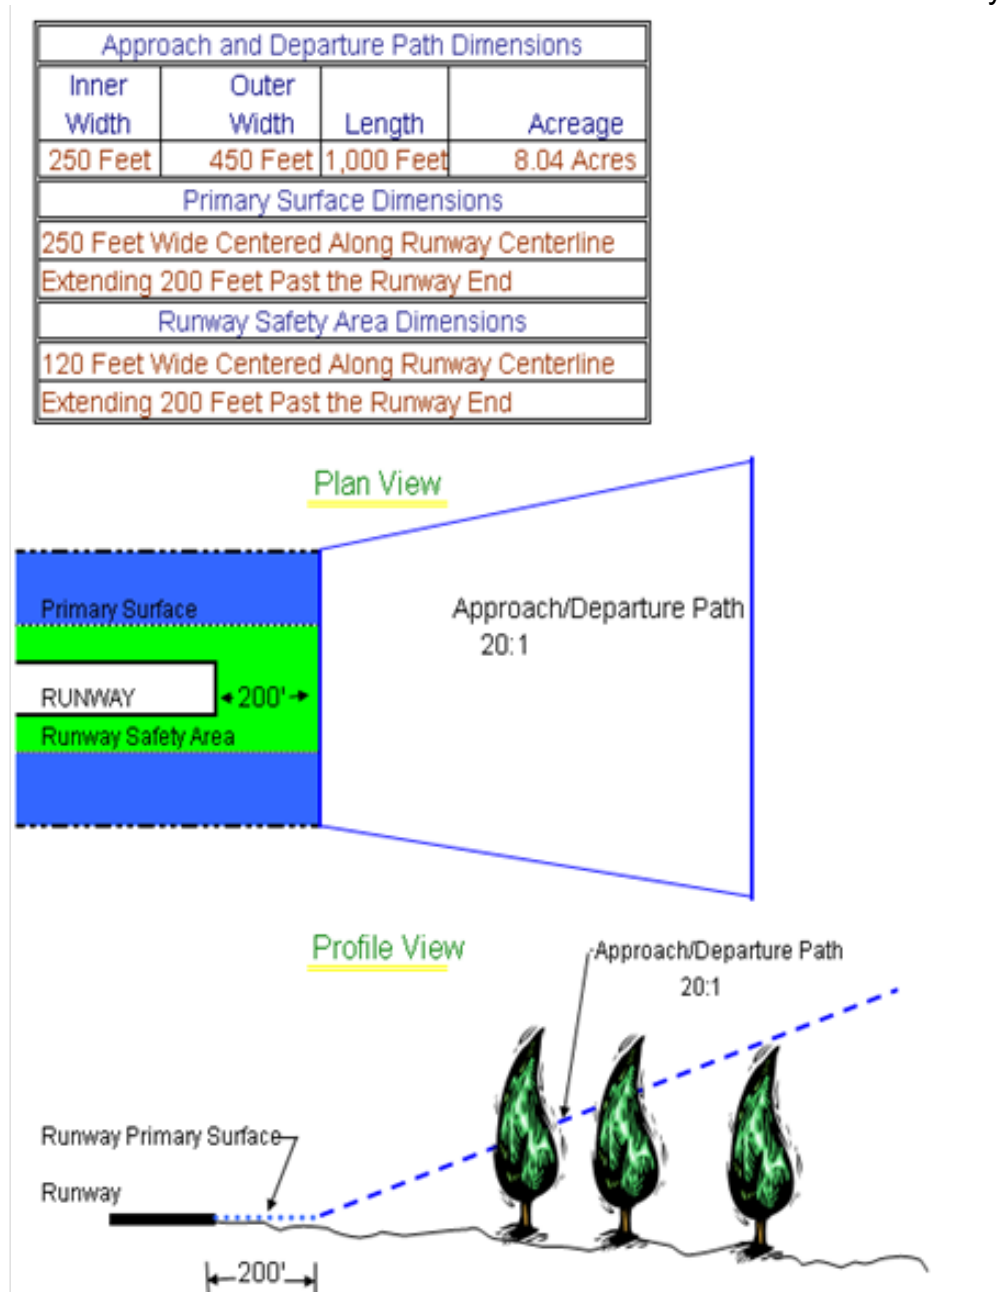
APPENDIX 1

- Runway Safety Area (Appendix 1): All runways are required to maintain an obstruction free area adjacent to each runway. This area is 120 feet wide, centered on the runway centerline, and extends for a distance of 200 feet past the runway end. The area must be compacted and graded smooth with no ruts, humps, depressions or other potentially hazardous surface variations. The slope along the longitudinal centerline shall not exceed a rise or fall of three percent in elevation relative to the runway end elevation. The lip from the top of the pavement to the grade adjacent to the runway should not exceed 3 inches.
