Subject: Annual Inspection Report
Mac Crenshaw Memorial Airport
Greenville, Alabama

MAC CRENSHAW MEMORIAL AIRPORT
(KPRN)
GREENVILLE, ALABAMA

**Annual Inspection Report
Mac Crenshaw Memorial Airport
Greenville, Alabama**

May 19, 2020

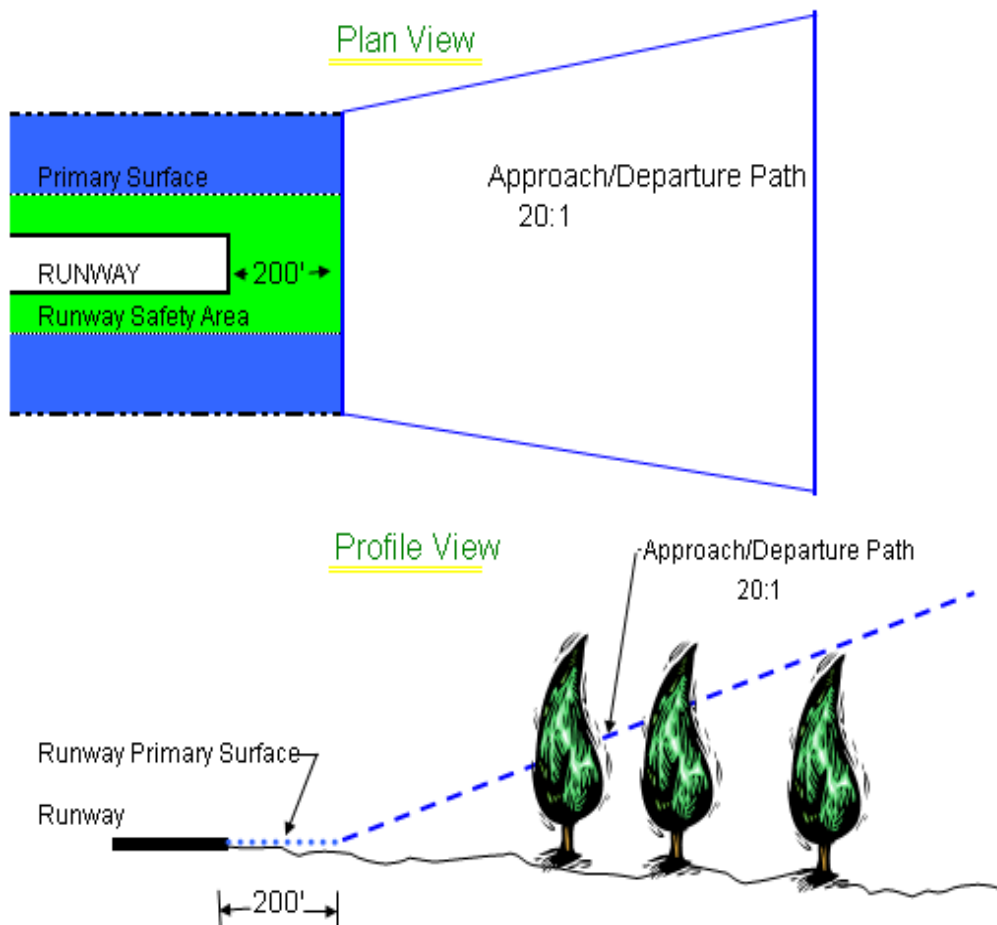
APPENDIX 1

Approach and Departure Path Dimensions			
Inner Width	Outer Width	Length	Acreage
250 Feet	450 Feet	1,000 Feet	8.04 Acres
Primary Surface Dimensions			
250 Feet Wide Centered Along Runway Centerline			
Extending 200 Feet Past the Runway End			
Runway Safety Area Dimensions			
120 Feet Wide Centered Along Runway Centerline			
Extending 200 Feet Past the Runway End
