Subject: Annual Inspection Report
Grove Hill Municipal Airport

ANNUAL INSPECTION REPORT

GROVE HILL MUNICIPAL AIRPORT

GROVE HILL, ALABAMA

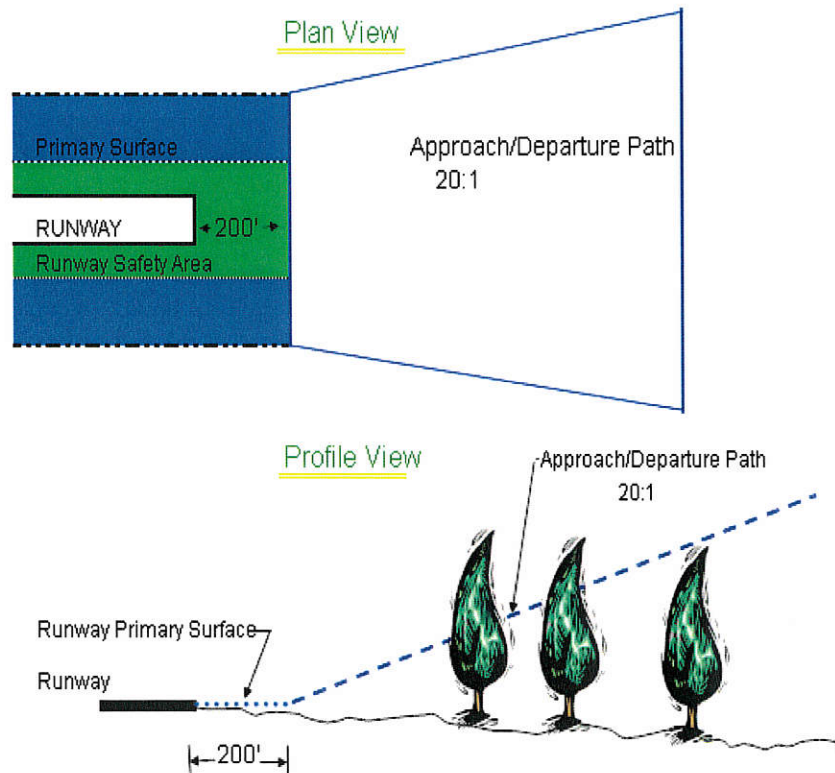
APPENDIX 1

- Runway Safety Area (Appendix 1): All runways are required to maintain an obstruction free area adjacent to each runway. This area is 120 feet wide, centered on the runway centerline, and extends for a distance of 200 feet past the runway end. The area must be compacted and graded smooth with no ruts, humps, depressions or other potentially hazardous surface variations. The slope along the longitudinal centerline shall not exceed a rise or fall of three percent in elevation relative to the runway end elevation. The lip from the top of the pavement to the grade adjacent to the runway should not exceed 3 inches.

Approach and Departure Path Dimensions			
Inner Width	Outer Width	Length	Acreage
250 Feet	450 Feet	1,000 Feet	8.04 Acres
Primary Surface Dimensions			
250 Feet Wide Centered Along Runway Centerline			
Extending 200 Feet Past the Runway End			
Runway Safety Area Dimensions			
120 Feet Wide Centered Along Runway Centerline			
Extending 200 Feet Past the Runway End
