**Subject: Re-Inspection Report
Robbins Field (20A)**

**Subject: Annual Inspection Report
Robbins Field (20A)**

**Annual Inspection Report
Robbins Field (20A)
Oneonta, Alabama**

July 13, 2020

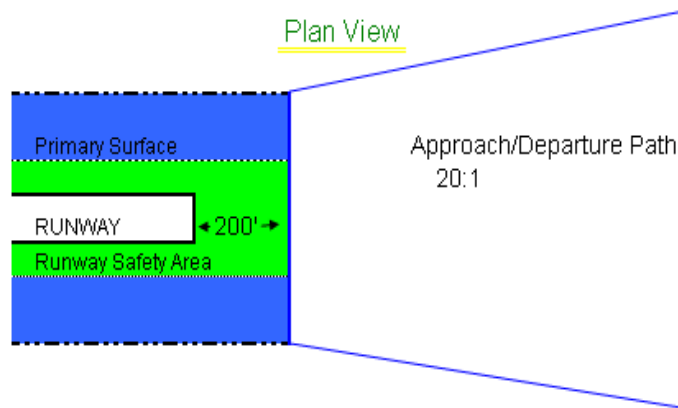
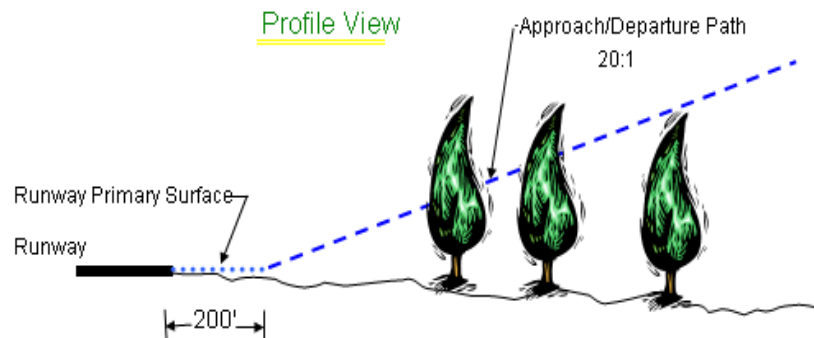
APPENDIX 1

*Oneonta-Robbins Field
Runway 05 20:1 Obstructions
July 13, 2020*

1. Tree 12' Abv. RWY End
282' From RWY End
98' Right of Cntln.
6:1 Obst. Clnc.
VIOLATION

VIOLATION
