Subject: Annual Inspection Report
Prattville Municipal (Grouby Field) Airport

**Annual Inspection Report
Prattville (Grouby Field) Municipal Airport
Prattville, Alabama**

November 16, 2020

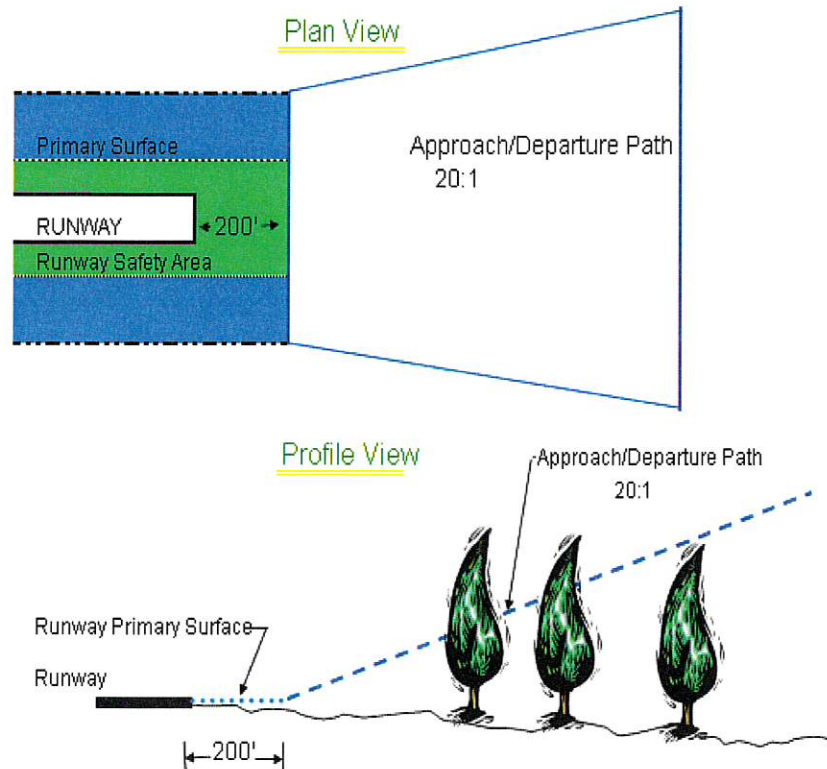
APPENDIX 1

Approach and Departure Path Dimensions			
Inner Width	Outer Width	Length	Acreage
250 Feet	450 Feet	1,000 Feet	8.04 Acres
Primary Surface Dimensions			
250 Feet Wide Centered Along Runway Centerline			
Extending 200 Feet Past the Runway End			
Runway Safety Area Dimensions			
120 Feet Wide Centered Along Runway Centerline			
Extending 200 Feet Past the Runway End
