Subject: Annual Inspection Report
Reeves Airport (41A)

**Annual Inspection Report
Reeves Airport (41A)
Tallassee, Alabama**

June 23, 2017

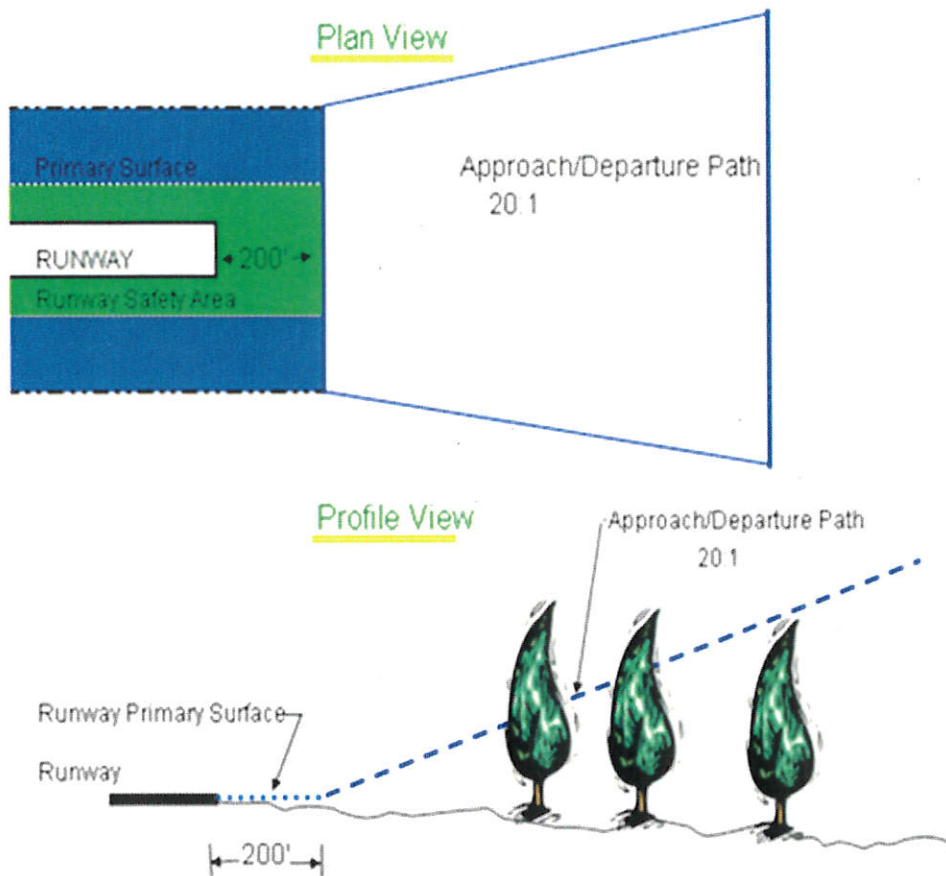
APPENDIX 1

- Runway Safety Area (Appendix 1): All runways are required to maintain an obstruction free area adjacent to each runway. This area is 120 feet wide, centered on the runway centerline, and extends for a distance of 200 feet past the runway end. The area must be compacted and graded smooth with no ruts, humps, depressions or other potentially hazardous surface variations. The slope along the longitudinal centerline shall not exceed a rise or fall of three percent in elevation relative to the runway end elevation. The lip from the top of the pavement to the grade adjacent to the runway should not exceed 3 inches.
