# Alabama Statewide Airport Pavement Management Program Update

Vaiden Field (A08)

Final Report

February 2022

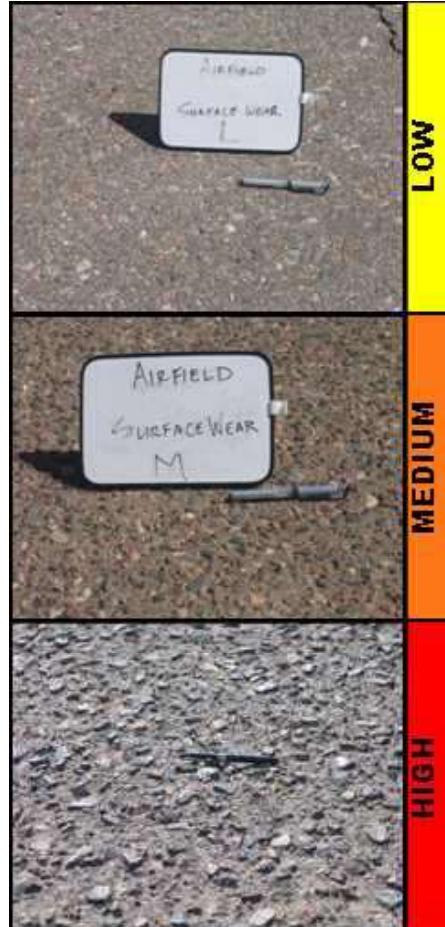
## 16. Weathering (AC)

The wearing away of the asphalt binder and fine aggregate matrix from the pavement surface

- L** Asphalt surface beginning to show signs of aging which may be accelerated by climatic conditions. Loss of fine aggregate matrix is noticeable and may be accompanied by fading of the asphalt color. Edges of the coarse aggregates are beginning to be exposed (less than 0.05 inches or 1 mm). Pavement may be relatively new (as new as 6 months old).
- M** Loss of fine aggregate matrix is noticeable and edges of coarse aggregate have been exposed up to 1/4 width (of the longest side) of the coarse aggregate due to the loss of fine aggregate matrix.
- H** Edges of coarse aggregate have been exposed greater than 1/4 width (of the longest side) of the coarse aggregate. There is considerable loss of fine aggregate matrix leading to potential or some loss of coarse aggregate.

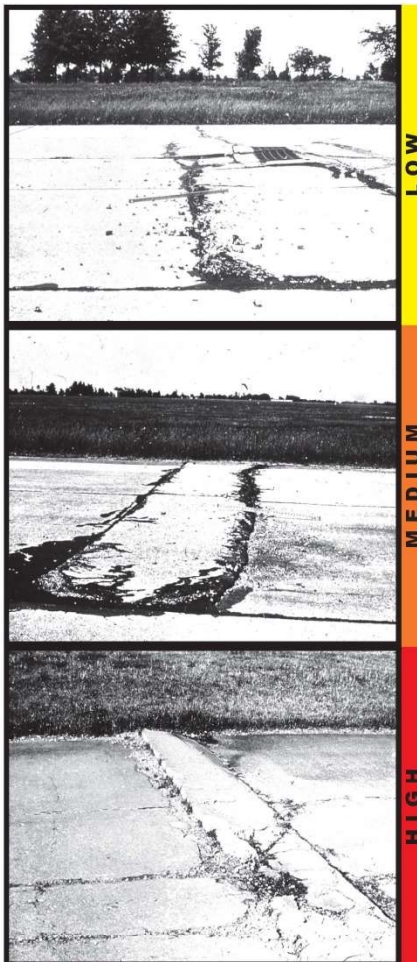
## 17. Blow-Up (PCC)

Blowups occur in hot weather, usually at a transverse crack or joint that is not wide enough to permit expansion by the concrete slabs. The insufficient width is usually caused by infiltration of incompressible materials into the joint space. When expansion cannot relieve enough pressure, a localized upward movement of the slab edges (buckling) or shattering will occur in the vicinity of the joint. Blowups can also occur at utility cuts and drainage inlets. This type of distress is almost always repaired immediately because of severe damage potential to aircraft. Blowups are induced for reference when cross sections are being evaluated for repair.

- L** Buckling or shattering has not rendered the pavement impactive, and only a slight amount of roughness exists
- M** Buckling or shattering has not rendered the pavement impactive, but a significant amount of roughness exists
- H** Buckling or shattering has rendered the pavement impactive

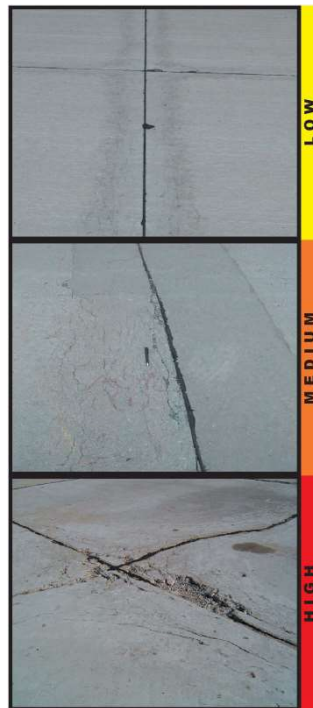
## 20. Durability Cracks (PCC)

**Durability cracking is caused by the inability of the concrete to withstand environmental factors such as freeze thaw cycles. It usually appears as a pattern of cracks running parallel to a joint or linear crack. A dark coloring can usually be seen around the fine durability cracks. This type of cracking may eventually lead to disintegration of the concrete within 1 to 2 feet (300 to 600 millimeters) of the joint or crack.**

- L** "D" cracking is defined by hairline cracks occurring in a limited area of the slab such as one or two corners or along one joint. Little or no disintegration has occurred. No FOD potential.
- M** (1) "D" cracking has developed over a considerable amount of slab area with little or no disintegration or FOD potential; or (2) "D" cracking has occurred in a limited area of the slab such as in one or two corners or along one joint, but pieces are missing and disintegration has occurred. Some FOD potential.
- H** "D" cracking has developed over a considerable amount of slab area with disintegration of FOD potential.

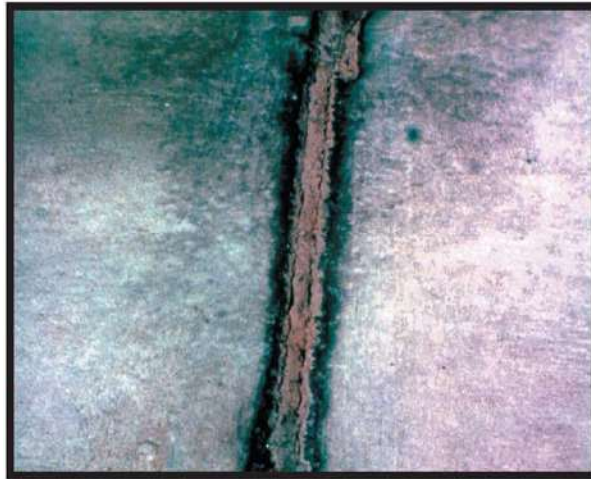
**Pumping is the ejection of material by water through joints or cracks caused by deflection of the slab under passing loads. As the water is ejected, it carries particles of gravel, sand, clay, or silt and results in a progressive loss of pavement support. Surface staining and base or subgrade material on the pavement close to joints or cracks are evidence of pumping. Pumping near joints indicates poor joint seal and loss of support which will lead to cracking under repeated loads.**

**No degrees of severity are defined. It is sufficient to indicate that pumping exists.**

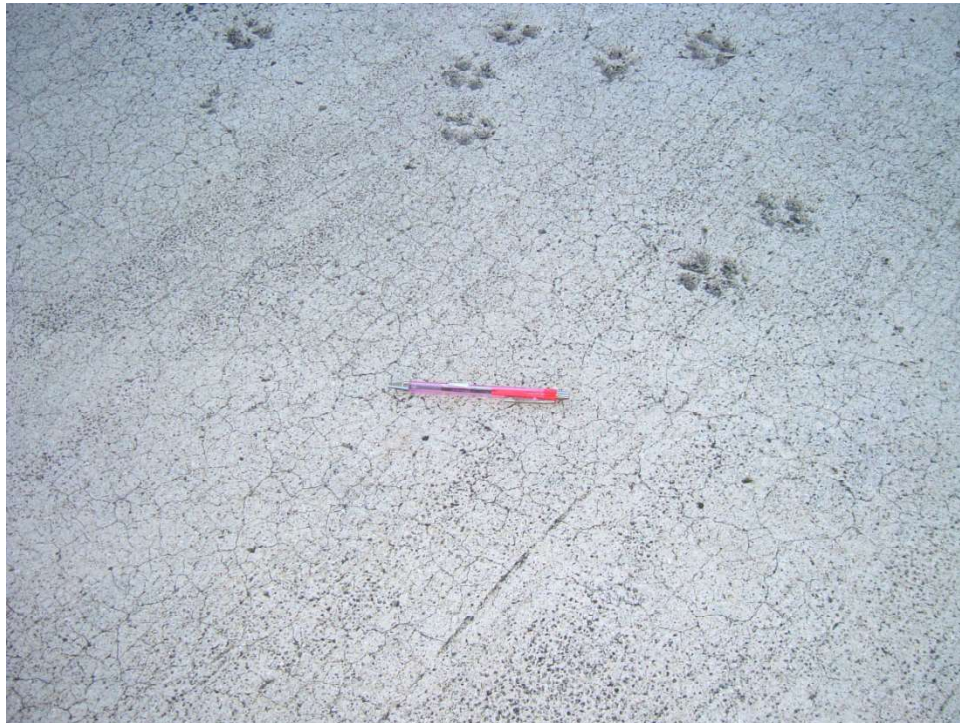
## 26. Scaling (PCC)

Map cracking or crazing refers to a network of shallow, fine, or hairline cracks that extend only through the upper surface of the concrete. The cracks tend to intersect at angles of 120 degrees. Map cracking or crazing is usually caused by overfinishing the concrete and may lead to scaling of the surface, which is the breakdown of the slab surface to a depth of approximately 1/4 to 1/2 inch. Scaling may also be caused by improper construction and poor aggregate. Another recognized source of distress is the reaction between the alkalis ( $\text{Na}_2\text{O}$  and  $\text{K}_2\text{O}$ ) in some cements and certain minerals in some aggregates. Products formed by the reaction between the alkalis and aggregate result in expansions that cause a breakdown in the concrete.

- ◆ **Low-** Crazing or map cracking exists over significant slab area. The surface is in good condition with no scaling. The crack pattern must be well defined and easily recognized.
- ◆ **Medium-** Slab is scaled over approximately 5% or less of the surface with some FOD potential.
- ◆ **High-** Slab is severely scaled causing a high FOD potential. Usually, more than 5% of the surface is affected.

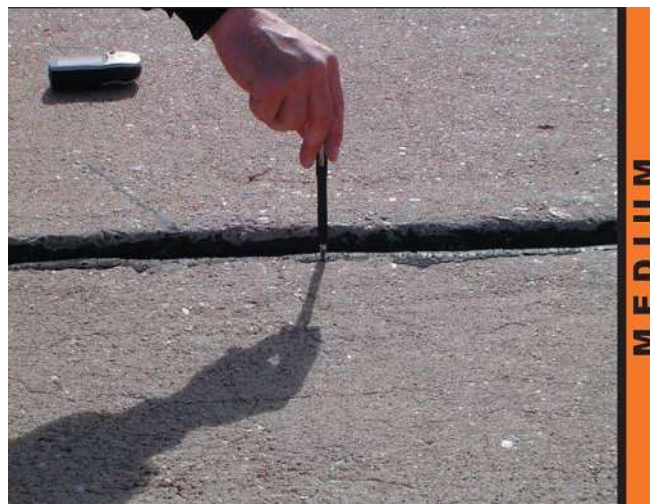
## 27. Faulting (PCC)

**Settlement or faulting is a difference of elevation at a joint or crack caused by upheaval or consolidation**

- ◆ **Low- No action**
- ◆ **Medium- Grinding along the joint;**
- ◆ **High- Grinding or joint load transfer restoration**

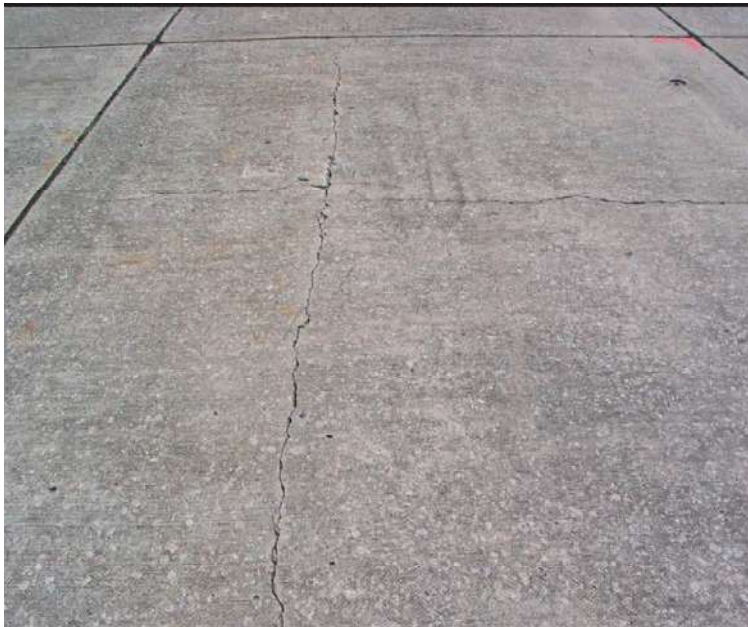
## 28. Shattered Slab (PCC)

**Intersecting cracks are cracks that break into four or more pieces because of overloading and/or inadequate support. The high severity level of this distress type, as defined below, is referred to as a shattered slab. If all pieces or cracks are contained within a corner break, the distress is categorized as a severe corner break.**

- ◆ **Low-** Slab is broken into four or five pieces with the vast majority of the cracks **(over 85 percent) of low severity;**
- ◆ **Medium-** (1) Slab is broken into four or five pieces with over 15 percent of the **cracks of medium severity (no high severity cracks); or (2) slab is broken into six or more pieces with over 85 percent of the cracks of low;**
- ◆ **High-** **At this level of severity, the slab is called shattered (1) slab is broken into four or five pieces with some or all of the cracks of high severity; (2) slab is broken into six or more pieces with over 15 percent of the cracks of medium or high severity.**

- ◆ **Low- Seal Cracks**
- ◆ **Medium- Full depth patch or replace the slab**
- ◆ **High- Full depth patch or replace the slab**

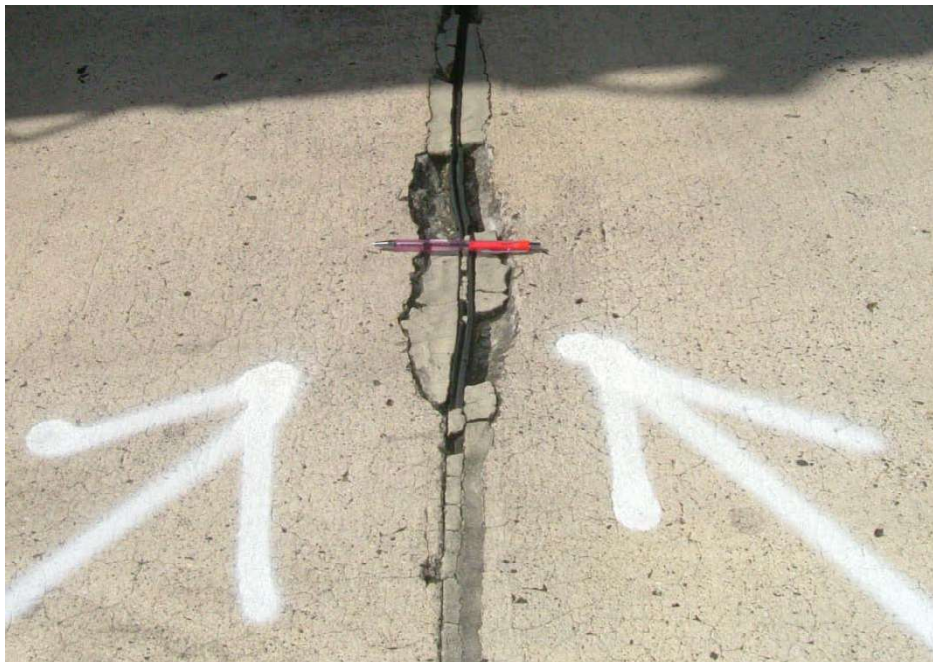
### 30. Joint Spalls (PCC)

**Joint spalling is the disintegration of the slab edges within 2 feet of the side of the joint. A joint spall usually does not extend vertically through the slab, but intersects the joint at an angle. Spalling results from excessive stresses at the joint crack caused by infiltration of incompressible materials or traffic loads. Weak concrete at the joint (caused by overworking) combined with traffic loads is another cause of spalling.**

- ◆ **Low-** over 2 feet long and is broken into no more than three pieces defined by low or medium severity cracks, with little or no FOD potential, or is 2) less than 2 feet long and is broken into no more than three pieces, with little FOD or tire damage potential;
- ◆ **Medium-** over 2 feet long and is broken into no more than 3 pieces defined by light or medium cracks or some FOD potential existing or is 2) less than 2 feet long and is broken into pieces or fragmented, with some of the pieces loose or absent, causing considerable FOD or tire damage potential;
- ◆ **High-** over 2 feet long and is broken into no more than three pieces defined by one or more high severity cracks with high FOD potential.

- ◆ **Low-** No action
- ◆ **Medium-** perform a partial depth patch
- ◆ **High-** perform a partial depth patch

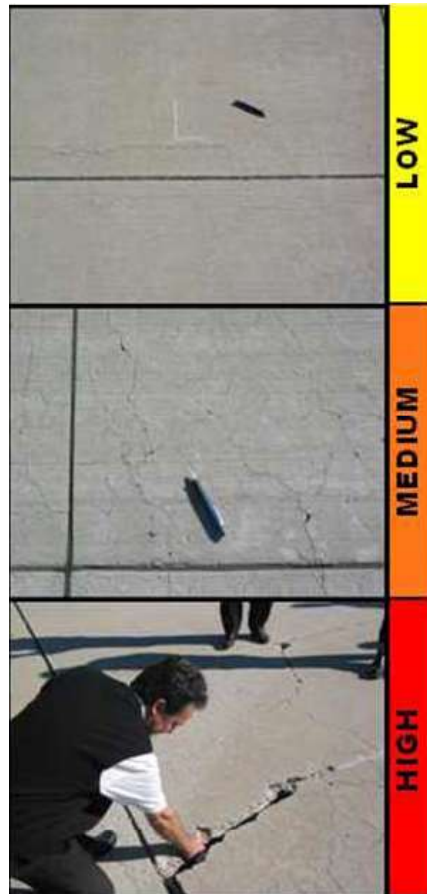
## 32. ASR (PCC)

**ASR is caused by chemical reaction between alkalis and certain reactive siliceous materials which form a gel. The gel absorbs water, causing expansion which may damage the concrete and adjacent structures. Alkalis are most often introduced by the portland cement within the pavement. ASR cracking may be accelerated by chemical pavement deicers.**

- 1 Cracking of the concrete pavement (often in a map pattern)**
- 2 White, brown, gray or other colored gel or staining may be present at the crack surface**
- 3 Aggregate popouts**
- 4 Increase in concrete volume (expansion) that may result in distortion of adjacent or integral structures or physical elements. Examples of expansion include shoving of asphalt pavements, slight canting, slab faulting, joint misalignment, and extrusion of joint seals or expansion joint fillers.**

**L** Minimal to no Foreign Object Damage (FOD) potential from roads, joints or ASR related popouts; cracks at the surface are tight (predominantly 1 mm or less). Little to no evidence of movement in pavement or surrounding structures or elements

**M** Medium ASR distress is differentiated from low by having one or more of the following: increased FOD potential, increased loading of the slab, some fragments along roads or at crack in sections present; surface popouts of concrete may occur; pattern of wide cracks (predominantly 1 mm or wider) that may be subdivided by tighter cracks

**H** One or both of the following exist: 1) Loose or missing concrete fragments which pose high FOD potential, 2) Slab surface integrity and function significantly degraded and pavement requires immediate repair; may also require repairs to adjacent structures or elements
