Alabama Statewide Airport Pavement Management Program Update

Prattville – Grouby Field (1A9)

Final Report

February 2022

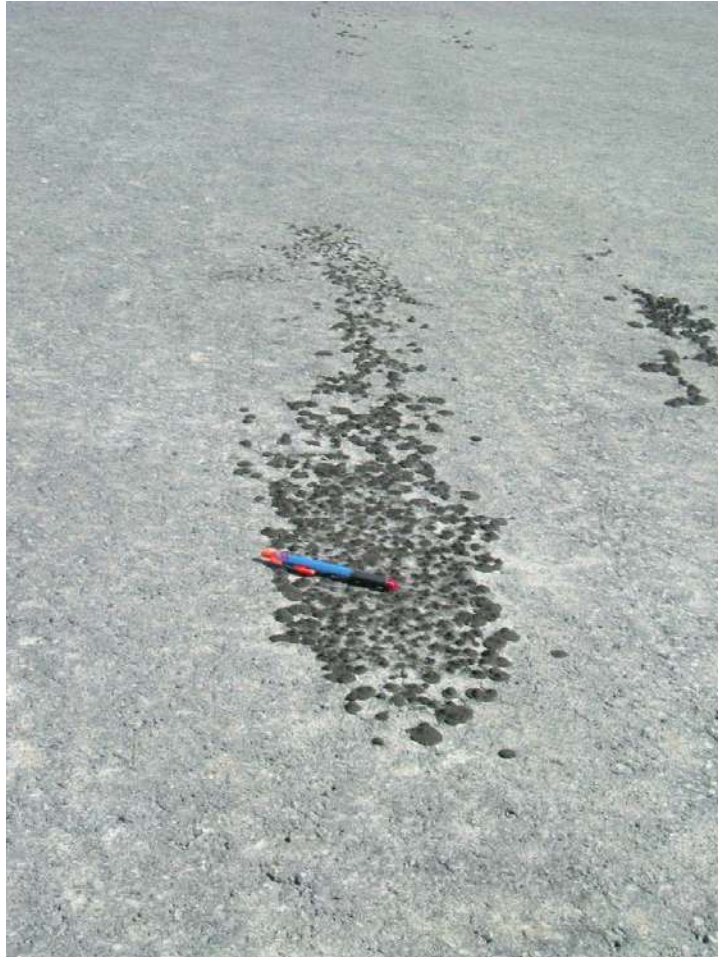
2. Bleeding (AC)

Bleeding is a film of bituminous material on the pavement surface that creates a shiny, glass-like, reflecting surface that usually becomes quite sticky. Bleeding is caused by excessive amounts of asphaltic cement or tars in the mix or low-air void content, or both. It occurs when asphalt fills the voids of the mix during hot weather and then expands out onto the surface of the pavement. Since the bleeding process is not reversible during cold weather, asphalt or tar will accumulate on the surface.

Severities: No degrees of severity are defined. Bleeding should be noted when it is extensive enough to reduce skid resistance.

Repair Policies: Do nothing; sand blot the distressed area by applying heat and roll sand into the areas affected with bleeding, remove the excess material; patch.

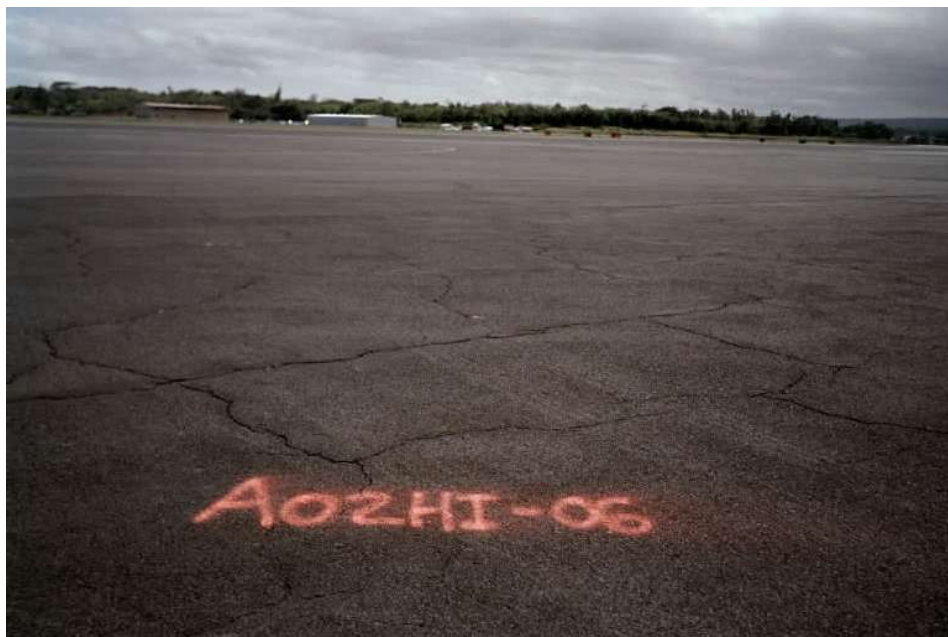
3. Block Cracking (AC)

Block cracks are interconnected cracks that divide the pavement into rectangular shaped pieces. The blocks may range in size from 1 by 1 foot to 10 by 10 feet. Block cracking is caused mainly by shrinkage of the asphalt concrete and is not load associated. The occurrence of block cracking usually indicates that the asphalt has hardened significantly. Block cracking normally occurs over a large proportion of the pavement area, but will sometimes occur only in the non-traffic areas.

- ◆ Low - No action;
- ◆ Medium - seal cracks, apply rejuvenator, recycle surface or heat scarify and overlay;
- ◆ High - recycle surface or heat scarify and overlay.

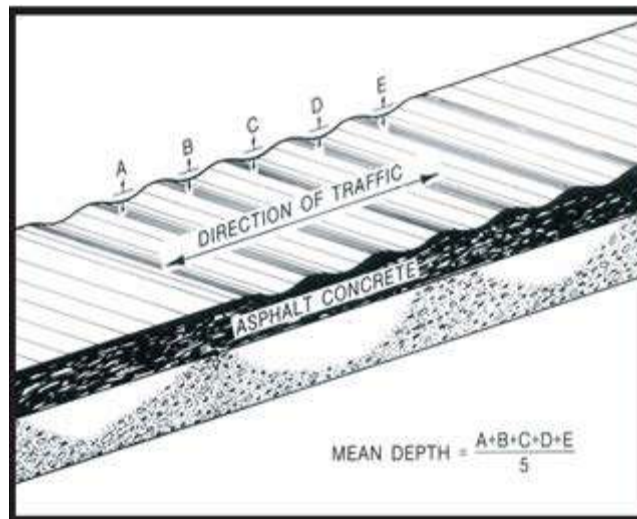
4. Corrugation (AC)

- L** Corrugations are minor and do not significantly affect ride quality (see measurement criteria below).
- M** Corrugations are noticeable and significantly affect ride quality (see measurement criteria below).
- H** Corrugations are easily noticed and severely affect ride quality (see measurement criteria below).

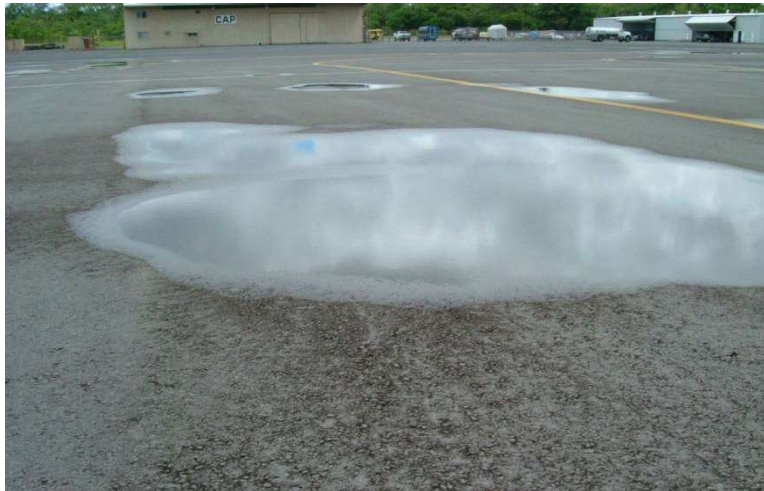
5. Depression (AC)

Depressions are localized pavement surface areas having elevations slightly lower than those of the surrounding pavement. In many instances, light depressions are not noticeable until after a rain, when ponding water creates “birdbath” areas; but the depressions can also be located without rain because of stains created by ponding of water. Depressions can be caused by settlement of the foundation soil or can be built during construction. Depressions cause roughness and, when filled with water of sufficient depth, could cause hydroplaning of aircraft.

- ◆ Low - No action;
- ◆ Medium - Shallow, partial or full depth patch;
- ◆ High - Shallow, partial or full depth patch.

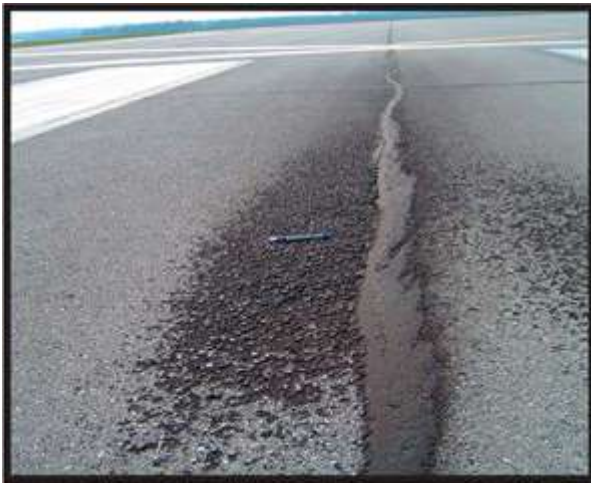
6. Jet Blast (AC)

Jet blast erosion causes darkened areas on the pavement surface when bituminous binder has been burned or carbonized; localized burned areas may vary in depth up to approximately 1/2 inch (13 millimeters).

No degrees of severity are defined. It is sufficient to indicate that jet blast erosion exists.

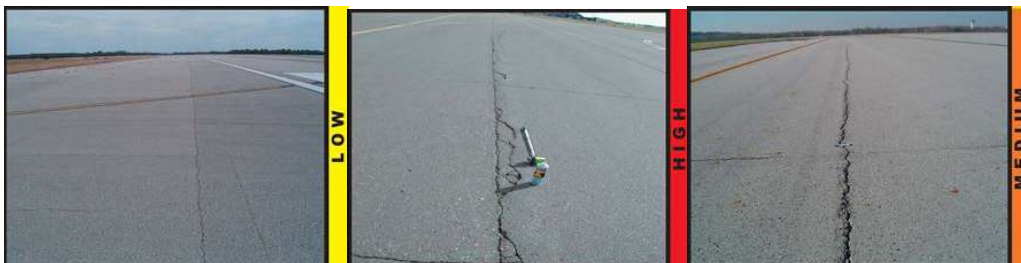
7. Joint Reflection Cracking (AC)

This distress occurs only on pavements having an asphalt or tar surface over a PCC slab. This category does not include reflection cracking from any other type of base (i. e., cement stabilized, lime stabilized); such cracks are listed as longitudinal and transverse cracks. Joint-reflection cracking is caused mainly by movement of the PCC slab beneath the AC surface because of thermal and moisture changes; it is not load related. However, traffic loading may cause a breakdown of the AC near the crack, resulting in spalling and FOD potential. If the pavement is fragmented along a crack, the crack is said to be spalled. A knowledge of slab dimensions beneath the AC surface will help to identify these cracks.

- L** Cracks have only light spalling (little or no FOD potential) or no spalling and can be filled or non-filled. If non-filled, the cracks have a mean width of 1/4 inch (6 millimeters) or less. Filled cracks are of any width, but their filler material is in satisfactory condition.
- M** One of the following conditions exists: (1) cracks are moderately spalled (some FOD potential) and can be either filled or non-filled of any width; (2) filled cracks are not spalled or are only lightly spalled, but the filler is in unsatisfactory condition; (3) non-filled cracks are not spalled or are only lightly spalled, but the mean crack width is greater than 1/4 inch (6 millimeters); or (4) light random cracking exists near the crack or at the corner of intersecting cracks.
- H** Cracks are severely spalled (definite FOD potential) and can be either filled or non-filled of any width.

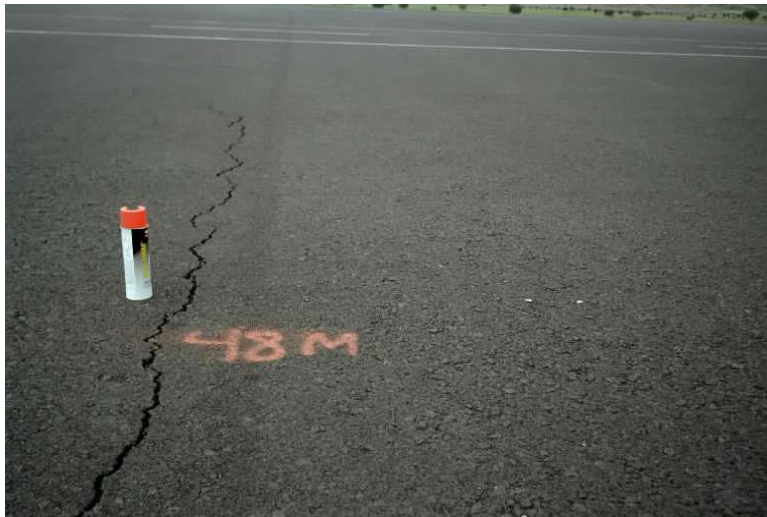
8. Longitudinal and Transverse Cracking (AC)

Longitudinal and transverse (L&T) cracks are parallel to the pavement's centerline or laydown direction. They may be caused by: 1) a poorly constructed paving lane joint, 2) shrinkage of the AC surface due to hardening of the asphalt, or 3) a reflective crack caused by cracks beneath the surface course. Transverse cracks extend across the pavement perpendicularly to the pavement centerline or laydown direction, and may be caused by items 2) or 3) as stated above. These types of cracks are not usually load related.

- ◆ Low - No action;
- ◆ Medium - seal cracks;
- ◆ High - seal cracks or perform a full depth patch.

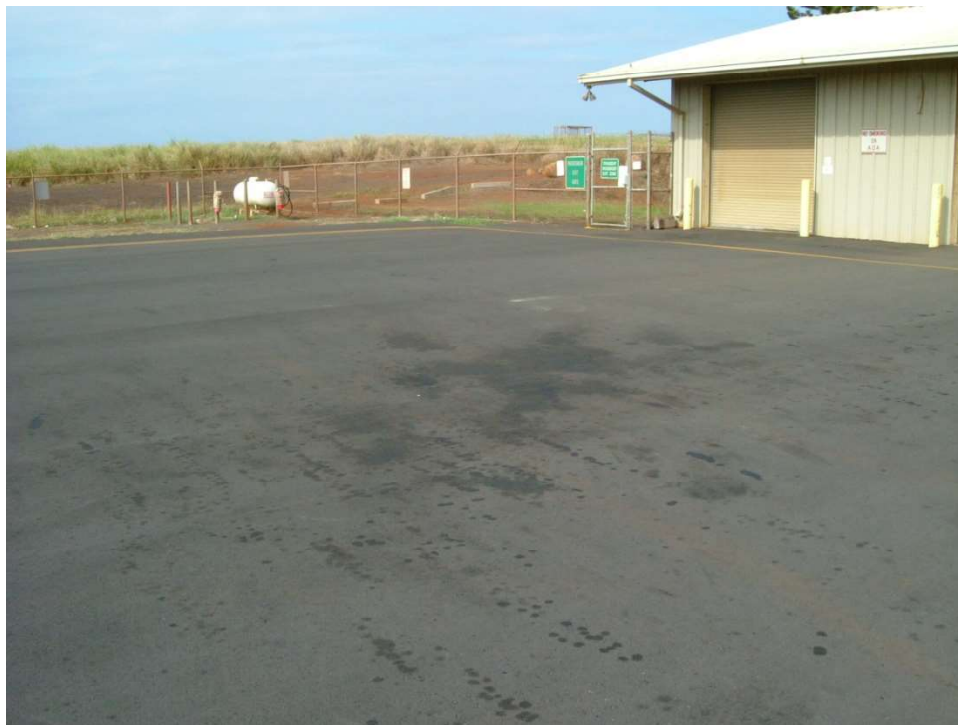
9. Oil Spillage (AC)

Oil spillage is the deterioration or softening of the pavement surface caused by the spilling of oil, fuel, or other solvents.

- ◆ Do nothing;
- ◆ Partial or full depth patch.

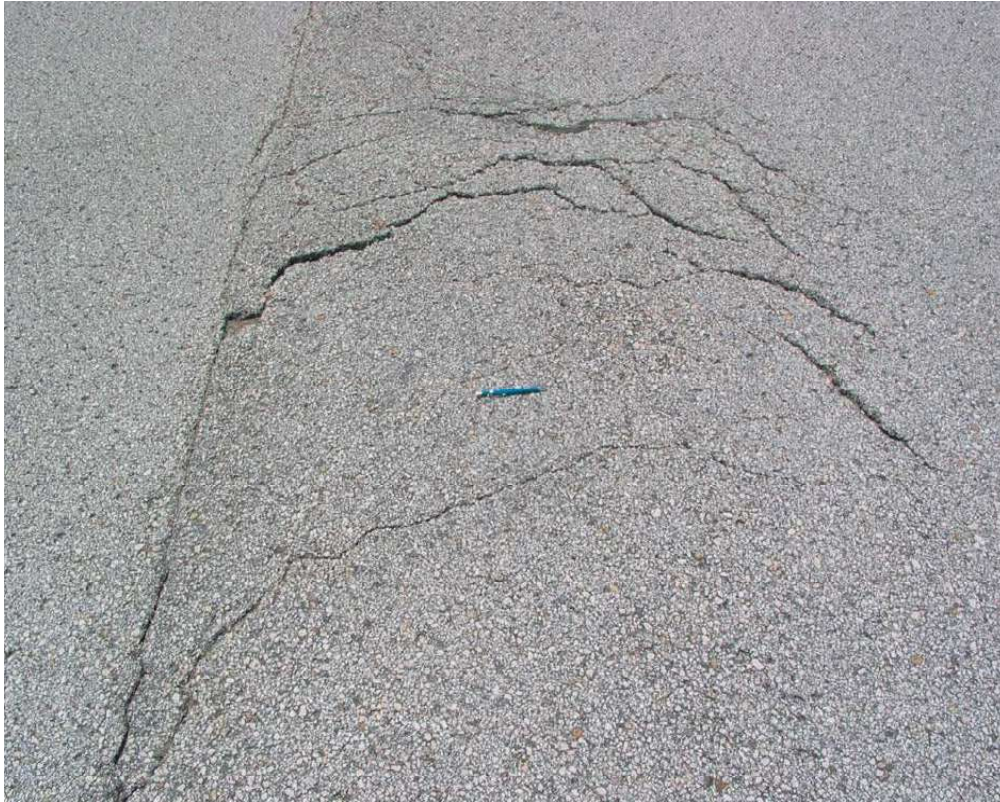
Figure C.10: Slippage Cracking.

Slippage cracks are crescent- or half-moon shaped cracks having two ends pointed away from the direction of traffic. They are produced when braking or turning wheels cause the pavement surface to slide and deform. This usually occurs when there is a low-strength surface mix or poor bond between the surface and next layer of pavement structure.

- ◆ Do nothing;
- ◆ Partial or full depth patch.

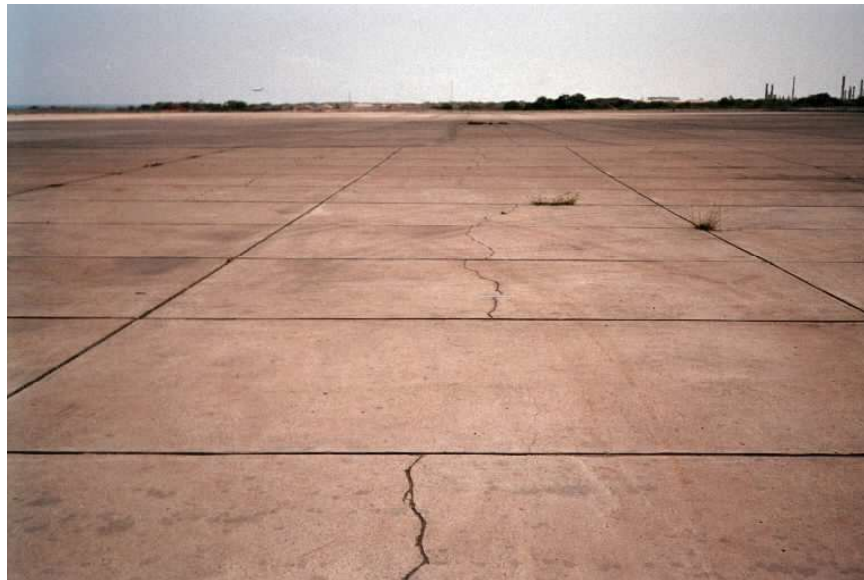
Figure C.12: PCC Transverse Cracks.

These cracks divide the slab into two or three pieces, and are usually caused by a combination of load repetition, curling stresses, and shrinkage stresses. Low severity cracks are not considered major structural distresses. Medium or high severity cracks are usually working cracks and are considered major structural distresses.

- ◆ Low - No action or seal cracks;
- ◆ Medium - seal cracks;
- ◆ High - seal cracks, apply a full depth patch or replace the slab.

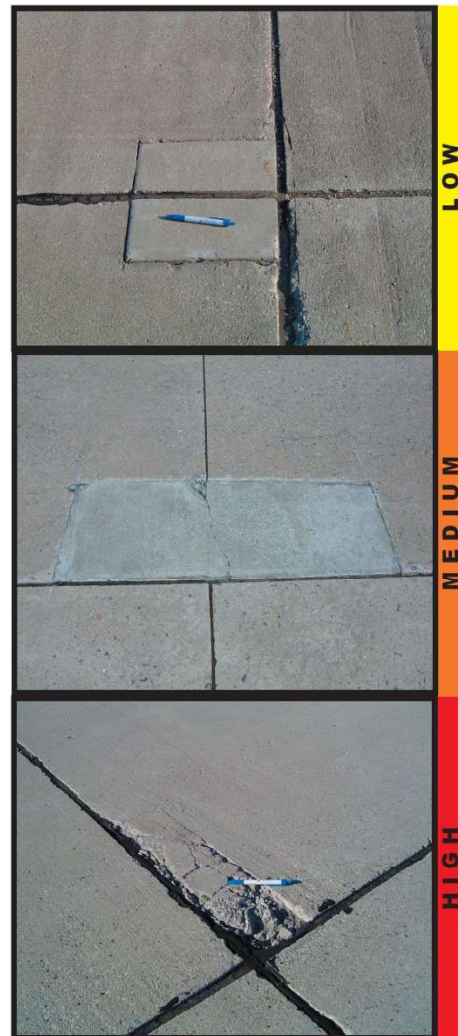
Figure C.14: PCC Small Patch.

A patch is an area where the original pavement has been removed and replaced by a filler material. For condition evaluation, patching is divided into two types: small (less than 5 square feet) and large (over 5 square feet). Large patches are described in the next section.

- ◆ Low – Do Nothing;
- ◆ Medium - Replace patch or replace the slab;
- ◆ High – Replace patch or replace the slab.

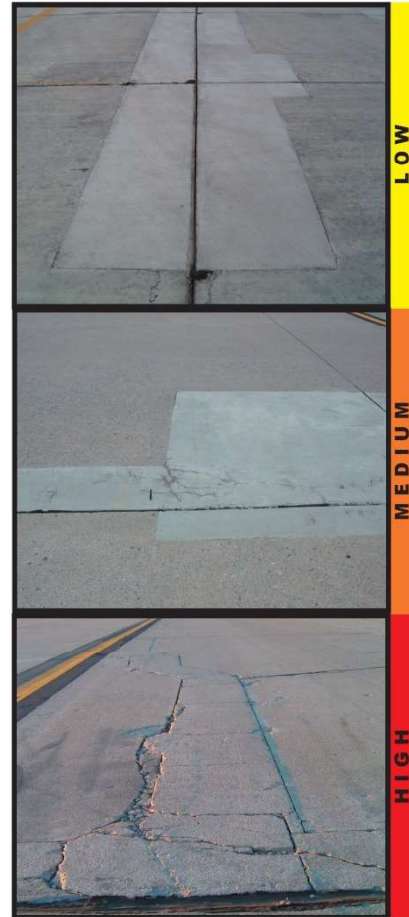
Figure C.15: PCC Large Patch.

Patching is the same as defined for a small patch; however, the area of the patch is more than 5 square feet. A utility cut is a patch that has replaced the original pavement because of placement of underground utilities. The severity levels of a utility cut are the same as those for regular patching..

- ◆ Low – Do Nothing;
- ◆ Medium - Replace patch or replace the slab;
- ◆ High – Replace patch or replace the slab.
