**Subject: Corrective Actions Completed  
Bill Pugh Field Airport (M22)**

**Subject: Annual Inspection Report  
Bill Pugh Field Airport (M22)**

**Annual Inspection Report  
Bill Pugh Field Airport (M22)  
Russellville, Alabama**

January 20, 2021

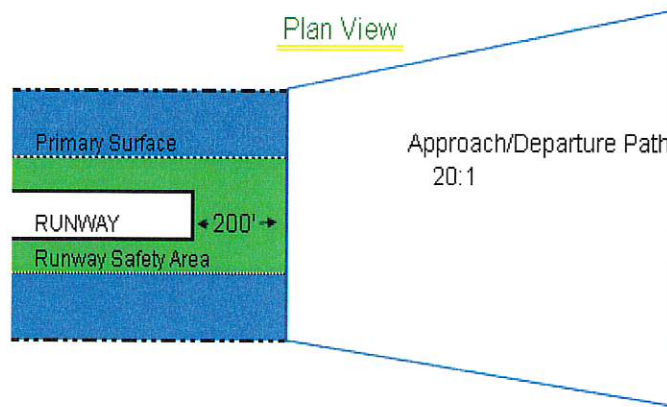
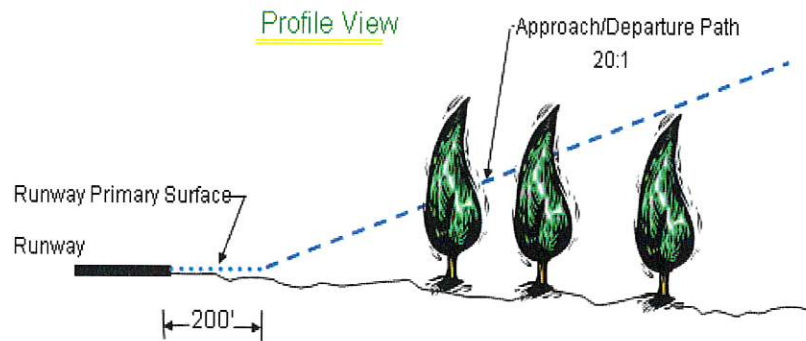
## APPENDIX 1

Approach and Departure Path Dimensions			
Inner Width	Outer Width	Length	Acreage
250 Feet	450 Feet	1,000 Feet	8.04 Acres
Primary Surface Dimensions			
250 Feet Wide Centered Along Runway Centerline Extending 200 Feet Past the Runway End			
Runway Safety Area Dimensions			
120 Feet Wide Centered Along Runway Centerline Extending 200 Feet Past the Runway End
