**Subject: Annual Inspection Report**  
**George Downer Field Airport**

**December 21, 2023**

## **ANNUAL INSPECTION REPORT**

**GEORGE DOWNER FIELD AIRPORT  
ALICEVILLE, ALABAMA**

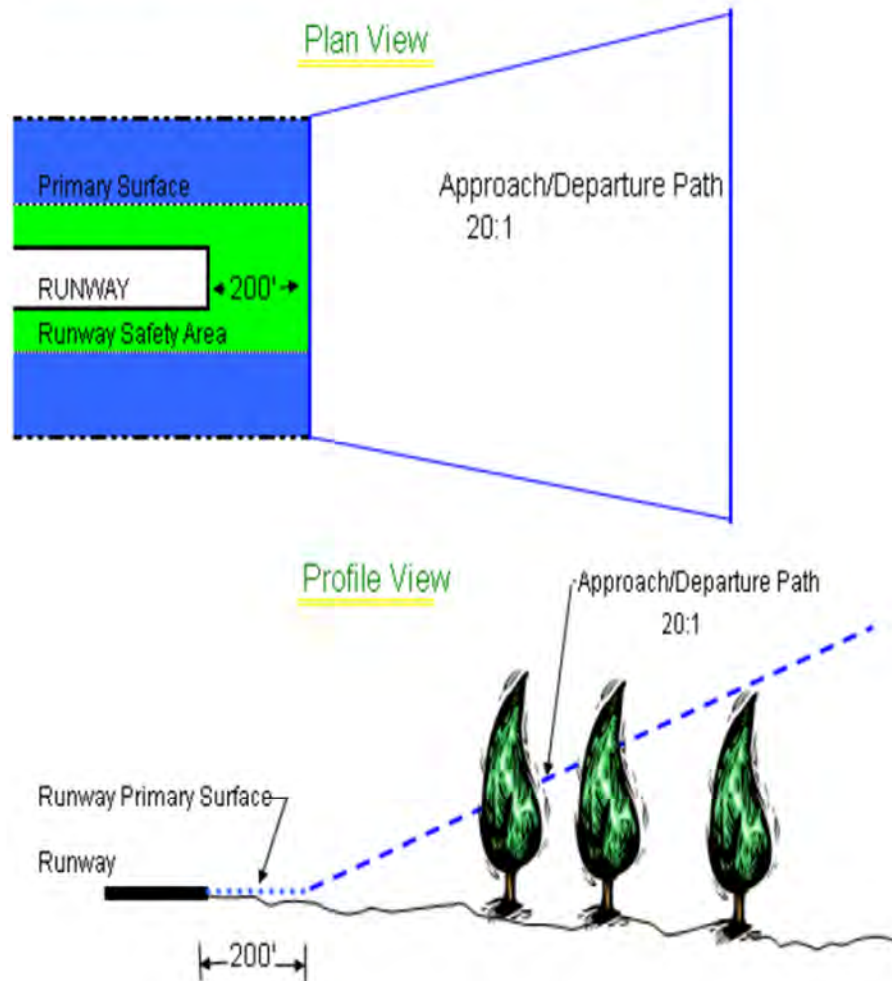
Appendix 2

Obstructions were located in the ALDOT Approach/Departure Path of Runway 6. The tree identified as Obstruction 5 is an ALDOT Approach/Departure Path Violation. The tree identified as Obstruction 6 is a FAA Part 77 Approach Surface Violation. See Appendix #2.

George Downer Field Airport  
Aliceville, AL  
December 21, 2023  
Runway 6  
Obstruction Evaluation

- ALDOT APP/DEP VIOLATION
- FAA PART 77 VIOLATION
- Controlling Obstruction
