**Subject: Annual Inspection Report**  
**Marion County – Rankin Fite Airport (HAB)**

# Annual Inspection Report

October 22, 2020

***Marion County – Rankin Fite Airport  
(HAB)  
Hamilton, Alabama***

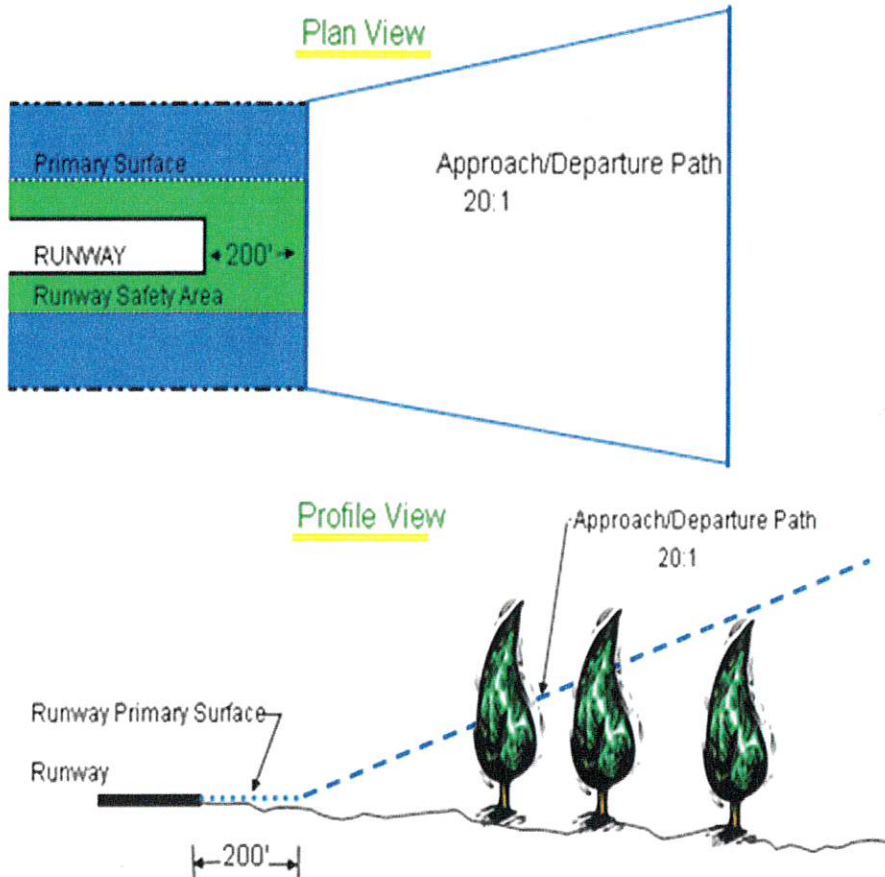
## APPENDIX I

Approach and Departure Path Dimensions			
Inner Width	Outer Width	Length	Acreage
250 Feet	450 Feet	1,000 Feet	8.04 Acres
Primary Surface Dimensions			
250 Feet Wide Centered Along Runway Centerline Extending 200 Feet Past the Runway End			
Runway Safety Area Dimensions			
120 Feet Wide Centered Along Runway Centerline Extending 200 Feet Past the Runway End
