Subject: Annual Inspection Report Lamar County Airport (M55)

Annual Inspection Report June 17, 2021

Lamar County Airport (M55) Vernon, Alabama

June 17, 2021

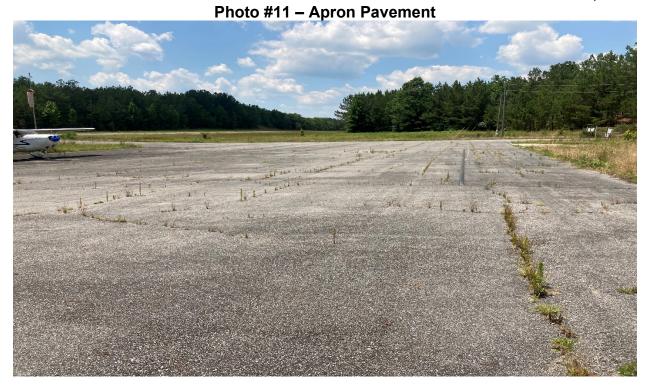
Photo #12 – Gravel on Runway

- Runway pavement is in <u>POOR</u> condition due to cracking, vegetation, and failing crack seal. Some areas are showing block cracking, an early sign of pavement failure (See Photo #9).
- Taxiway pavement is in <u>POOR</u> condition due to cracking, vegetation, and an area of erosion that is washing away the taxiway subgrade (See Photo #10).
- Apron pavement is in <u>FAIR</u> condition due to cracking and vegetation (See Photo #11).
- Gravel is being washed onto the runway from water runoff, causing a foreign object debris (FOD) hazard (See Photo #12).
