Alabama Statewide Airport Pavement Management Program Update

Bibb County Airport (0A8)

Final Report

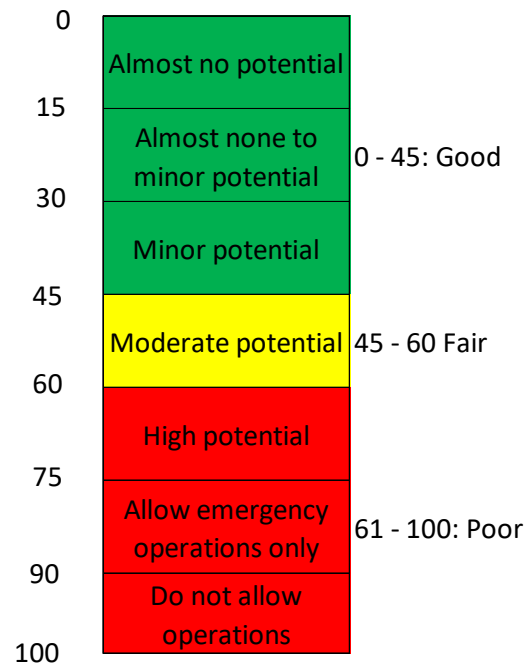
Figure 3.1: FOD Potential Rating Scale.

The FOD index was developed by the US Air Force and is described in detail in the US Army Corp of Engineers Engineering Technical Letter (ETL) 04-09, Pavement Engineering Assessment (EA) Standards. Loose objects on an airfield pavement surface resulting from pavement distresses can be detrimental to aircraft engines, specifically engines that are low to the ground. The objects are ingested into the engines causing costly damage and presenting a safety hazard. Not all pavement distresses create a FOD potential. Therefore, an additional index was identified that uses the results of the PCI distress survey. As shown in Figure 3.1, the scale ranges from 0 to 100 with 0 being no FOD potential. Note that the FOD index uses a simplified three color scale.

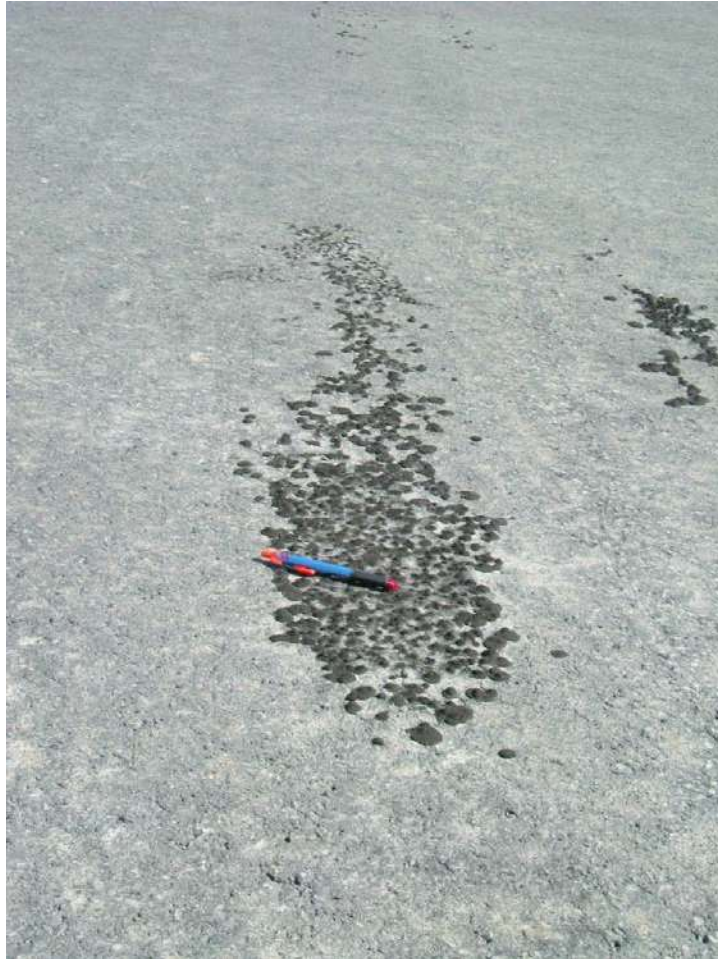
2. Bleeding (AC)

Bleeding is a film of bituminous material on the pavement surface that creates a shiny, glass-like, reflecting surface that usually becomes quite sticky. Bleeding is caused by excessive amounts of asphaltic cement or tars in the mix or low-air void content, or both. It occurs when asphalt fills the voids of the mix during hot weather and then expands out onto the surface of the pavement. Since the bleeding process is not reversible during cold weather, asphalt or tar will accumulate on the surface.

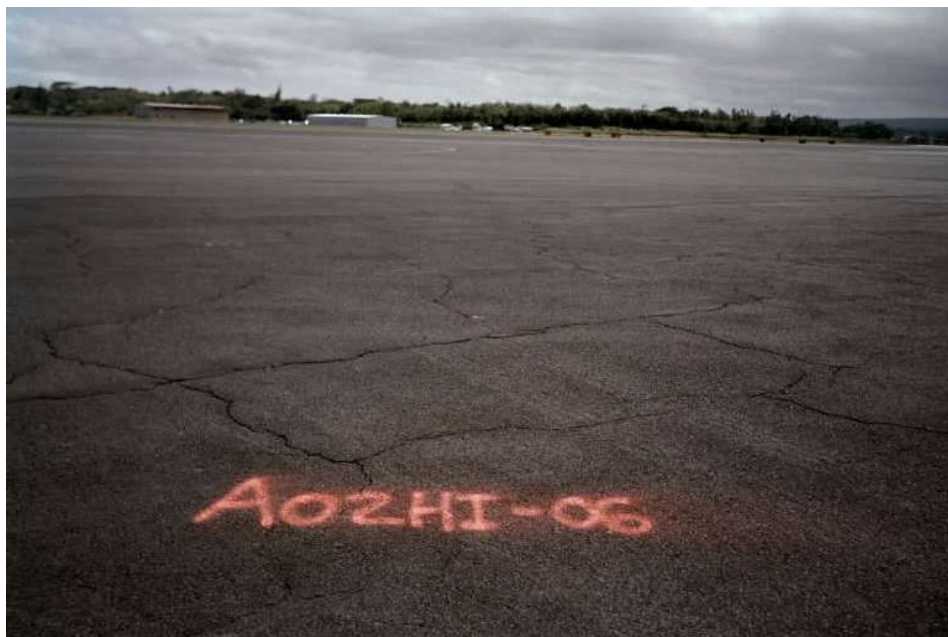
3. Block Cracking (AC)

Block cracks are interconnected cracks that divide the pavement into rectangular shaped pieces. The blocks may range in size from 1 by 1 foot to 10 by 10 feet. Block cracking is caused mainly by shrinkage of the asphalt concrete and is not load associated. The occurrence of block cracking usually indicates that the asphalt has hardened significantly. Block cracking normally occurs over a large proportion of the pavement area, but will sometimes occur only in the non-traffic areas.

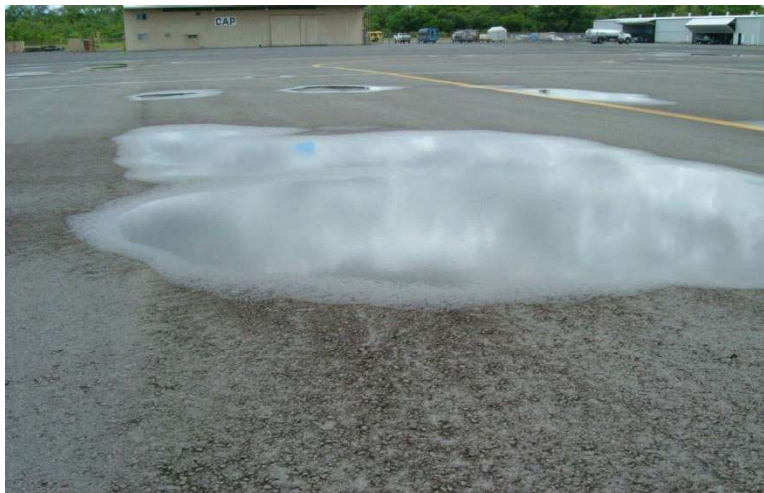
5. Depression (AC)

Depressions are localized pavement surface areas having elevations slightly lower than those of the surrounding pavement. In many instances, light depressions are not noticeable until after a rain, when ponding water creates “birdbath” areas; but the depressions can also be located without rain because of stains created by ponding of water. Depressions can be caused by settlement of the foundation soil or can be built during construction. Depressions cause roughness and, when filled with water of sufficient depth, could cause hydroplaning of aircraft.

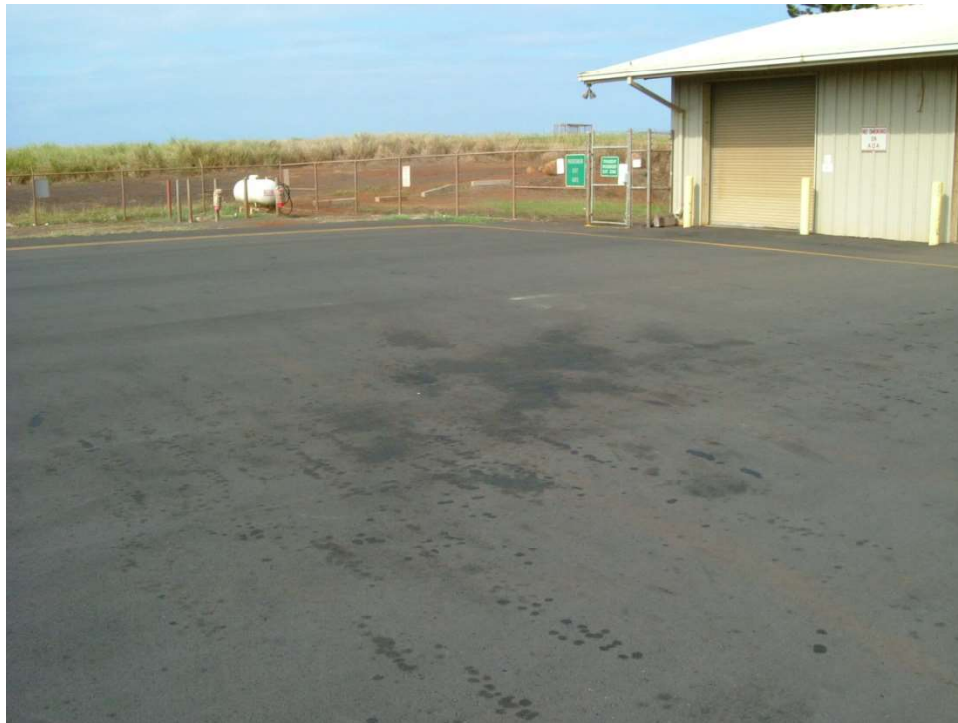
9. Oil Spillage (AC)

Oil spillage is the deterioration or softening of the pavement surface caused by the spilling of oil, fuel, or other solvents.

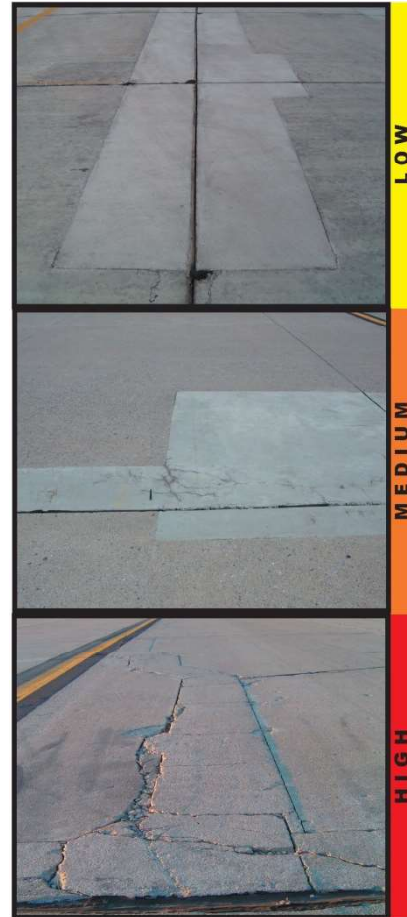
Figure C.15: PCC Large Patch.

Patching is the same as defined for a small patch; however, the area of the patch is more than 5 square feet. A utility cut is a patch that has replaced the original pavement because of placement of underground utilities. The severity levels of a utility cut are the same as those for regular patching..

- ◆ Low - Patch is functioning well, with little or no deterioration;
- ◆ Medium - Patch has deteriorated, and/or moderate spalling can be seen around the edges. Patch material can be dislodged, with considerable effort (minor FOD potential);
- ◆ High - Patch has deteriorated, either by spalling around the patch or cracking within the patch, to a state which warrants replacement.

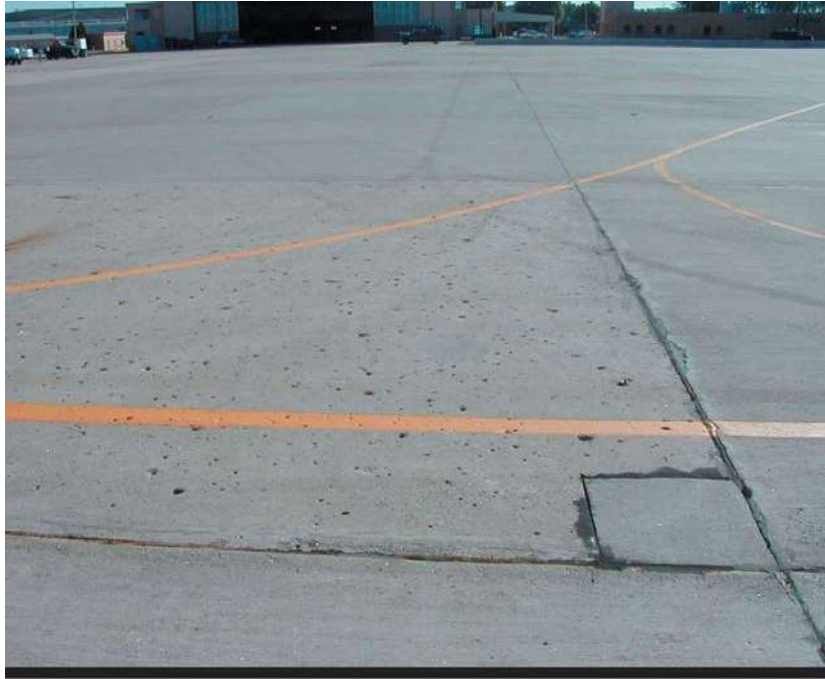
Figure C.16: Popouts.

A popout is a small piece of pavement that breaks loose from the surface due to freeze-thaw action in combination with expansive aggregates. Popouts usually range from approximately 1 inch to 4 inches in diameter and from 1/2 inch to 2 inches deep..

No degrees of severity are defined for popouts. However, popouts must be extensive before they are counted as a distress; i.e., average popout density must exceed approximately three popouts per square yard over the entire slab area.

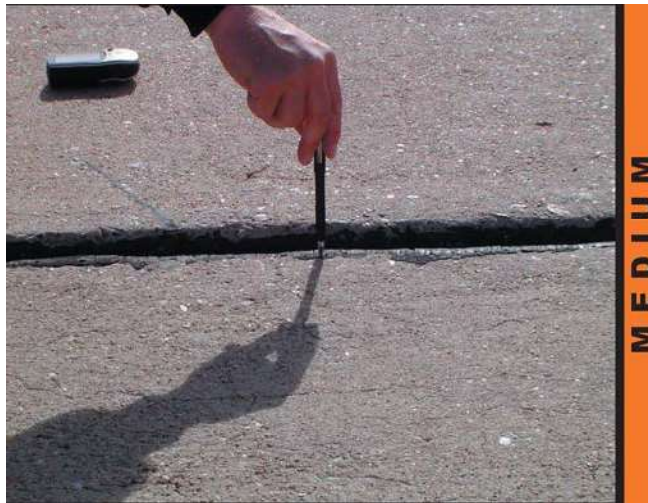
Settlement or faulting is a difference of elevation at a joint or crack caused by upheaval or consolidation.
