Alabama Statewide Airport Pavement Management Program Update

Floralia Municipal Airport (0J4)

Final Report

February 2022

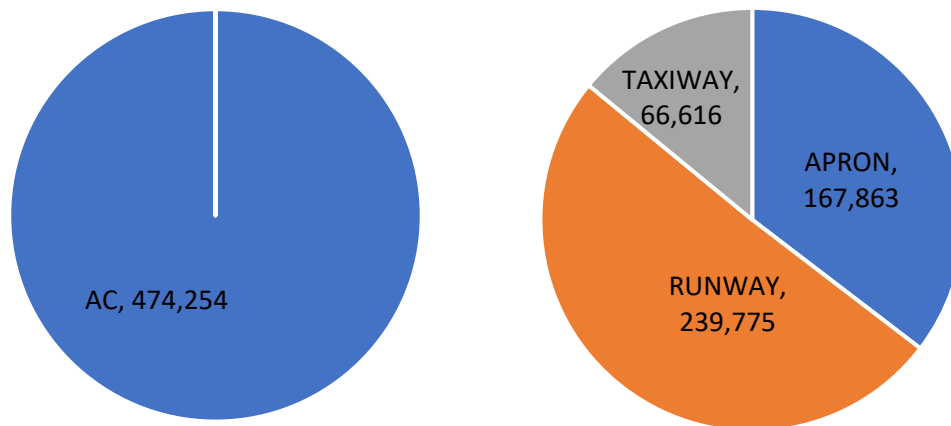
Figure ES-1: Pavement Area (sf) by Surface Type and Branch Use.

There are 7 branches and 9 sections within OJ4’s pavement network with a total surface area of approximately 0.47 million square feet (sf). Figure ES-1 shows the distribution of the pavement network by surface type and branch use.

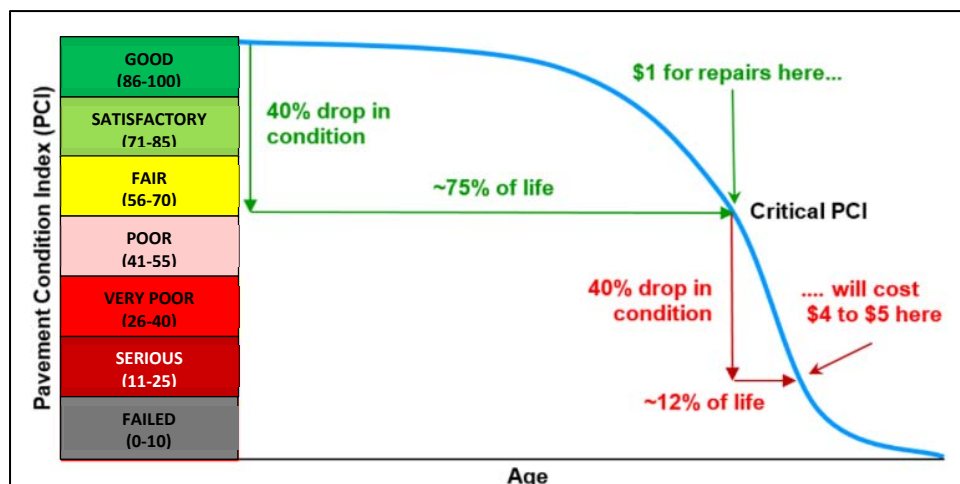
Figure 1.1: Pavement Management Concept.

In examining the lifespan of a 20-year pavement, a “Good” to “Fair” condition rating may last only 5 to 15 years. After that point, the rate of deterioration of pavements accelerates sharply as the age of the pavement increases, and within five years, the pavement may deteriorate to the point of failure. In order to extend pavement life, maintenance and repairs need to be scheduled and performed before the pavement surface declines to a “fair” condition. The point at which rehabilitation can be done before the steep decline occurs is called the “critical PCI”, and is generally considered to occur when the Pavement Condition Index (PCI) is between 60 and 70 for general aviation airports. If the work is done before deterioration accelerates, the cost of rehabilitation can be reduced as shown in Figure 1.1.

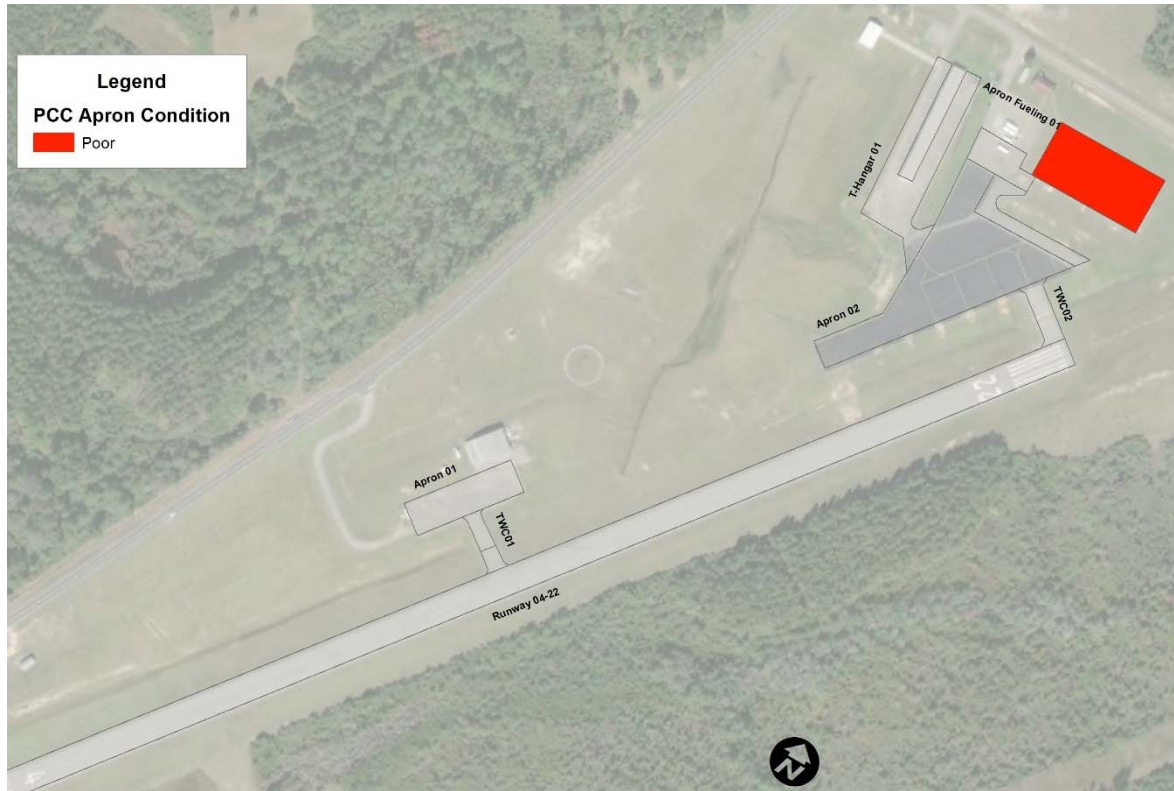
Figure 3.4: PCC Apron Condition Rating.

As stated earlier, the project scope did not include a detailed pavement condition survey for any Portland Cement Concrete (PCC) aprons. For these pavements, a rating of “Good”, “Fair”, or “Poor” was assigned based on the overall pavement condition. Figure 3.4 shows the condition of the PCC aprons at OJ4.

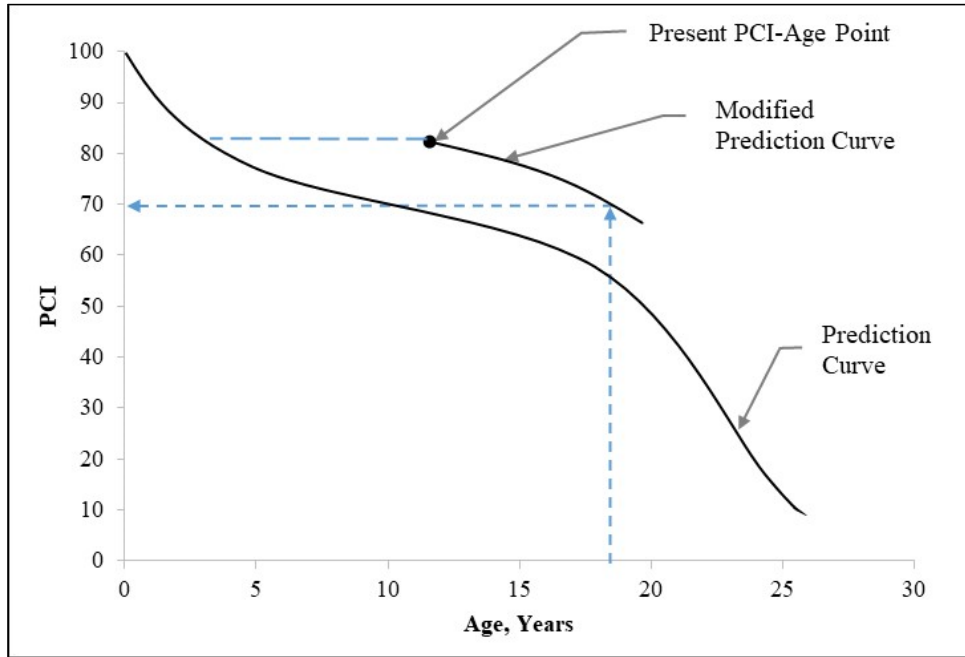
Figure 4.1: PCI Forecasting.

Prediction models are used at the section level to compute future conditions based on the typical performance of the pavement sections that are included in each model. Future condition is computed by defining its position relative to the prediction model. The section prediction curve, or equation, is drawn through the current PCI-age point for each specific section. Since the shifted curve will run parallel to the computed prediction model, the predicted condition can be computed for any future age. Figure 4.1 is an illustration of this process.

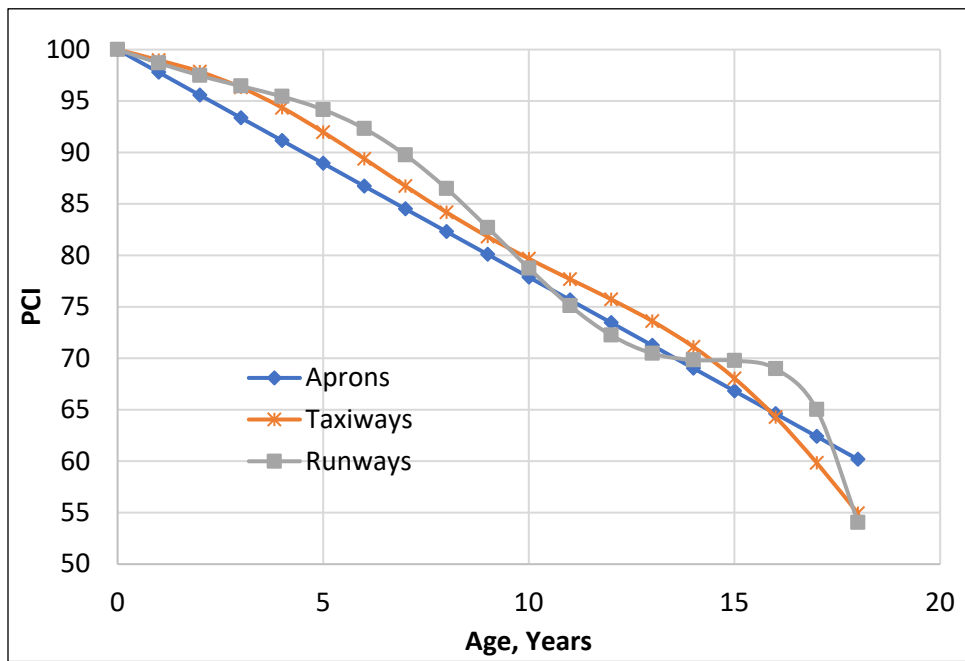
Figure 4.2: Family Curves.

Prediction models provide an effective way to compute future pavement performance based on past and current conditions, and pavement maintenance and rehabilitation practices. As new PCI inspection surveys are conducted, these models should be updated accordingly. In the case of the Alabama statewide airport pavement network, the best fit family curves were developed for each region by grouping pavements according to branch use (e.g. runway, taxiway) and surface type (e.g. AC, AAC, and APC). The family curves for ALDOT were developed based on branch use and are presented in Figure 4.2.

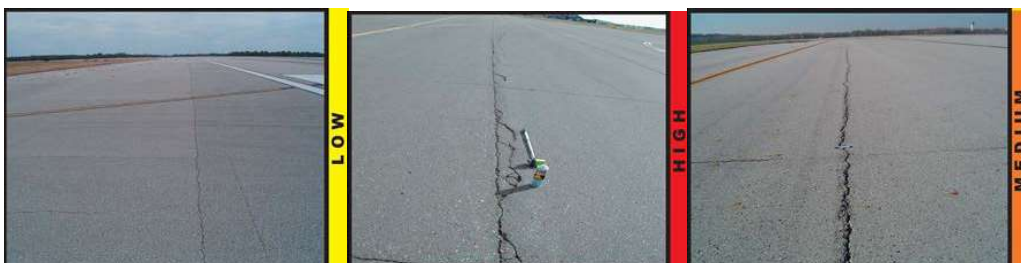
8. Longitudinal and Transverse Cracking (AC)

Longitudinal and transverse (L&T) cracks are parallel to the pavement's centerline or laydown direction. They may be caused by: 1) a poorly constructed paving lane joint, 2) shrinkage of the AC surface due to hardening of the asphalt, or 3) a reflective crack caused by cracks beneath the surface course. Transverse cracks extend across the pavement perpendicularly to the pavement centerline or laydown direction, and may be caused by items 2) or 3) as stated above. These types of cracks are not usually load related.

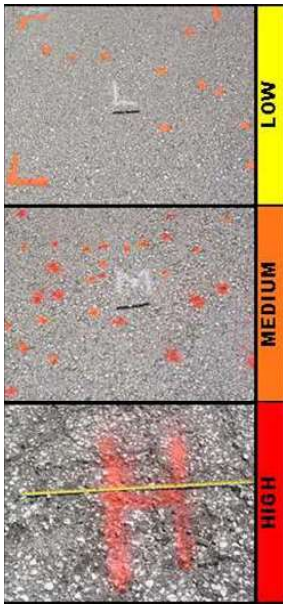
12. Raveling (AC)

As used herein, coarse aggregate refers to predominant coarse aggregate sizes of the asphalt mix. Aggregate clusters refer to when more than one adjoining coarse aggregate piece is missing. If in doubt about a severity level, three representative areas of 1 square yard (1 square meter) each should be examined and the number of missing coarse aggregate particles counted.

L Low severity occurs if any one of these conditions exist: (1) In a square yard (square meter) representative area, the number of coarse aggregate particles missing is between 5 and 20. (2) Missing aggregate clusters is less than 2 percent of the examined square yard (square meter) area. In low severity raveling, there is little or no FOD potential.

M Medium severity occurs if any one of these conditions exist: (1) In a square yard (square meter) representative area, the number of coarse aggregate particles missing is between 21 and 40. (2) Missing aggregate clusters is between 2 and 10 percent of the examined square yard (square meter) area. In medium severity raveling, there is some FOD potential.

H High severity occurs if any one of these conditions exist: (1) In a square yard (square meter) representative area, the number of coarse aggregate particles missing is over 40. (2) Missing aggregate clusters is more than 10 percent of the examined square yard (square meter) area. In high severity raveling, there is significant FOD potential.

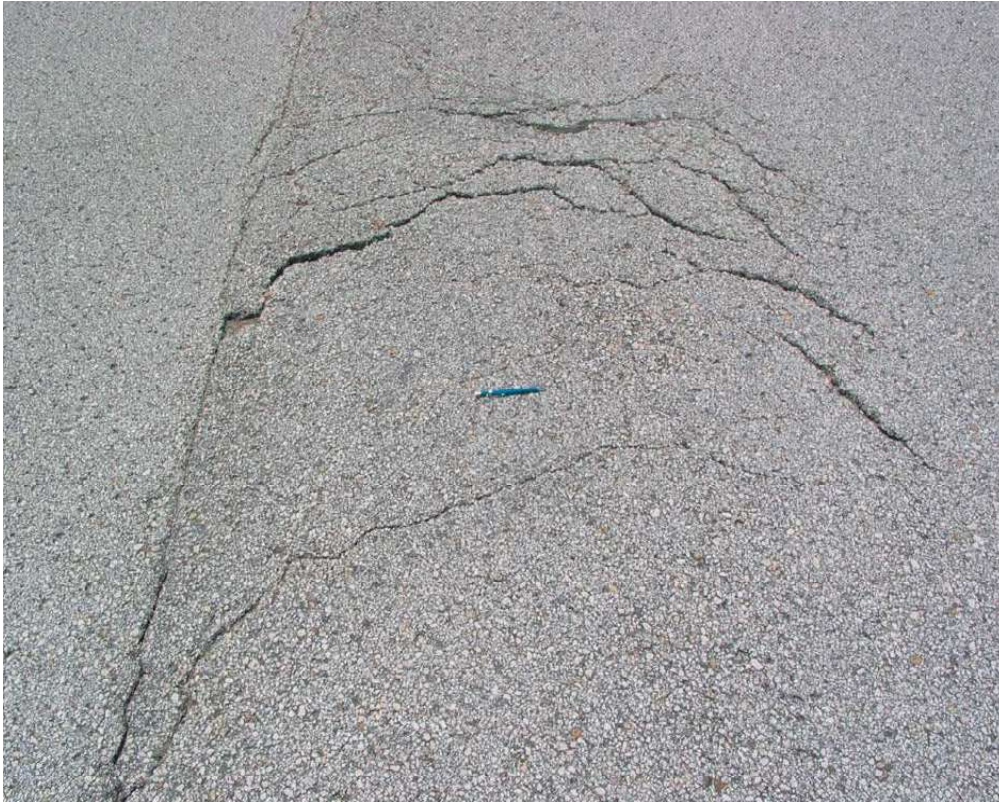
Figure C.10: Slippage Cracking.

14. Slippage Cracking (AC)

Slippage cracks are crescent- or half-moon shaped cracks having two ends pointed away from the direction of traffic. They are produced when braking or turning wheels cause the pavement surface to slide and deform. This usually occurs when there is a low-strength surface mix or poor bond between the surface and next layer of pavement structure.

Severities: No degrees of severity are defined. It is sufficient to indicate that a slippage crack exists.

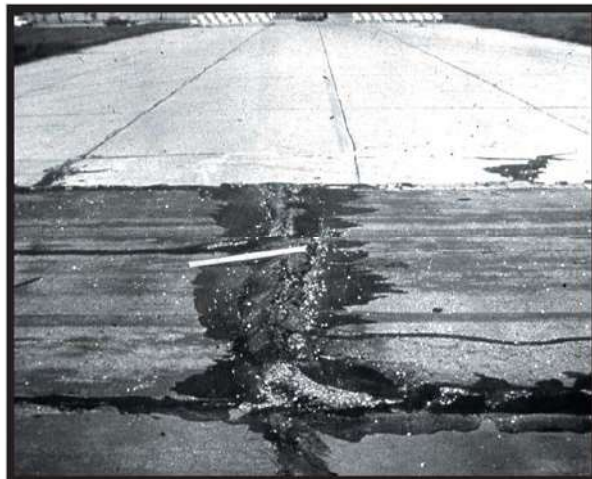
15. Swelling (AC)

A swell is characterized by an upward bulge in the pavement's surface. A swell may occur sharply over a small area or as a longer, gradual wave. Either type of swell can be accompanied by surface cracking. A swell is usually caused by frost action in the subgrade or by swelling soil, but a small swell can also occur on the surface of an asphalt overlay (over PCC) as a result of a blow-up in the PCC slab.

- L** Swell is barely visible and has a minor effect on the pavement's ride quality as determined at the normal aircraft speed for the pavement section under consideration. (Low-severity swells may not always be observable, but their existence can be confirmed by driving a vehicle over the section at the normal aircraft speed. An upward acceleration will occur if the swell is present).
- M** Swell can be observed without difficulty and has a significant effect on the pavement's ride quality as determined at the normal aircraft speed for the pavement section under consideration.
- H** Swell can be readily observed and severely affects the pavement's ride quality at the normal aircraft speed for the pavement section under consideration.

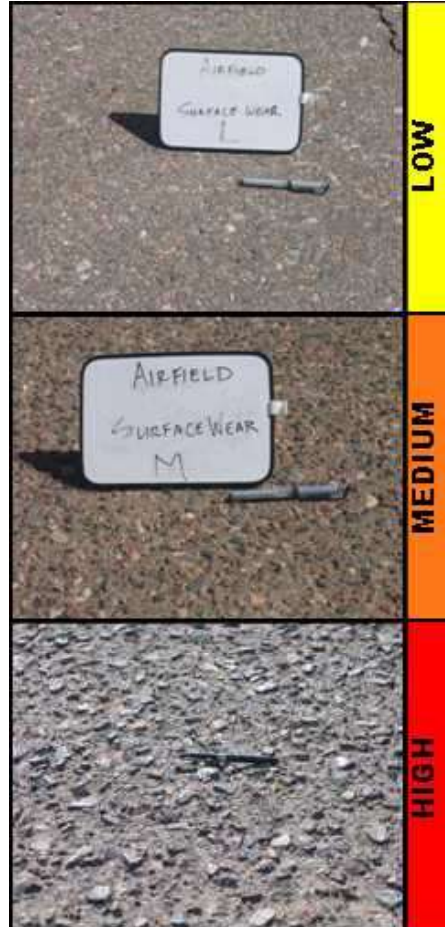
16. Weathering (AC)

The wearing away of the asphalt binder and fine aggregate matrix from the pavement surface.

- L** Asphalt surface beginning to show signs of aging which may be accelerated by climatic conditions. Loss of the fine aggregate matrix is noticeable and may be accompanied by fading of the asphalt color. Edges of the coarse aggregates are beginning to be exposed (less than 0.05 inches or 1 mm). Pavement may be relatively new (as new as 6 months old).
- M** Loss of fine aggregate matrix is noticeable and edges of coarse aggregate have been exposed up to 1/4 width (of the longest side) of the coarse aggregate due to the loss of fine aggregate matrix.
- H** Edges of coarse aggregate have been exposed greater than 1/4 width (of the longest side) of the coarse aggregate. There is considerable loss of fine aggregate matrix leading to potential or some loss of coarse aggregate.

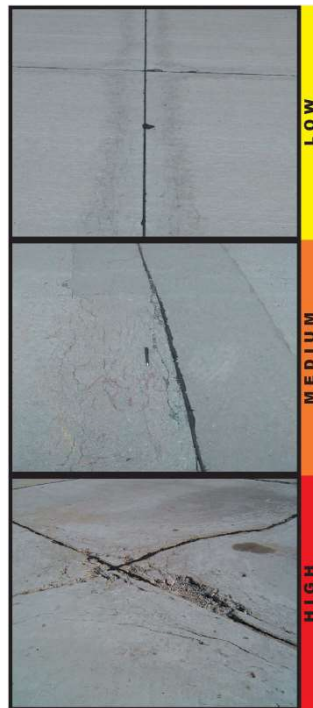
20. Durability Cracks (PCC)

Durability cracking is caused by the inability of the concrete to withstand environmental factors such as freeze-thaw cycles. It usually appears as a pattern of cracks running parallel to a joint or linear crack. A dark coloring can usually be seen around the fine durability cracks. This type of cracking may eventually lead to disintegration of the concrete within 1 to 2 feet (300 to 600 millimeters) of the joint or crack.

- L** “D” cracking is defined by hairline cracks occurring in a limited area of the slab, such as one or two corners or along one joint. Little or no disintegration has occurred. No FOD potential.
- M** (1) “D” cracking has developed over a considerable amount of slab area with little or no disintegration or FOD potential; or (2) “D” cracking has occurred in a limited area of the slab, such as in one or two corners or along one joint, but pieces are missing and disintegration has occurred. Some FOD potential.
- H** “D” cracking has developed over a considerable amount of slab area with disintegration of FOD potential.

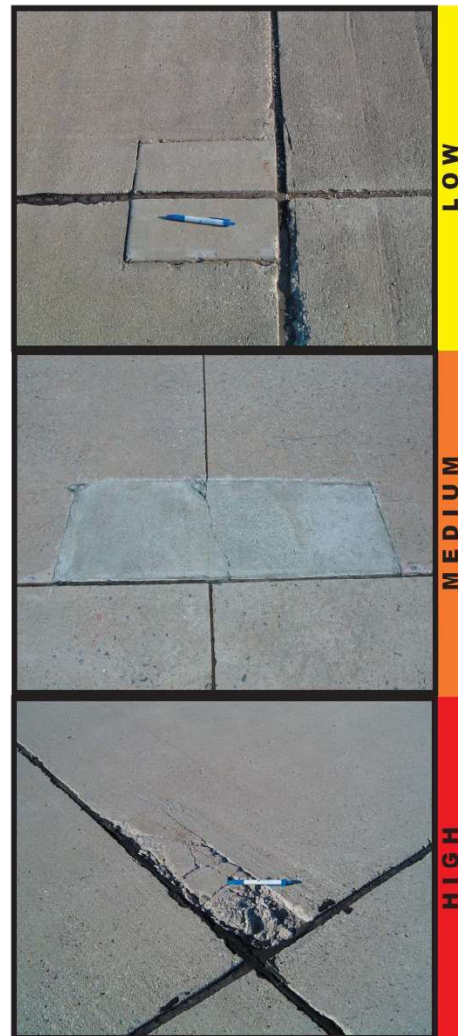
Figure C.14: PCC Small Patch.

A patch is an area where the original pavement has been removed and replaced by a filler material. For condition evaluation, patching is divided into two types: small (less than 5 square feet) and large (over 5 square feet). Large patches are described in the next section.

- ◆ Low - Patch is functioning well, with little or no deterioration;
- ◆ Medium - Patch has deteriorated, and/or moderate spalling can be seen around the edges. Patch material can be dislodged, with considerable effort (minor FOD potential);
- ◆ High - Patch has deteriorated, either by spalling around the patch or cracking within the patch, to a state which warrants replacement.

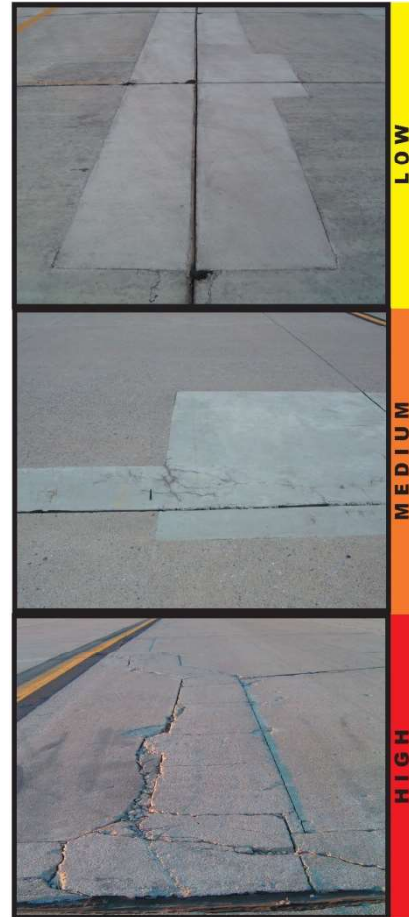
Figure C.15: PCC Large Patch.

23. Large Patch (PCC)

Patching is the same as defined for a small patch; however, the area of the patch is more than 5 square feet. A utility cut is a patch that has replaced the original pavement because of placement of underground utilities. The severity levels of a utility cut are the same as those for regular patching..

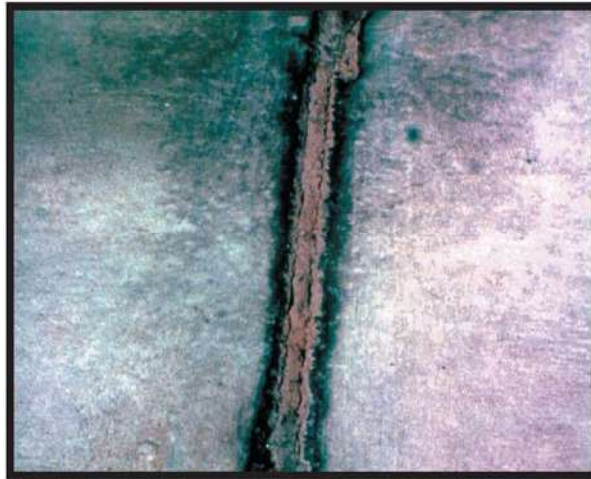
Pumping is the ejection of material by water through joints or cracks caused by deflection of the slab under passing loads. As the water is ejected, it carries particles of gravel, sand, clay, or silt and results in a progressive loss of pavement support. Surface staining and base or subgrade material on the pavement close to joints or cracks are evidence of pumping. Pumping near joints indicates poor joint sealer and loss of support which will lead to cracking under repeated loads.

No degrees of severity are defined. It is sufficient to indicate that pumping exists.

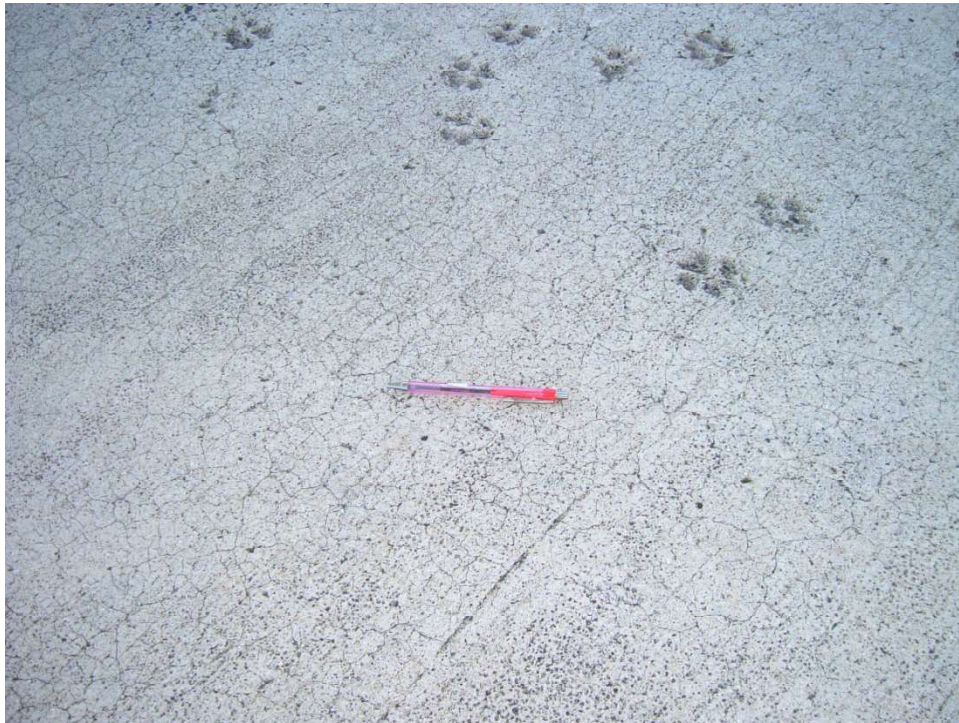
26. Scaling (PCC)

Map cracking or crazing refers to a network of shallow, fine, or hairline cracks that extend only through the upper surface of the concrete. The cracks tend to intersect at angles of 120 degrees. Map cracking or crazing is usually caused by over finishing the concrete and may lead to scaling of the surface, which is the breakdown of the slab surface to a depth of approximately 1/4 to 1/2 inch. Scaling may also be caused by improper construction and poor aggregate. Another recognized source of distress is the reaction between the alkalis (Na_2O and K_2O) in some cements and certain minerals in some aggregates. Products formed by the reaction between the alkalis and aggregate result in expansions that cause a breakdown in the concrete.

- ◆ Low - Crazing or map cracking exists over significant slab area. The surface is in good condition with no scaling. The crack pattern must be well defined and easily recognized;
- ◆ Medium - Slab is scaled over approximately 5% or less of the surface with some FOD potential;
- ◆ High - Slab is severely scaled causing a high FOD potential. Usually, more than 5% of the surface is affected.

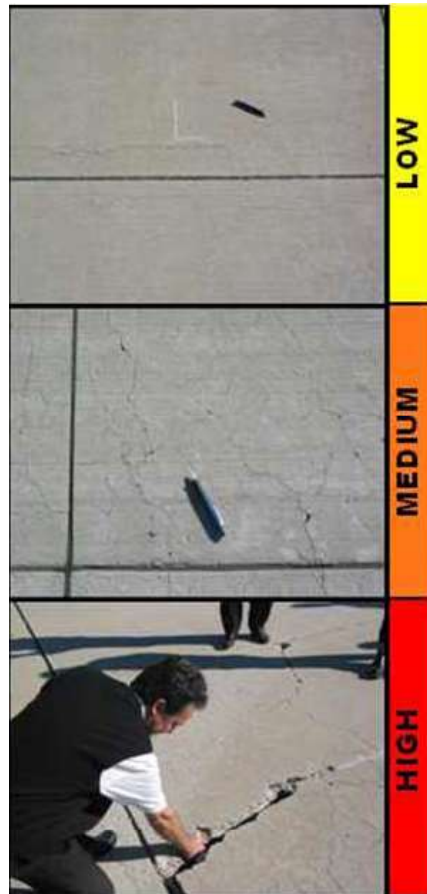
32. ASR (PCC)

ASR is caused by chemical reaction between alkalis and certain reactive silica minerals which form a gel. The gel absorbs water, causing expansion which may damage the concrete and adjacent structures. Alkalis are most often introduced by the portland cement within the pavement. ASR cracking may be accelerated by chemical pavement deicers.

1. Cracking of the concrete pavement (often in a map pattern)
2. White, brown, gray or other colored gel or staining may be present at the crack surface
3. Aggregate popouts
4. Increase in concrete volume (expansion) that may result in distortion of adjacent or integral structures or physical elements. Examples of expansion include shoving of asphalt pavements, light can tilting, slab faulting, joint misalignment, and extrusion of joint seals or expansion joint fillers.

L Minimal to no Foreign Object Damage (FOD) potential from cracks, joints or ASR related popouts; cracks at the surface are tight (predominantly 1 mm or less). Little to no evidence of movement in pavement or surrounding structures or elements.

M Medium ASR distress is differentiated from low by having one or more of the following: increased FOD potential, increased cracking of the slab, some fragments along cracks or at crack intersections present, surface popouts of concrete may occur, pattern of wider cracks (predominantly 1 mm or wider) that may be subdivided by tighter cracks.

H One or both of the following exist: 1) Loose or missing concrete fragments which pose high FOD potential, 2) Slab surface integrity and function significantly degraded and pavement requires immediate repair; may also require repairs to adjacent structures or elements.
