Alabama Statewide Airport Pavement Management Program Update

**Ozark Airport – Blackwell Field
(71J)**

Final Report

Ozark Airport – Blackwell Field, Ozark (71J)

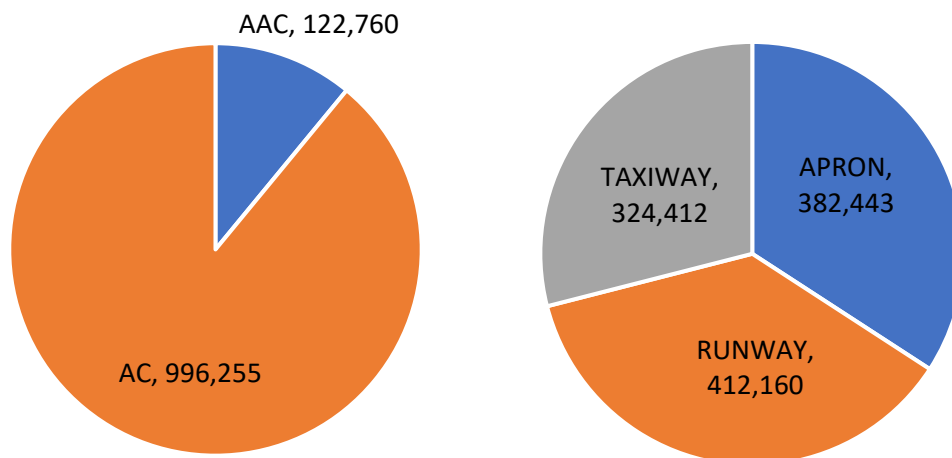
Figure ES-1: Pavement Area (sf) by Surface Type and Branch Use.

There are 15 branches and 17 sections within 71J’s pavement network with a total surface area of approximately 1.12 million square feet (sf). Figure ES-1 shows the distribution of the pavement network by surface type and branch use.

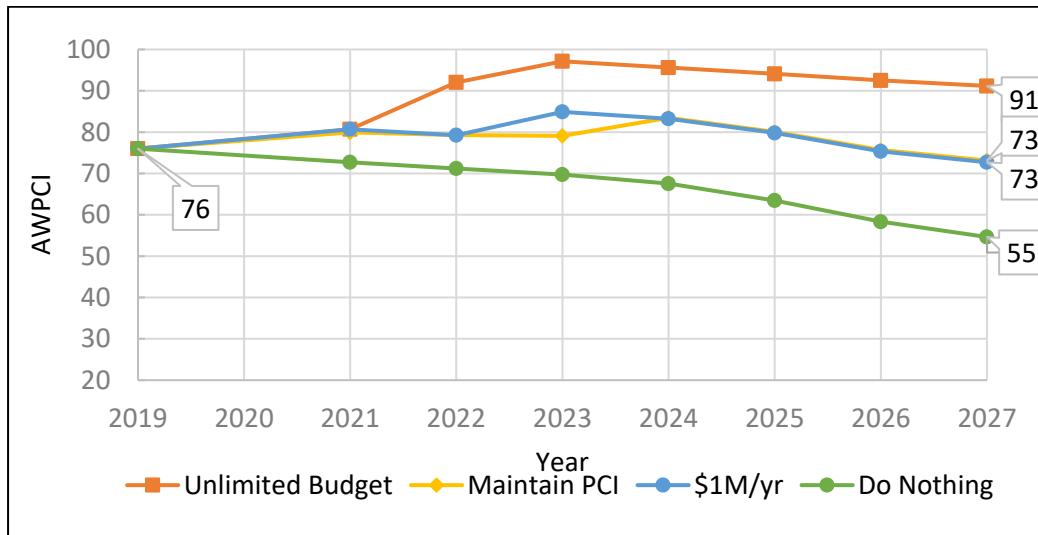
Figure ES-2: M&R Funding Levels.

The PAVER database was updated with 2019 condition data, maintenance and repair (M&R) policies, and unit costs; which were then used to evaluate the effect of multiple funding levels on the overall future pavement condition. Figure ES-2 presents the forecasted 71J network PCI values for each funding level.

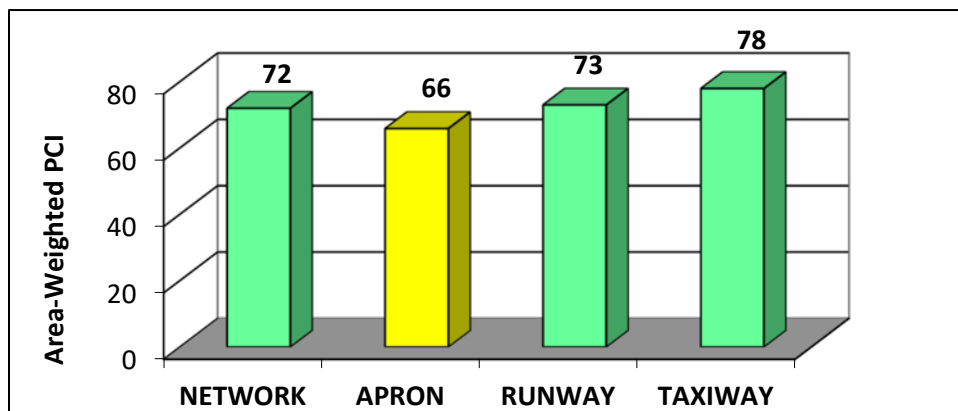
Figure 3.2: Pavement Condition by Branch Use.

Figure 3.2 presents the area-weighted PCI by use and the overall airside network.

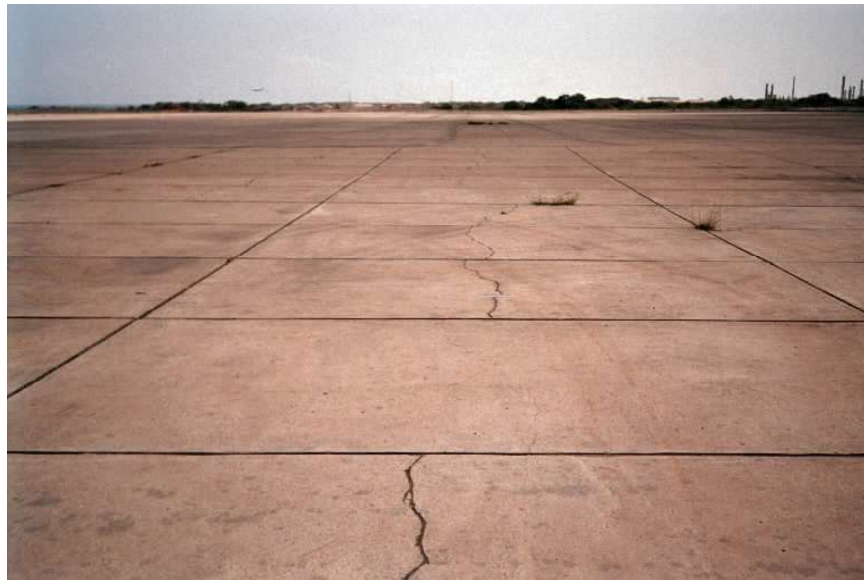
Figure C.12: PCC Transverse Cracks.

These cracks divide the slab into two or three pieces, and are usually caused by a combination of load repetition, curling stresses, and shrinkage stresses. Low severity cracks are not considered major structural distresses. Medium or high severity cracks are usually working cracks and are considered major structural distresses.

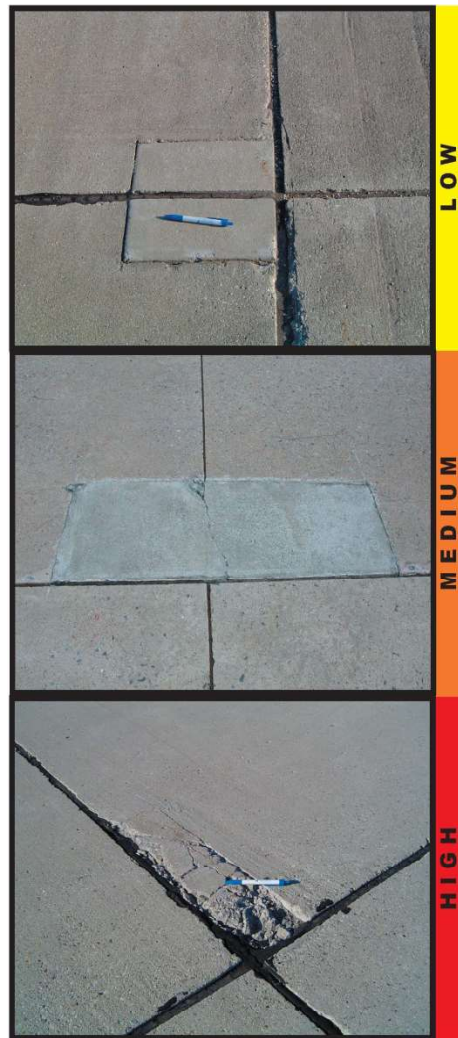
Figure C.14: PCC Small Patch.

A patch is an area where the original pavement has been removed and replaced by a filler material. For condition evaluation, patching is divided into two types: small (less than 5 square feet) and large (over 5 square feet). Large patches are described in the next section.

- ◆ Low - Patch is functioning well, with little or no deterioration;
- ◆ Medium - Patch has deteriorated, and/or moderate spalling can be seen around the edges. Patch material can be dislodged, with considerable effort (minor FOD potential);
- ◆ High - Patch has deteriorated, either by spalling around the patch or cracking within the patch, to a state which warrants replacement.

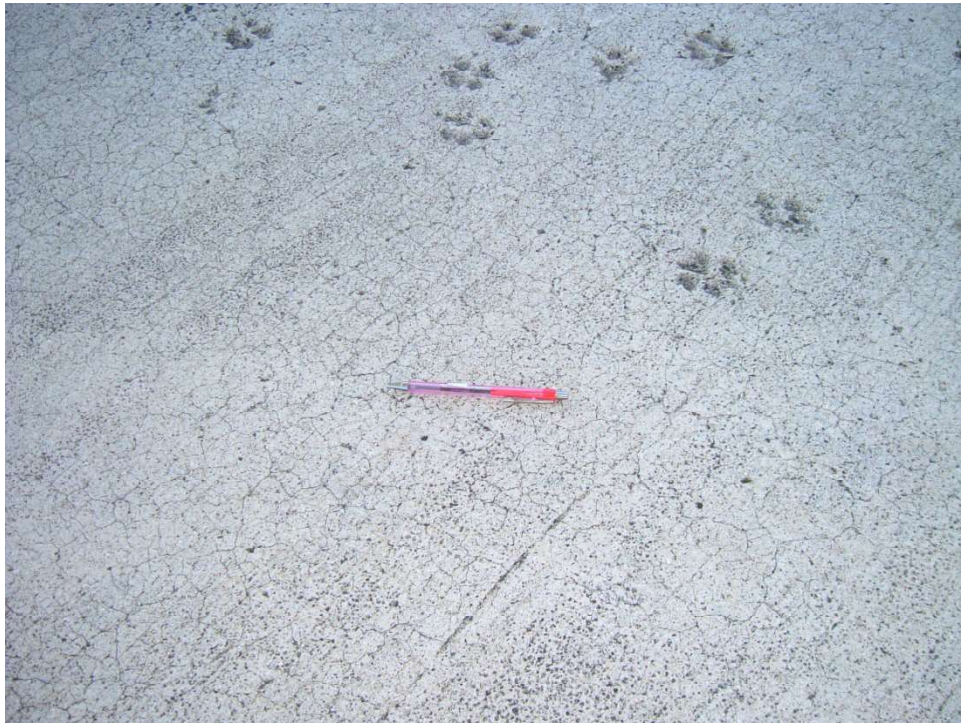
Map cracking or crazing refers to a network of shallow, fine, or hairline cracks that extend only through the upper surface of the concrete. The cracks tend to intersect at angles of 120 degrees. Map cracking or crazing is usually caused by over finishing the concrete and may lead to scaling of the surface, which is the breakdown of the slab surface to a depth of approximately 1/4 to 1/2 inch. Scaling may also be caused by improper construction and poor aggregate. Another recognized source of distress is the reaction between the alkalis (Na_2O and K_2O) in some cements and certain minerals in some aggregates. Products formed by the reaction between the alkalis and aggregate result in expansions that cause a breakdown in the concrete.

- ◆ Low - Crazing or map cracking exists over significant slab area. The surface is in good condition with no scaling. The crack pattern must be well defined and easily recognized;
- ◆ Medium - Slab is scaled over approximately 5% or less of the surface with some FOD potential;
- ◆ High - Slab is severely scaled causing a high FOD potential. Usually, more than 5% of the surface is affected.

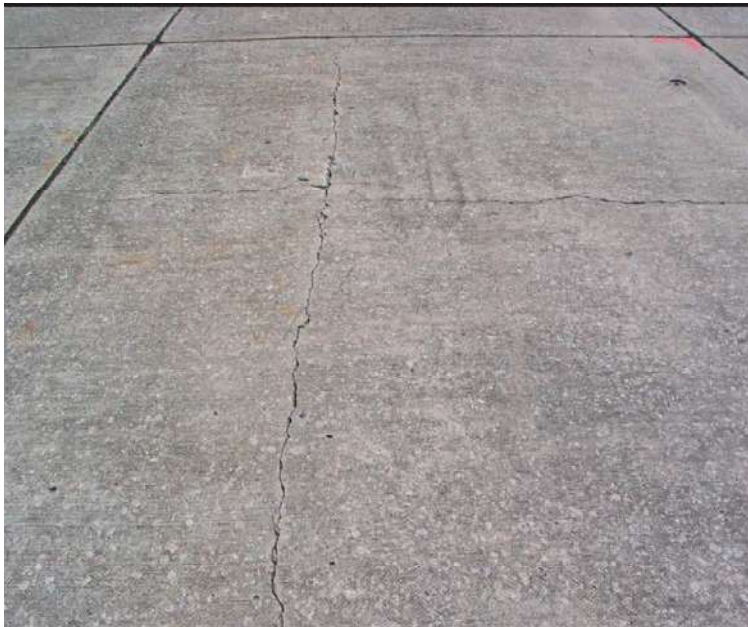
Intersecting cracks are cracks that break into four or more pieces because of overloading and/or inadequate support. The high-severity level of this distress type, as defined below, is referred to as a shattered slab. If all pieces or cracks are contained within a corner break, the distress is categorized as a severe corner break.

- ◆ Low - Slab is broken into four or five pieces with the vast majority of the cracks (over 85 percent) of low-severity;
- ◆ Medium - (1) Slab is broken into four or five pieces with over 15 percent of the cracks of medium severity (no high-severity cracks); or (2) slab is broken into six or more pieces with over 85 percent of the cracks of low-;
- ◆ High - At this level of severity, the slab is called shattered: (1) slab is broken into four or five pieces with some or all of the cracks of high severity; (2) slab is broken into six or more pieces with over 15 percent of the cracks of medium- or high-severity.

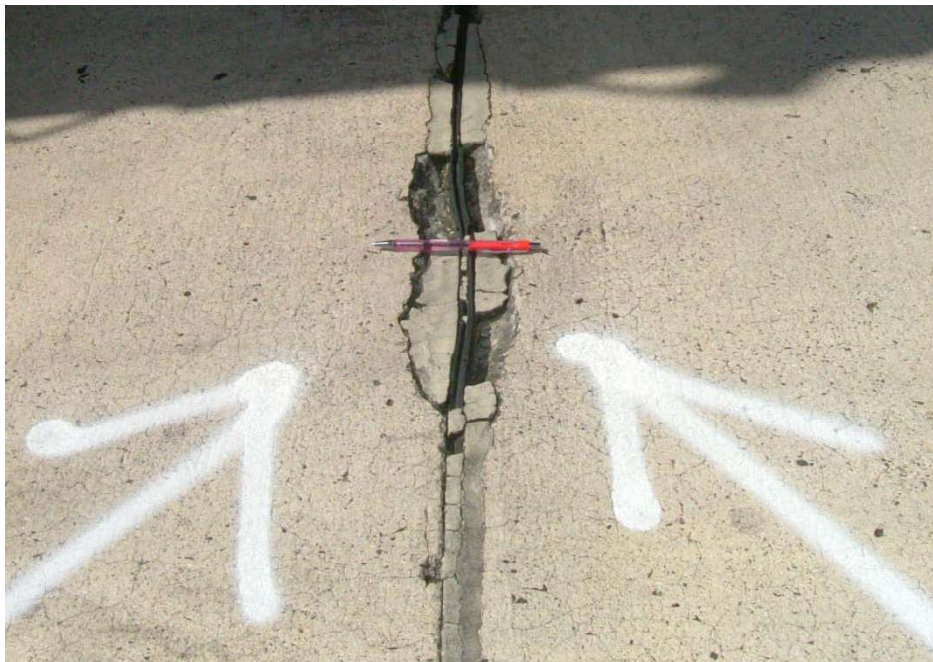
Joint spalling is the disintegration of the slab edges within 2 feet of the side of the joint. A joint spall usually does not extend vertically through the slab, but intersects the joint at an angle. Spalling results from excessive stresses at the joint crack caused by infiltration of incompressible materials or traffic loads. Weak concrete at the joint (caused by overworking) combined with traffic loads is another cause of spalling.

- ◆ Low - over 2 feet long and is broken into no more than three pieces defined by low or medium severity cracks, with little or no FOD potential, or is 2) less than 2 feet long and is broken into more than three pieces, with little FOD or tire damage potential;
- ◆ Medium - over 2 feet long and is broken into more than 3 pieces defined by light or medium cracks or some FOD potential existing, or is 2) less than 2 feet long and is broken into pieces or fragmented, with some of the pieces loose or absent, causing considerable FOD or tire damage potential;
- ◆ High - over 2 feet long and is broken into more than three pieces defined by one or more high severity cracks with high FOD potential.
