Alabama Statewide Airport Pavement Management Program Update

Bill Pugh Field (M22)

Final Report

February 2022

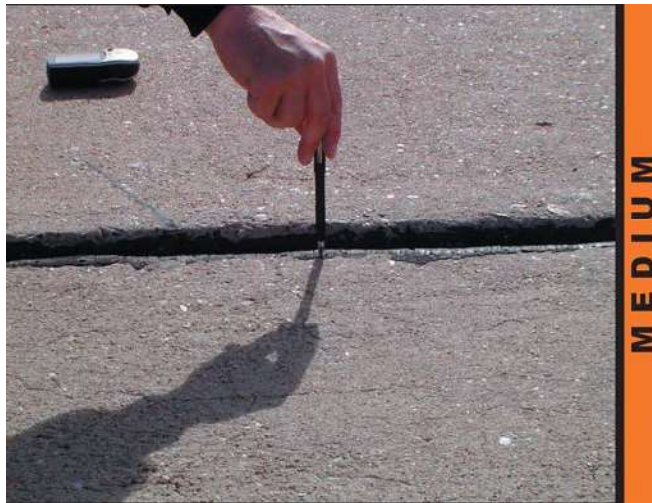
severity level of this distress type, as defined below,

-
- ◆ Slab is broken into four or five pieces with the vast majority of the cracks
 - ◆ (1) Slab is broken into four or five pieces with over 15 percent of the
 - ◆ four or five pieces with some or all of the cracks of high severity; (2) slab is

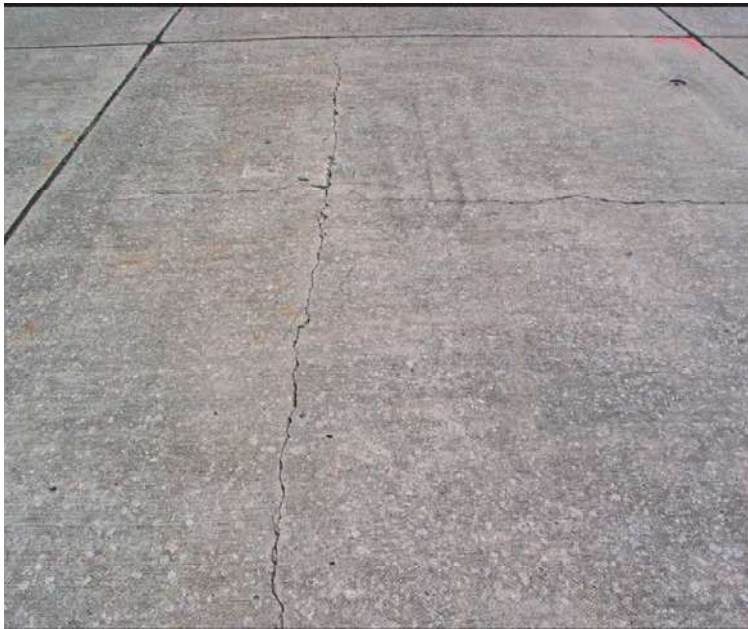
No degrees of severity are defined. It is sufficient to indicate that shrinkage cracks exist.

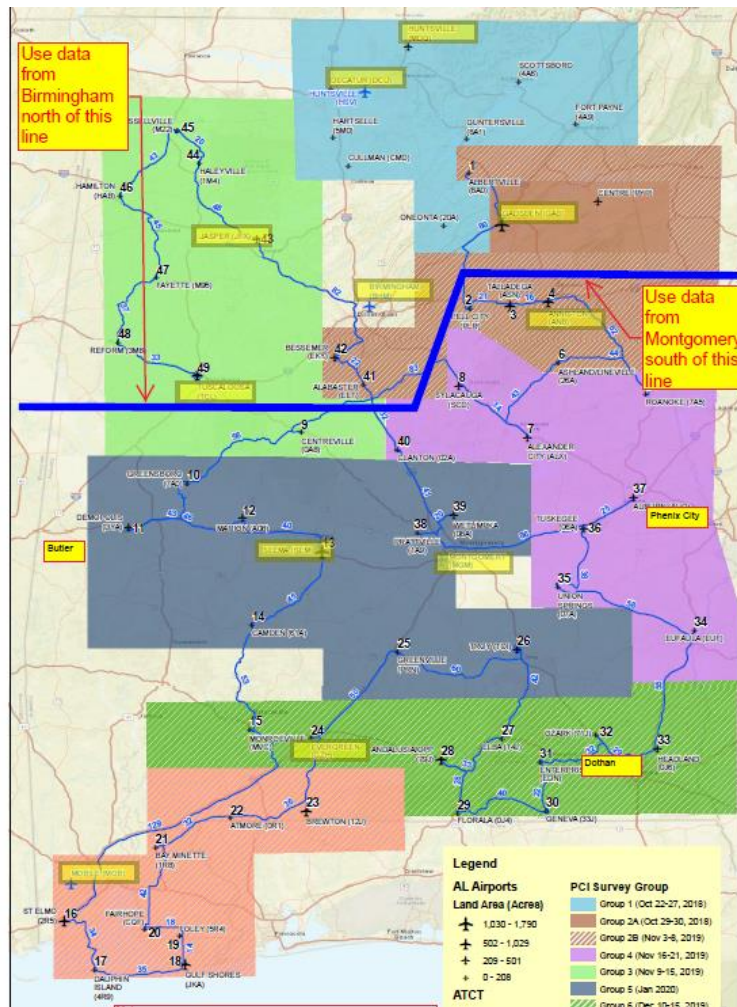
Figure 1: RSMMeans Unit Costs Locations.

The source for the M&R costs data is RSMMeans, which has data for 14 locations throughout Alabama, as identified by the yellow highlighted boxes in Figure 1. The cost data is presented in terms of individual line items like asphalt wearing course, aggregate base etc., which were consolidated to develop the activity costs described below.

The cost data show a distinct difference in costs between locations north and south of Birmingham, especially for the higher value items like the asphalt layers. Therefore, the unit costs were developed accordingly for the airports north and south of Birmingham, as identified in Figure 1. Appendix H2 presents the component costs used in developing the M&R costs.
