Alabama Statewide Airport Pavement Management Program Update

North Pickens Airport (3M8)

Final Report

February 2022

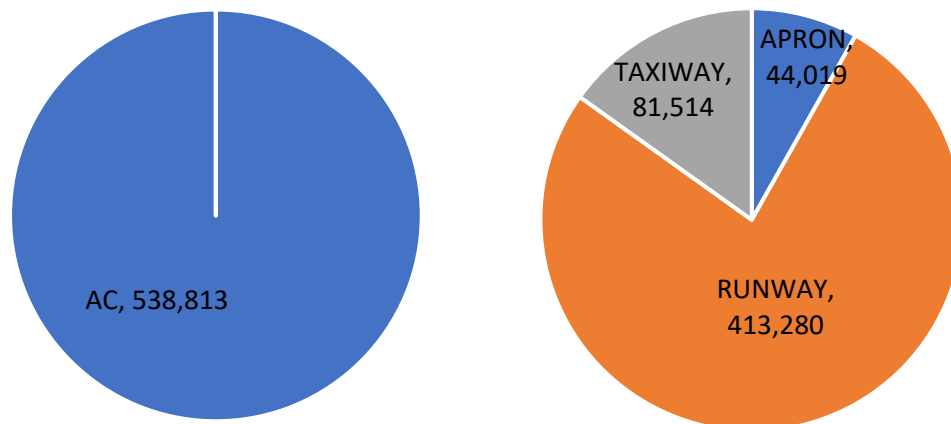
Figure ES-1: Pavement Area (sf) by Surface Type and Branch Use.

There are 7 branches and 11 sections within 3M8’s pavement network with a total surface area of approximately 0.5 million square feet (sf). Figure ES-1 shows the distribution of the pavement network by surface type and branch use.

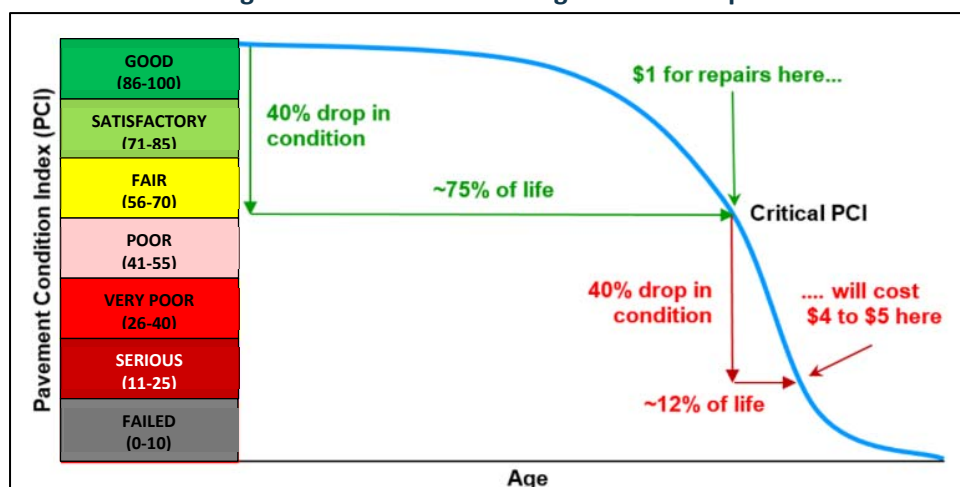
Figure 1.1: Pavement Management Concept.

In examining the lifespan of a 20-year pavement, a “Good” to “Fair” condition rating may last only 5 to 15 years. After that point, the rate of deterioration of pavements accelerates sharply as the age of the pavement increases, and within five years, the pavement may deteriorate to the point of failure. In order to extend pavement life, maintenance and repairs need to be scheduled and performed before the pavement surface declines to a “fair” condition. The point at which rehabilitation can be done before the steep decline occurs is called the “critical PCI”, and is generally considered to occur when the Pavement Condition Index (PCI) is between 60 and 70 for general aviation airports. If the work is done before deterioration accelerates, the cost of rehabilitation can be reduced as shown in Figure 1.1.

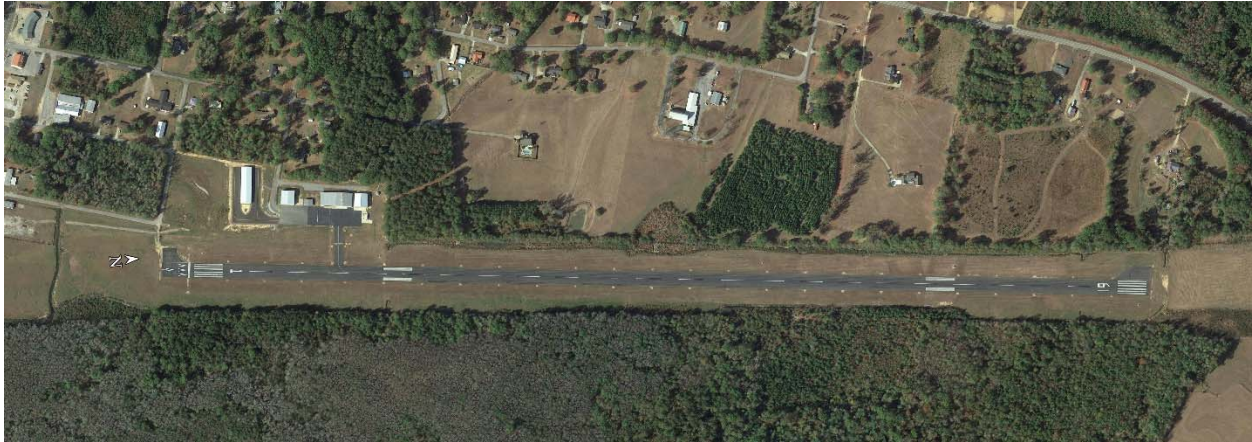
Figure 2.1: North Pickens Airport.

3M8 is a General Aviation (GA) airport located approximately 1 mile north of Reform. The airport was activated in July 1970 and is owned and operated by the Pickens County Commission. Figure 2.1 shows an aerial image of the airport.

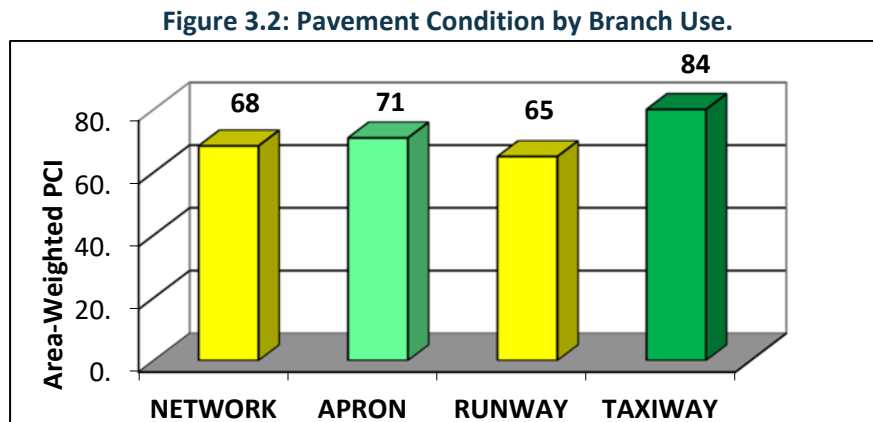
Figure 3.2 presents the area-weighted PCI by use and the overall airside network.

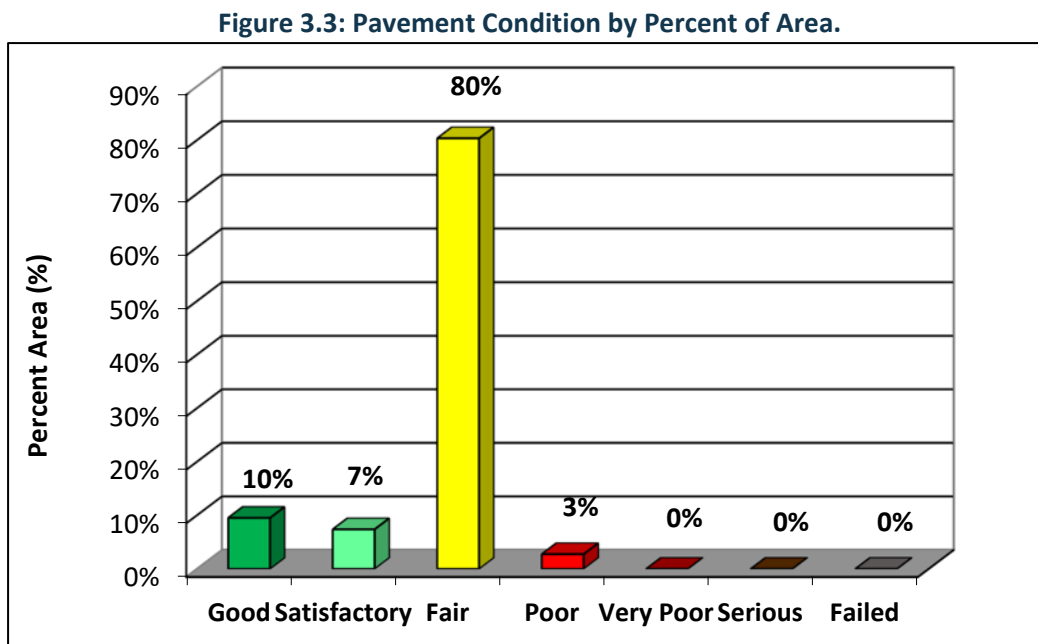
Figure 3.3 shows the distribution of the 3M8 pavement network by condition. Approximately 3 percent of the network is in “Poor” or worse condition.

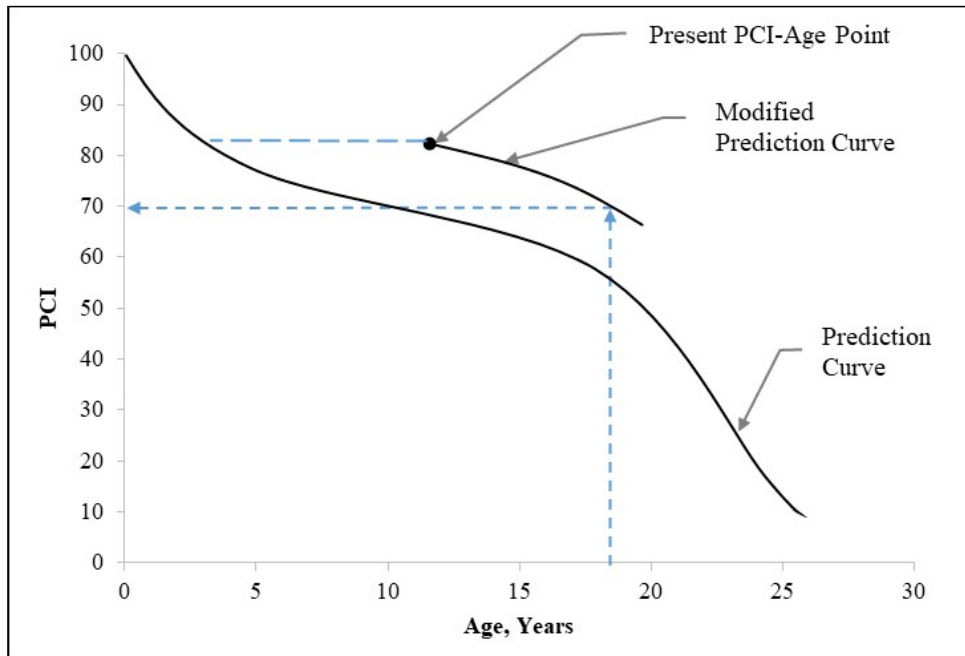
Figure 4.1: PCI Forecasting.

Prediction models are used at the section level to compute future conditions based on the typical performance of the pavement sections that are included in each model. Future condition is computed by defining its position relative to the prediction model. The section prediction curve, or equation, is drawn through the current PCI-age point for each specific section. Since the shifted curve will run parallel to the computed prediction model, the predicted condition can be computed for any future age. Figure 4.1 is an illustration of this process.

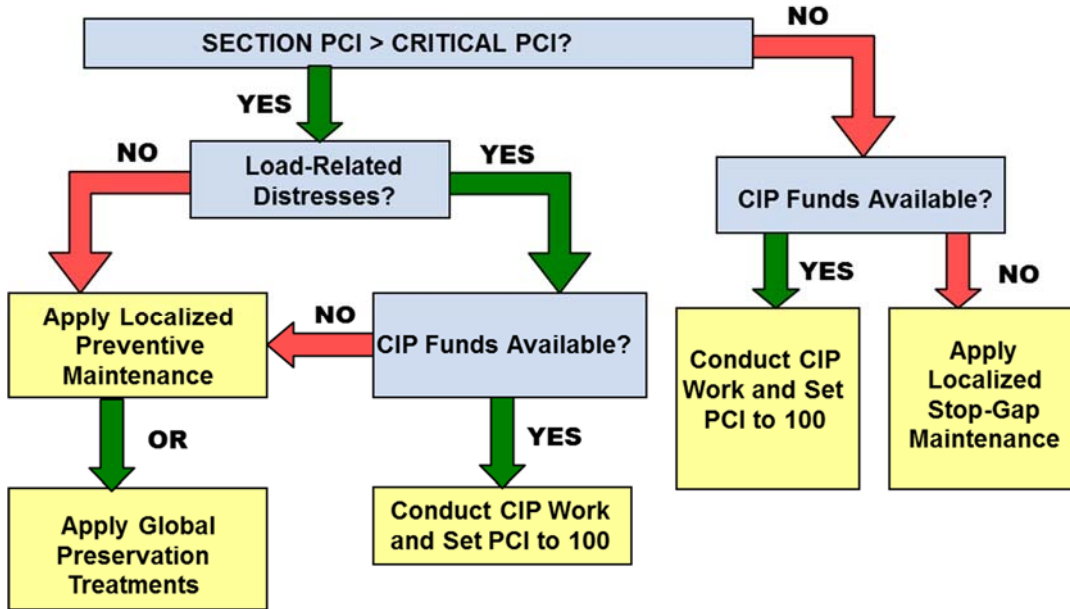
Figure 4.3: Budget Analysis Process.

The PAVER database, updated with condition data and customized with condition performance priorities, policies, and costs; was used to evaluate the effect of multiple funding levels on the overall future pavement condition. This output was further used to develop the PCIP. Figure 4.3 illustrates the process that PAVER uses in the funding analysis.

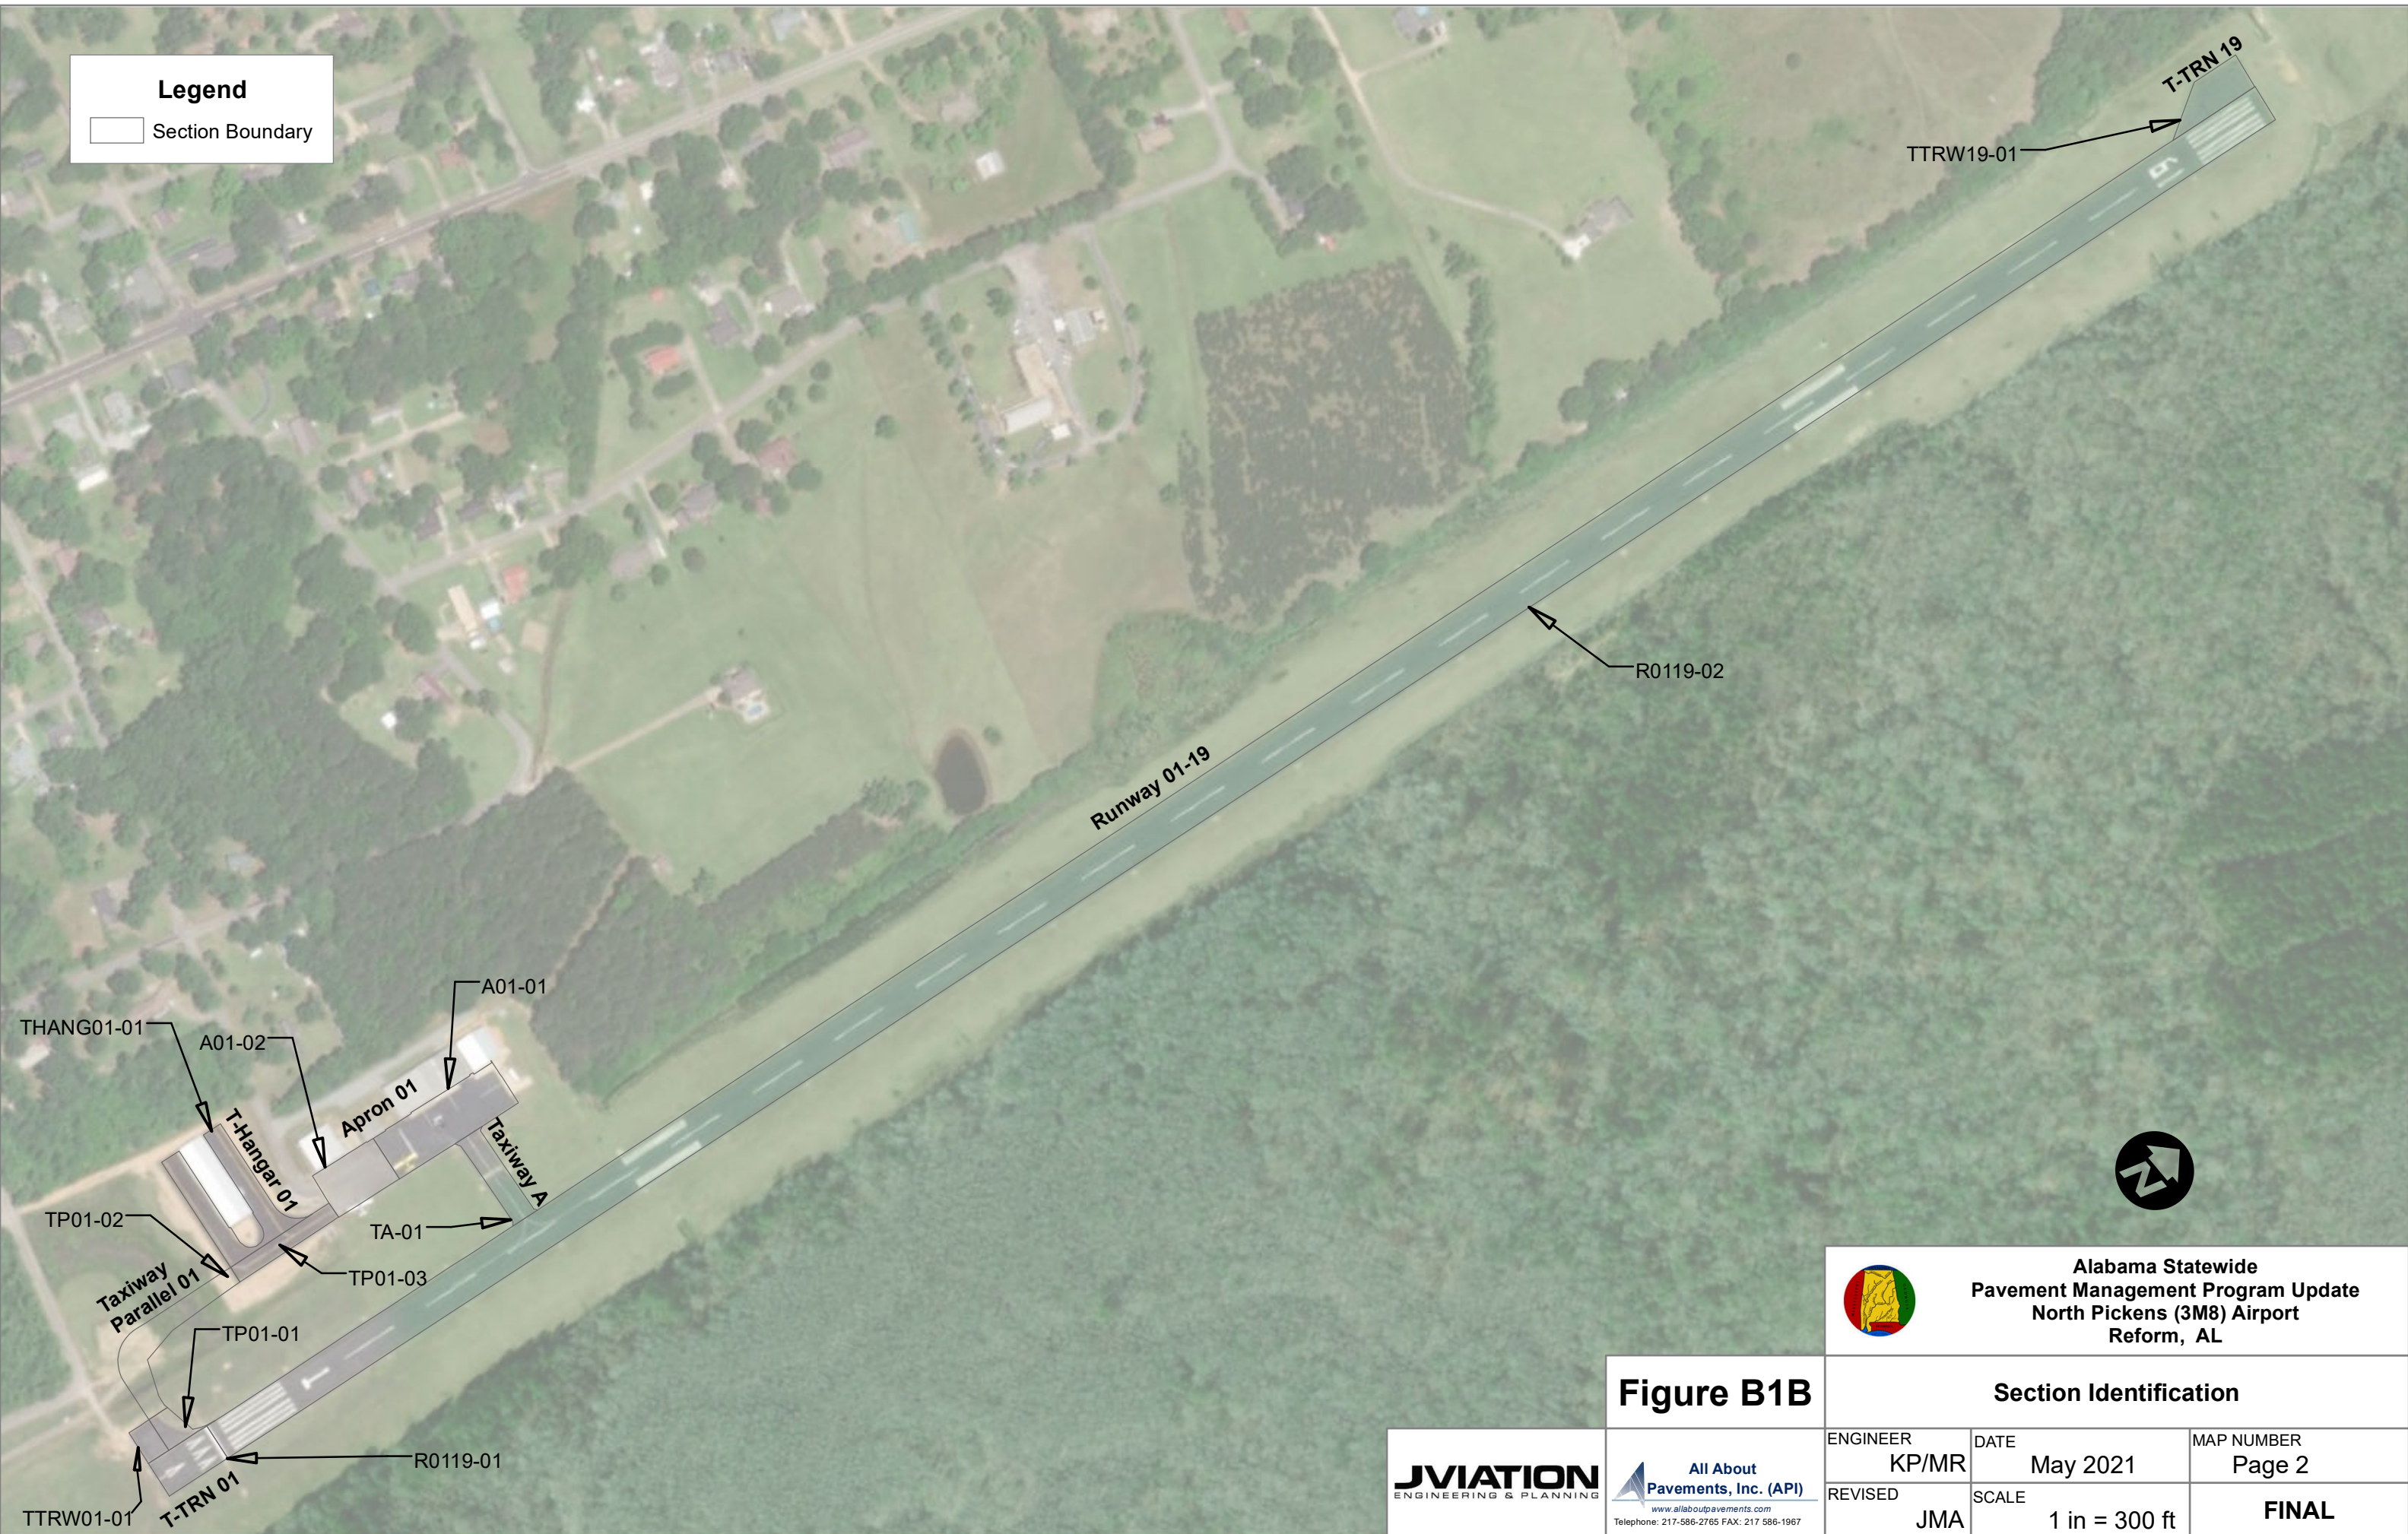
Once branches have been defined, pavement evaluation and analysis techniques require the airfield pavement system to be broken up into discrete sections. A pavement “section” is the smallest management unit that is used when considering the application and selection of maintenance and rehabilitation (M&R) treatments, and is defined in Section 2.1.8 of ASTM D 5340-12 as “a contiguous pavement area having uniform construction, maintenance, usage history, and condition. A section should also have the same traffic volume and load intensity.” A complete list of the pavement inventory and the corresponding section designations are included in Appendix A. Figure B1B presents the section layout.
