Subject: Annual Inspection Report
Eufaula (Weedon Field) Municipal Airport

ANNUAL INSPECTION REPORT

EUFAULA (WEEDDON FIELD) MUNICIPAL AIRPORT
(KEUF)
EUFAULA, ALABAMA

May 7, 2020

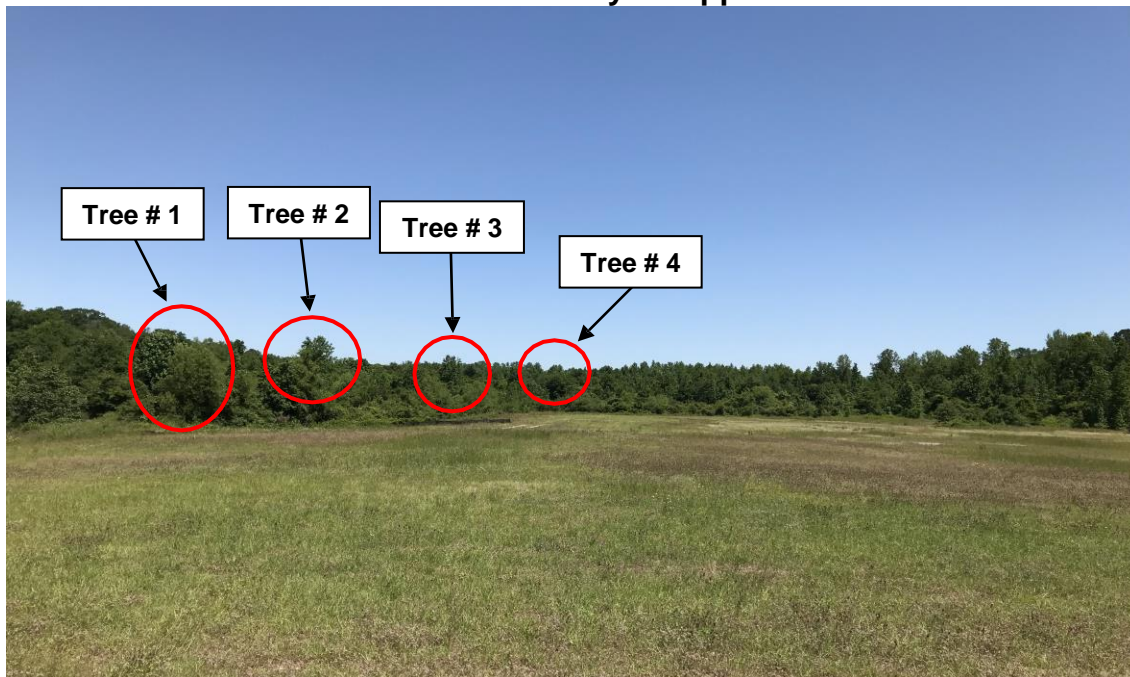
Photo # 1 – Runway 18 Approach

- Runway 18 – Trees labeled #1, #2, #3, and #4 obstruct the required 20:1 approach slope (See Photo #1).
- Runway 36 – No obstructions (See Photo #2).

1. Tree 22' Abv. RWY End
 284' From RWY End
 130' Right of Cntln.
 11:1 Obst. Clnc.

2. Tree 19' Abv. RWY End
 311' From RWY End
 91' Right of Cntln.
 5:1 Obst. Clnc.

3. Tree 36' Abv. RWY End
 526' From RWY End
 150' Right of Cntln.
 2:1 Obst. Clnc.

4. Tree 32' Abv. RWY End
 755' From RWY End
 105' Right of Cntln.
 17:1 Obst. Clnc.

Inspection Area	Violation/Maintenance	Corrective Action
Approach/Departure Paths	VIOLATION	Remove all trees that obstruct the required 20:1 Approach/Departure Path on RWY 18
Airport Lighting	Maintenance	Repair/replace inoperative lights
Fueling Area	Maintenance	Re-inspect and tag fire extinguishers on Jet-A refueler

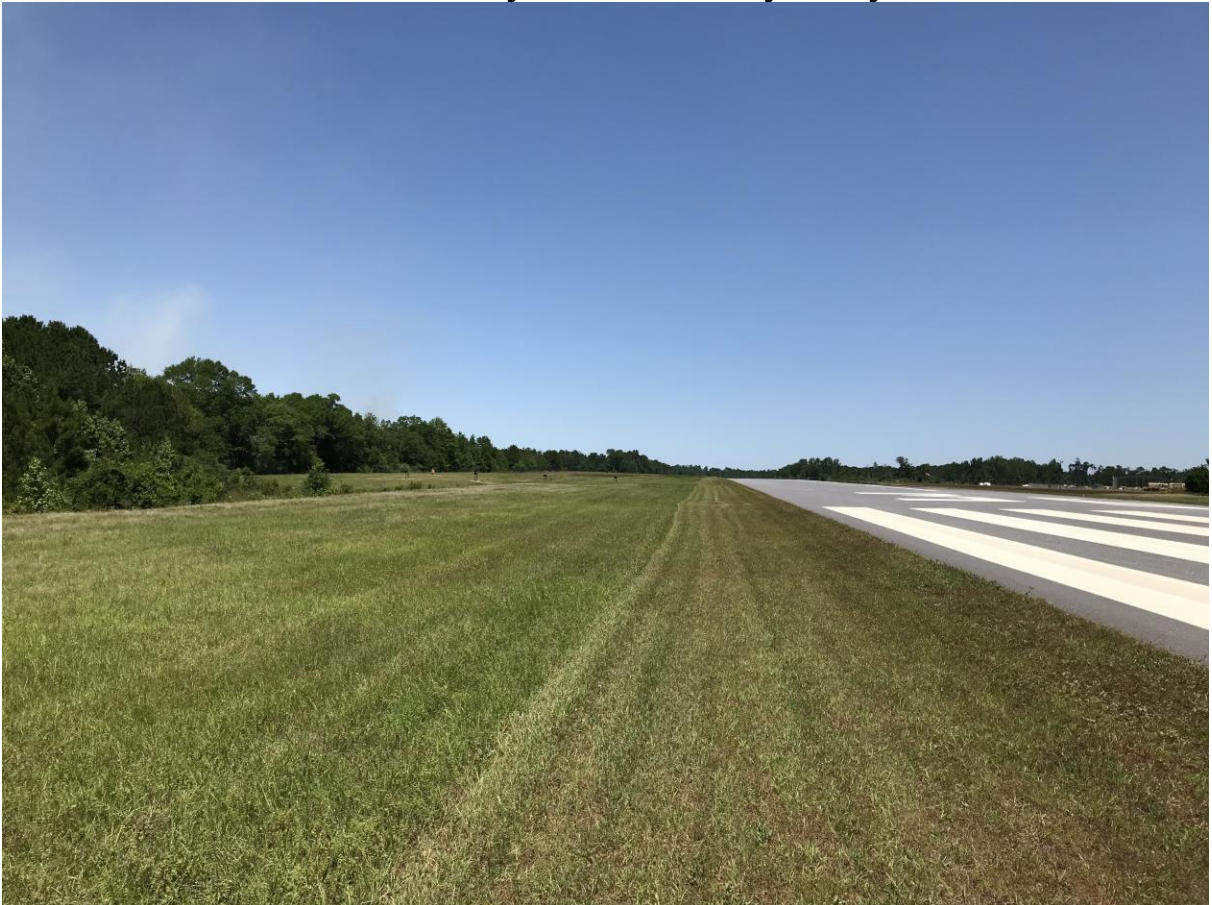
Photo #3—Primary Surface/Runway Safety Area

- The Primary Surface meets state licensing requirements (See Photo #3).

- The Runway Safety Area meets licensing requirements (See Photo #3).

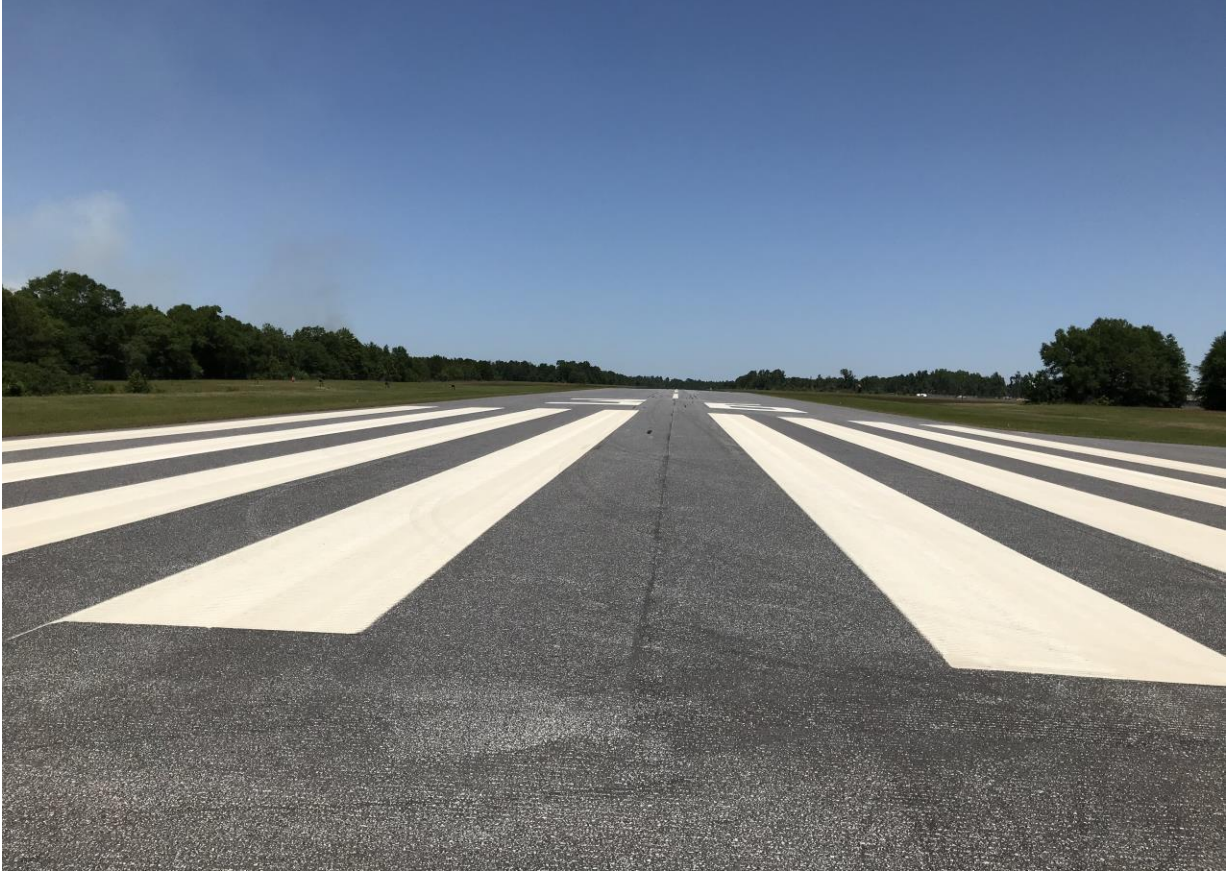
Photo #4—NPI Markings RWY 36

- The runway markings are in **GOOD** condition (See Photo #4).
- The taxiway markings are in **FAIR** condition.

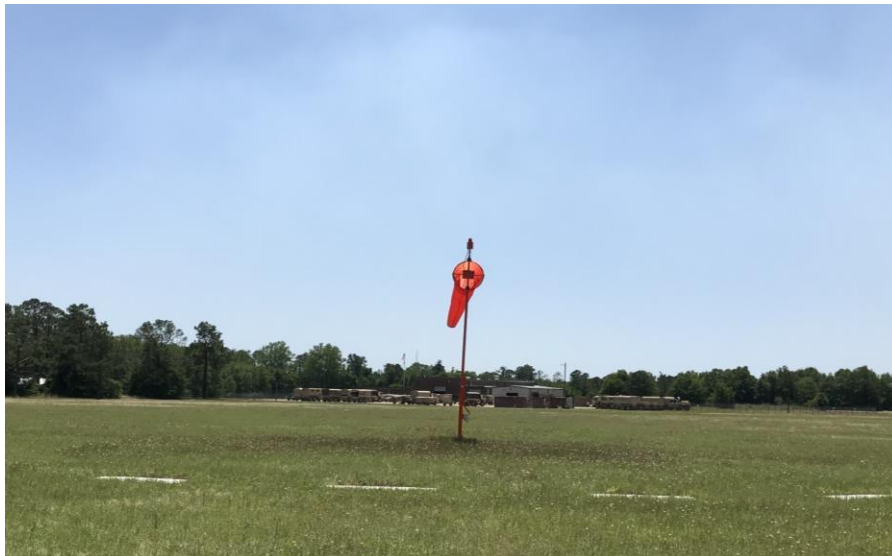
Photo #5 – Wind Cone

- The wind direction indicator (wind cone) is in **GOOD** condition (See Photo #5).

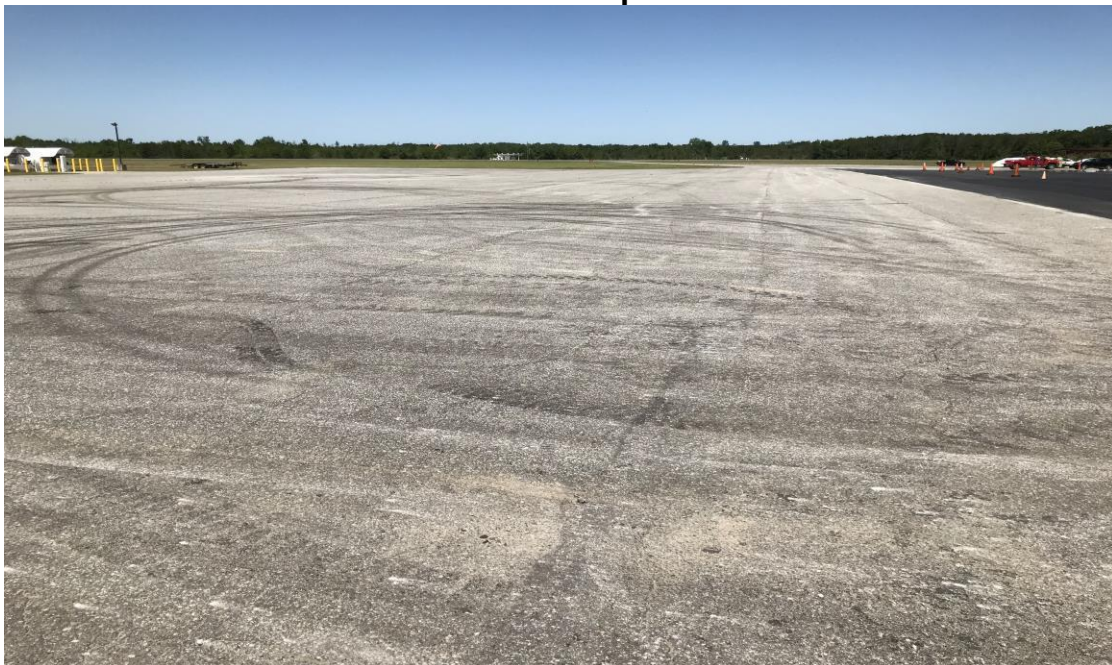
Photo #6—Apron

- The runway pavement surfaces are in **GOOD** condition.
- Taxiway/Apron pavement surfaces are in **FAIR** condition (See Photo #6).
- It should be noted that ramp improvements are ongoing.

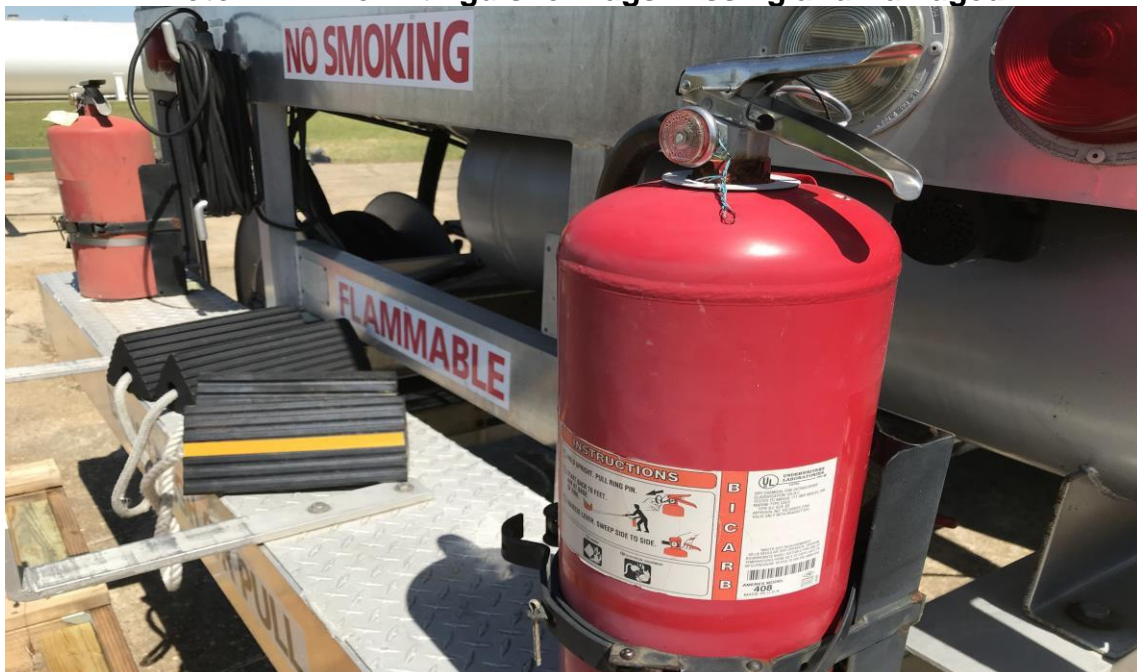
Photo #7 – Fire Extinguisher Tags Missing and Damaged

- Fire extinguisher tags were missing or damaged on the Jet-A refueler (See Photo #7).

- Have fire extinguishers re-inspected and tagged properly.
- It should be noted that new tags/inspections were on order.

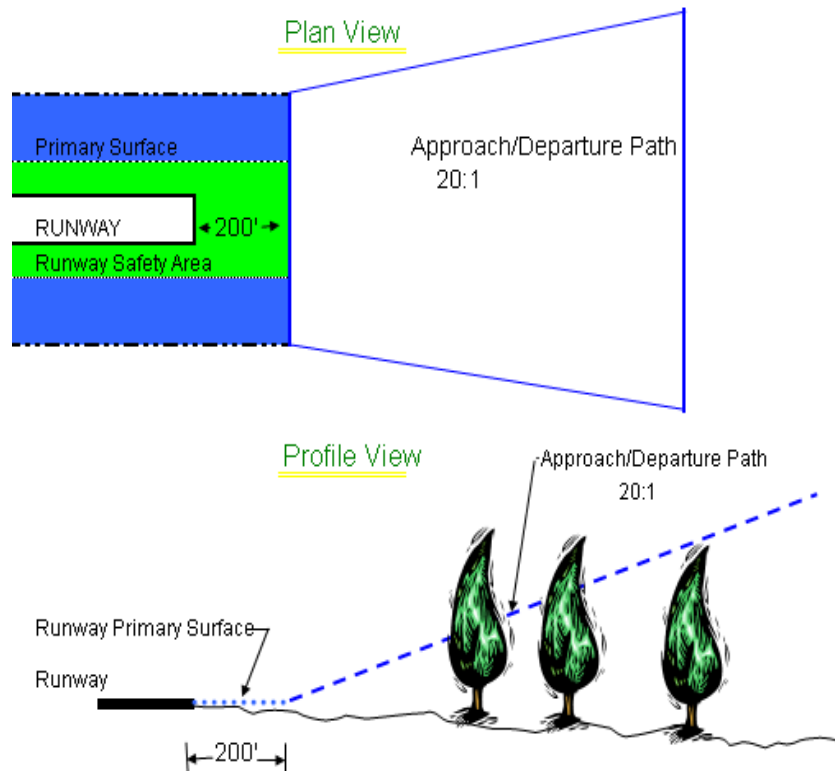
APPENDIX 1

Approach and Departure Path Dimensions			
Inner Width	Outer Width	Length	Acreage
250 Feet	450 Feet	1,000 Feet	8.04 Acres
Primary Surface Dimensions			
250 Feet Wide Centered Along Runway Centerline			
Extending 200 Feet Past the Runway End			
Runway Safety Area Dimensions			
120 Feet Wide Centered Along Runway Centerline			
Extending 200 Feet Past the Runway End
